**Review of Alyeska Pipeline Service Company's (APSC's)  
2010 American Petroleum Institute Standard No. 653 (API 653)  
out-of-service internal and external inspection on  
Crude Oil Tank No. 12 (Tank 12).**

Purchase Order 16704

January 22, 2016

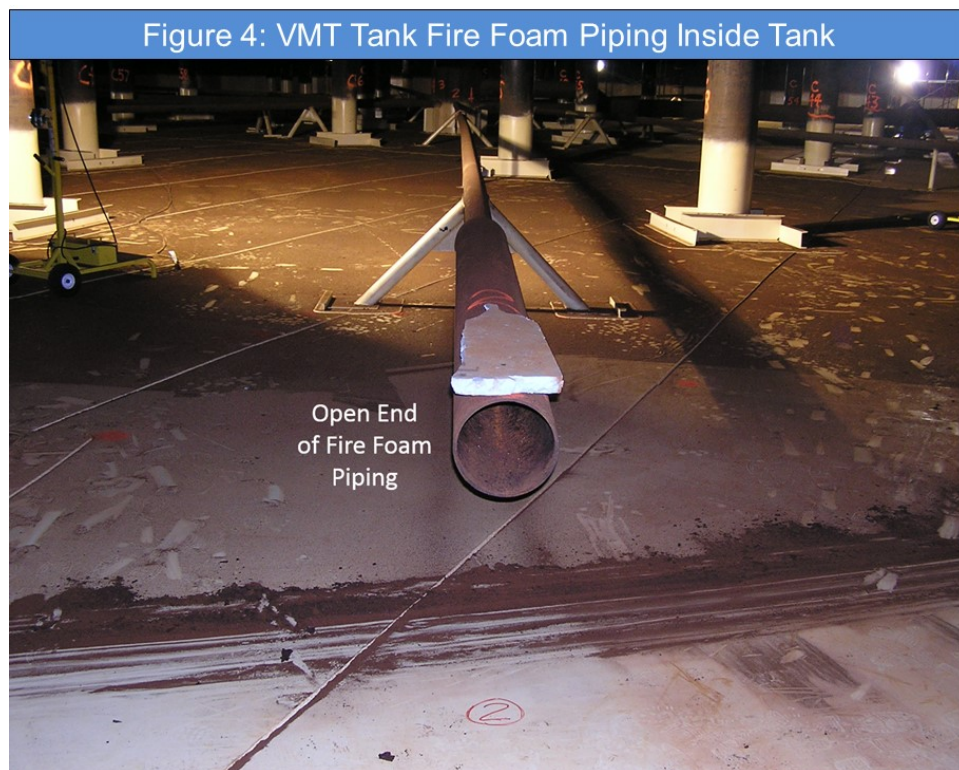
Figure 4 is a photo of the inside of a VMT tank showing the location of the fire foam system piping at the bottom of the tank, above the tank floor. This tank was opened for inspection and repair. This photo shows the open end of the fire foam system piping. The open end is 10" in diameter.
