LOSS CONTROL ASSOCIATES INCORPORATED

FIRE SAFETY REVIEW PWSRCAC FIRE CONSULTANTS OCTOBER 28-31, 2002

SLIDES ON CORRIOSION OF THE FIRE MAINS

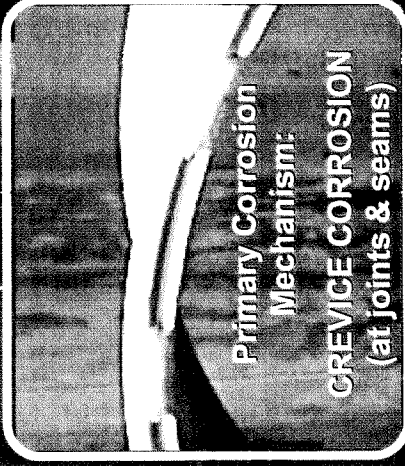
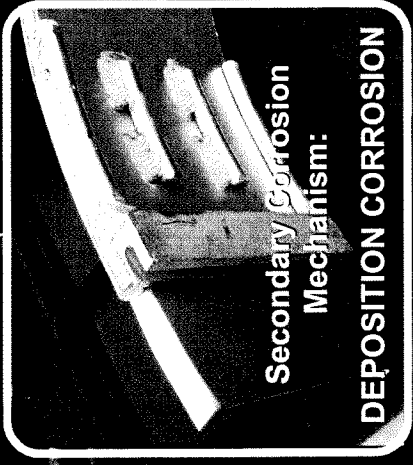
Corrosion Mechanisms vs. End-Seal Design

- Aluminum Components: Anodic to all other metals present in the firewater system and extremely susceptible to corrosion in saltwater environments.
- Tack Weld Construction: Creates numerous crevices, voids, and seams.
- Flow Characteristics of End-Seal Design: Protuberances (i.e. stiffener segments) creates "riffle" effect to concentrate aeration in crevice areas as well as debris and possible dissimilar metal particles.

- CREVICE CORROSION: "Forms in cracks or crevices between mating surfaces of metal assemblies. Metals that depend on oxide films for corrosion resistance [e.g. aluminum] are particularly susceptible to crevice corrosion"
- DEPOSITION CORROSION: "A form of galvanic corrosion that can occur in an aqueous environment when a more 'noble' metal [i.e. copper, bronze, or carbon steel] is plated out of solution onto a more anodic metal surface [aluminum]."

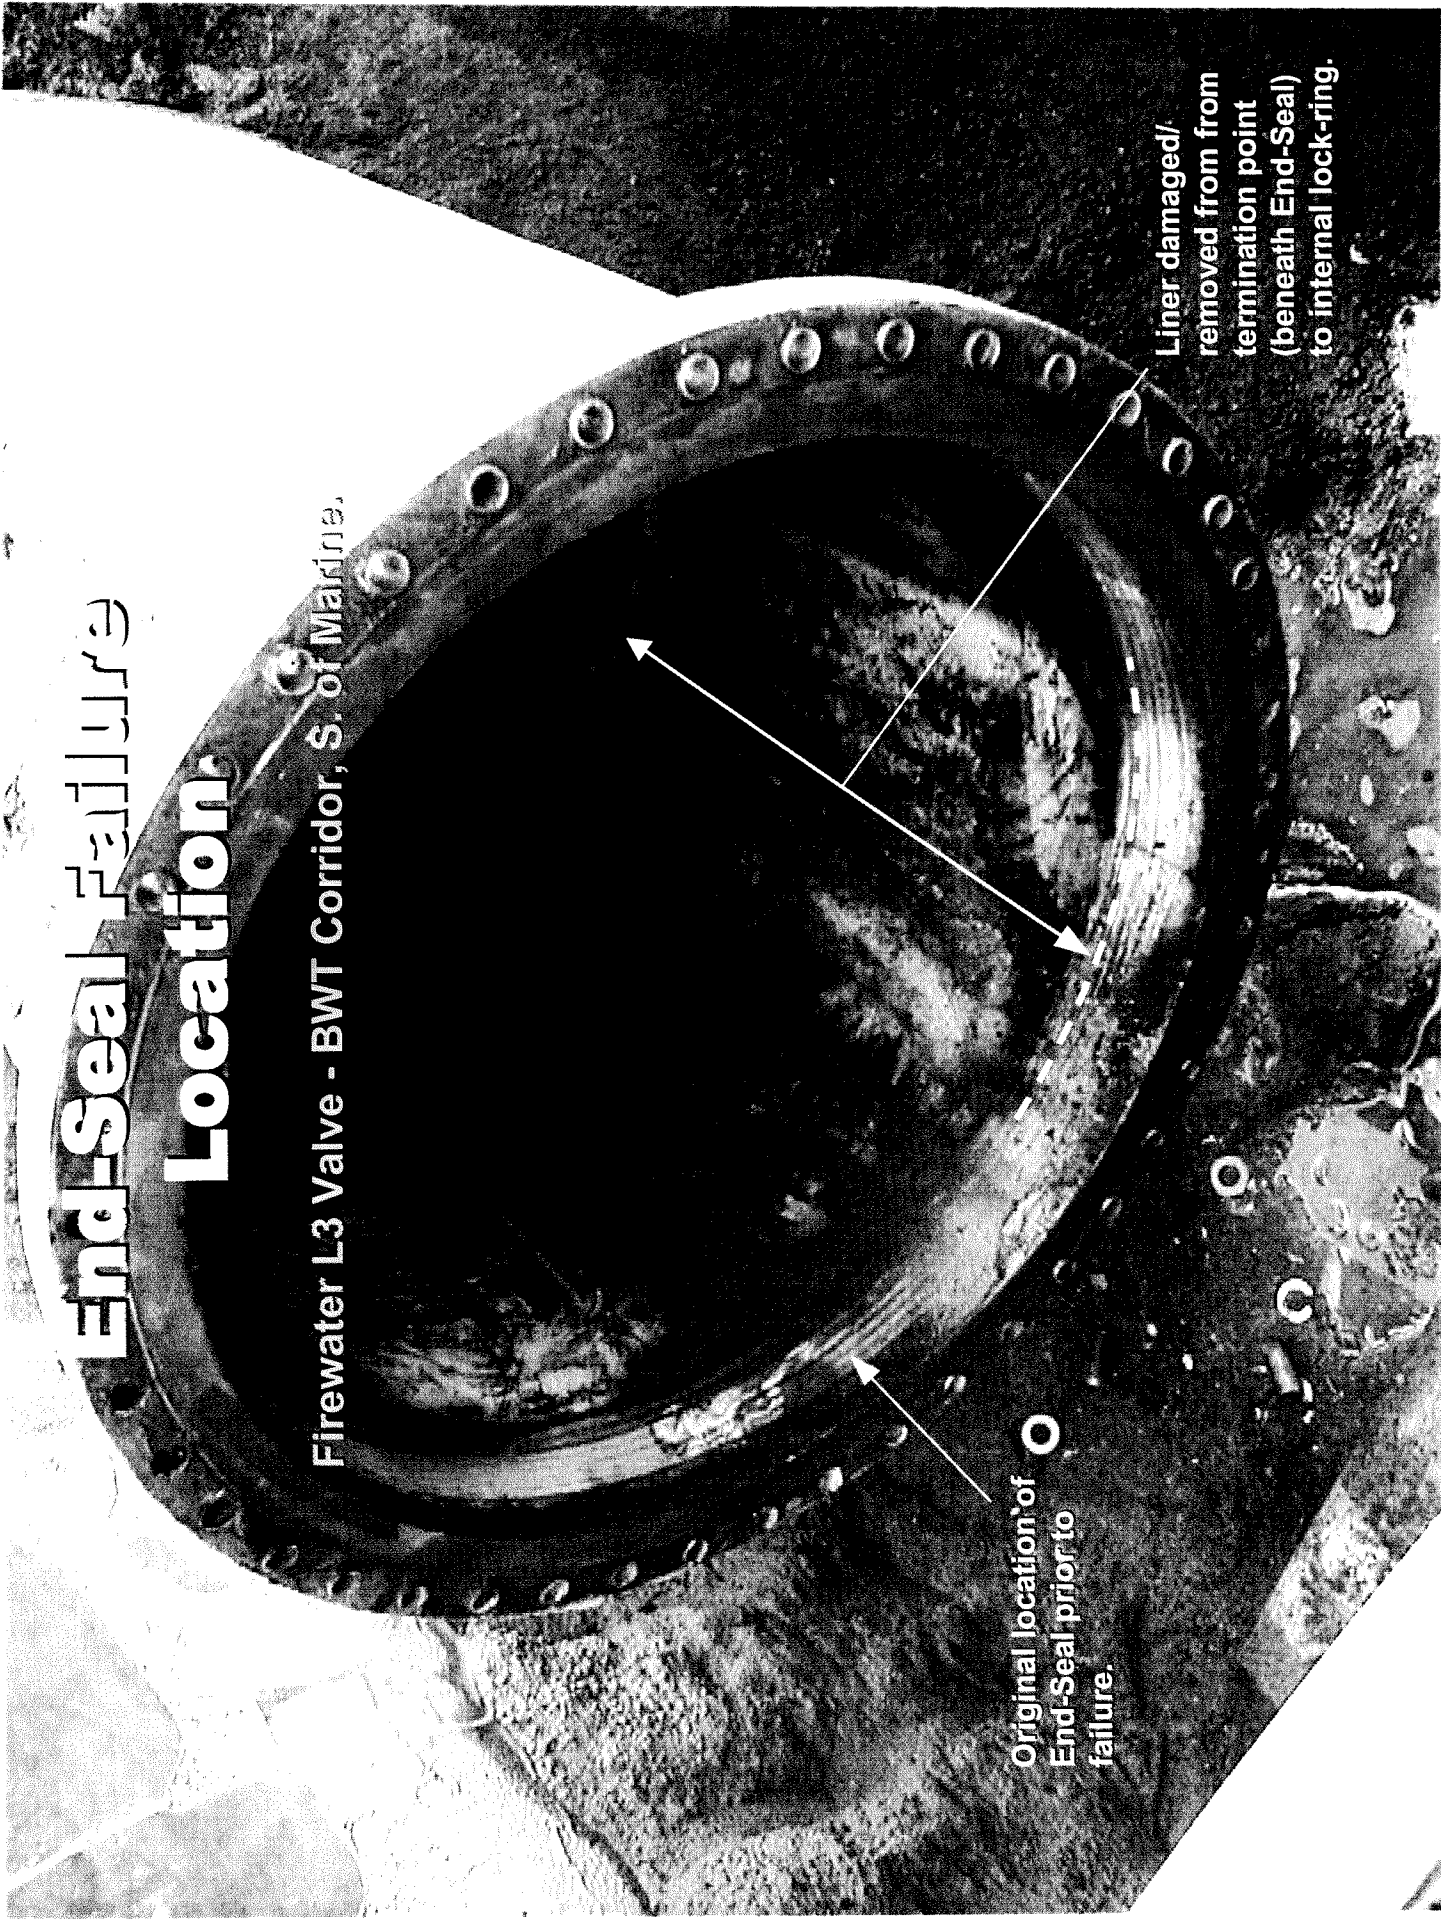
End-Seal Failure Location

Firewater L3 Valve - BWT Corridor, S. of Marine.

Original location of End-Seal prior to failure.

Liner damaged/removed from termination point (beneath End-Seal) to internal lock-ring.

VMT will be replacing liner rings with new rings after the proper metalurgical requirements are determined. The current failed rings will be replaced with spare items in stock. Once the new design is determined these rings will be replaced with the new design. (See **Attachment 1** for slides on the Corrosion of the Fire Mains).

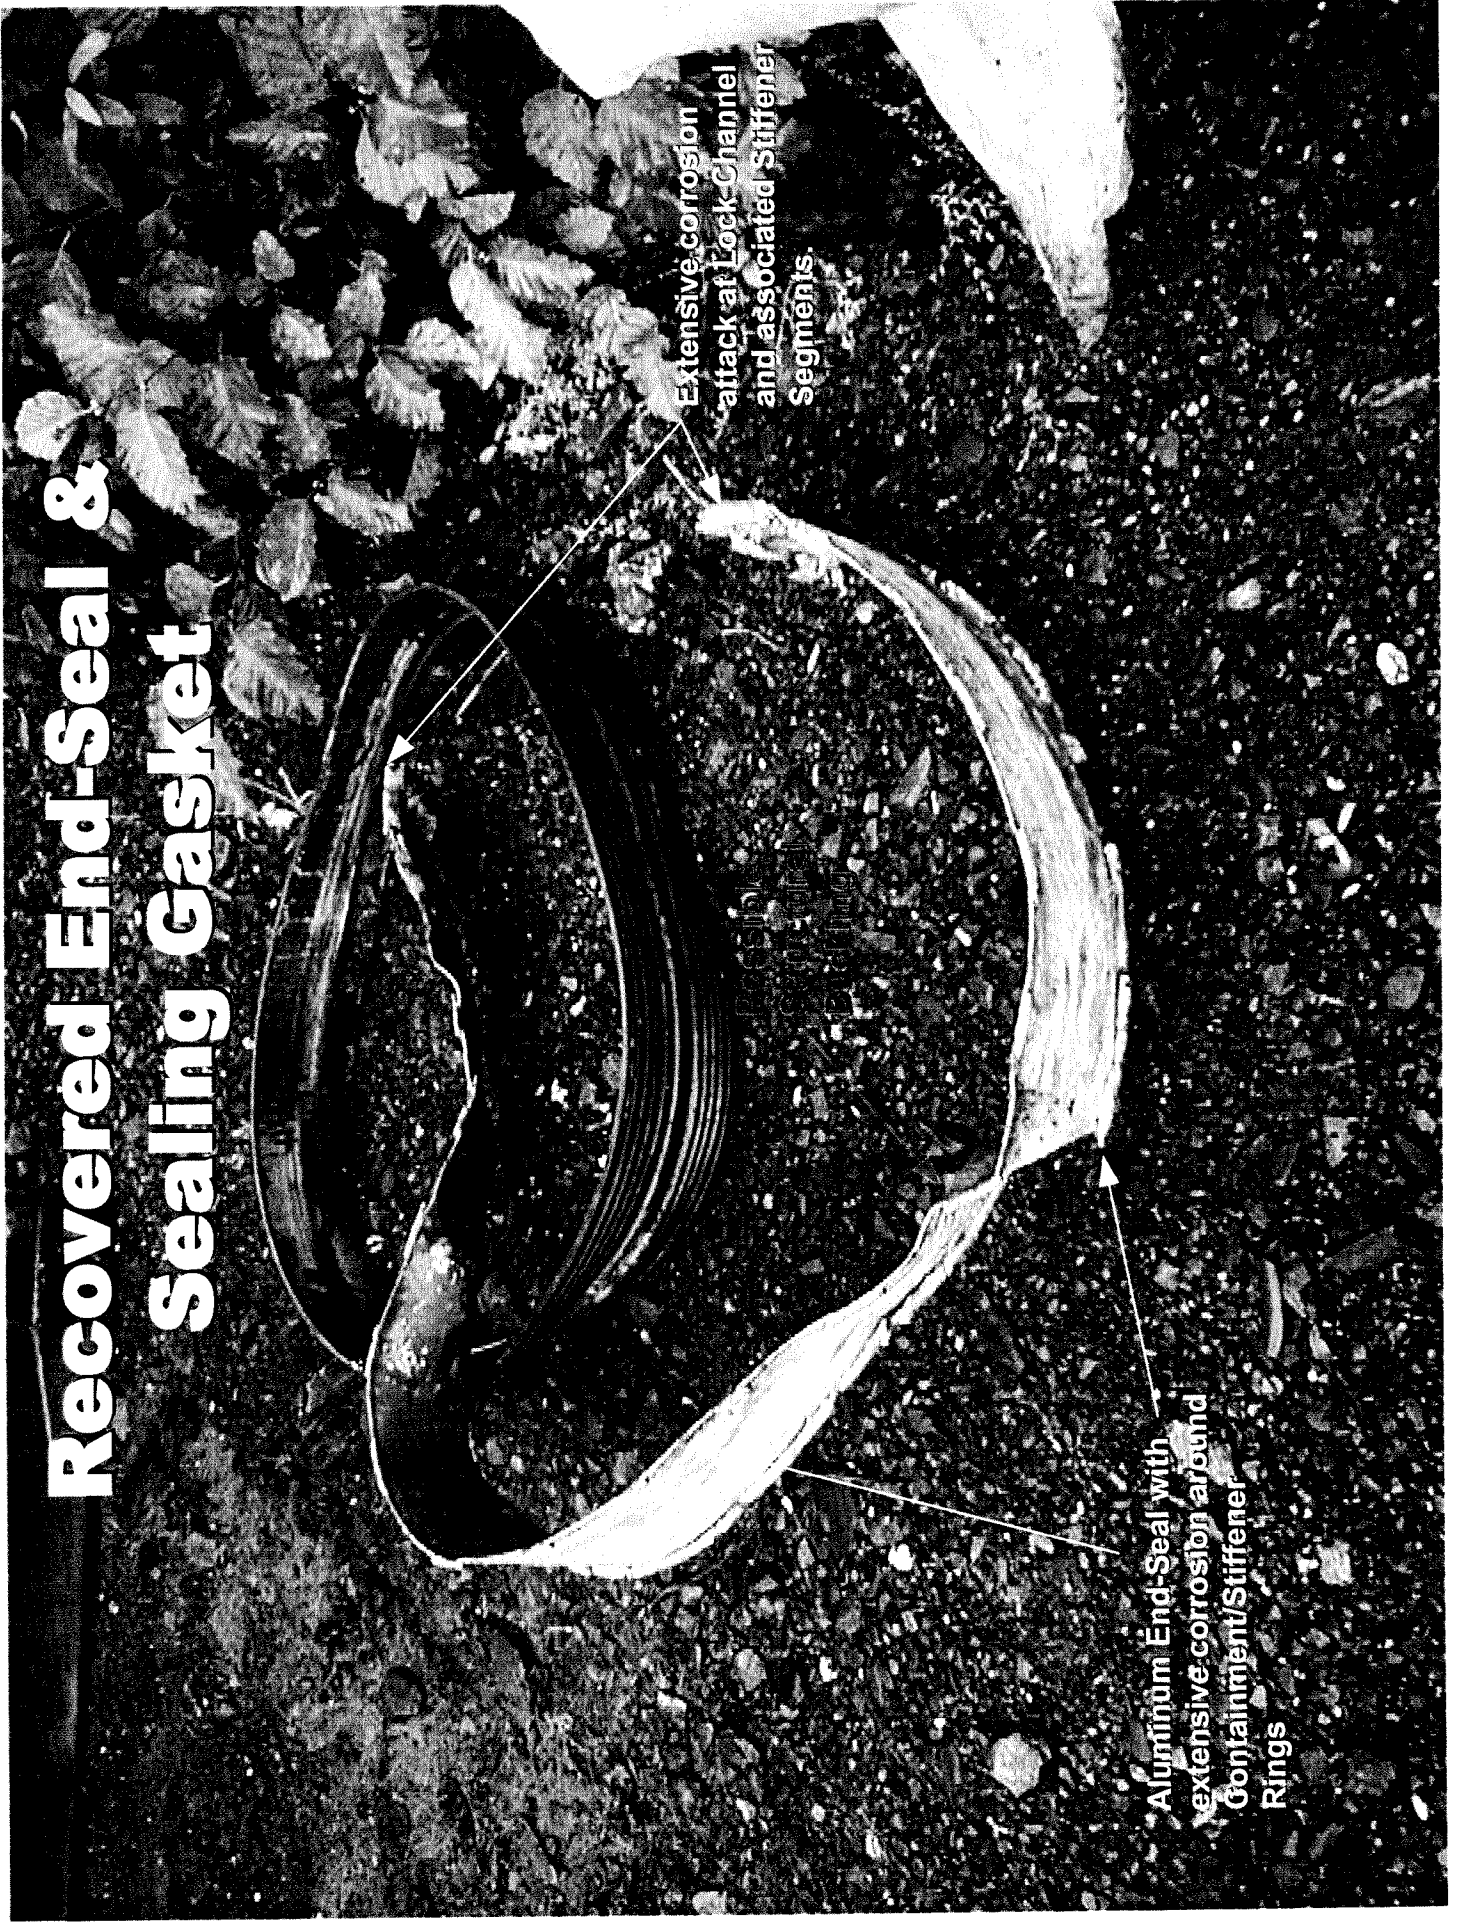
Recovered End-Seal & Sealing Gasket

Extensive corrosion
attack at Lock-Channel
and associated Stiffener
Segments.

Aluminum End-Seal with
extensive corrosion around
Containment/Stiffener
Rings

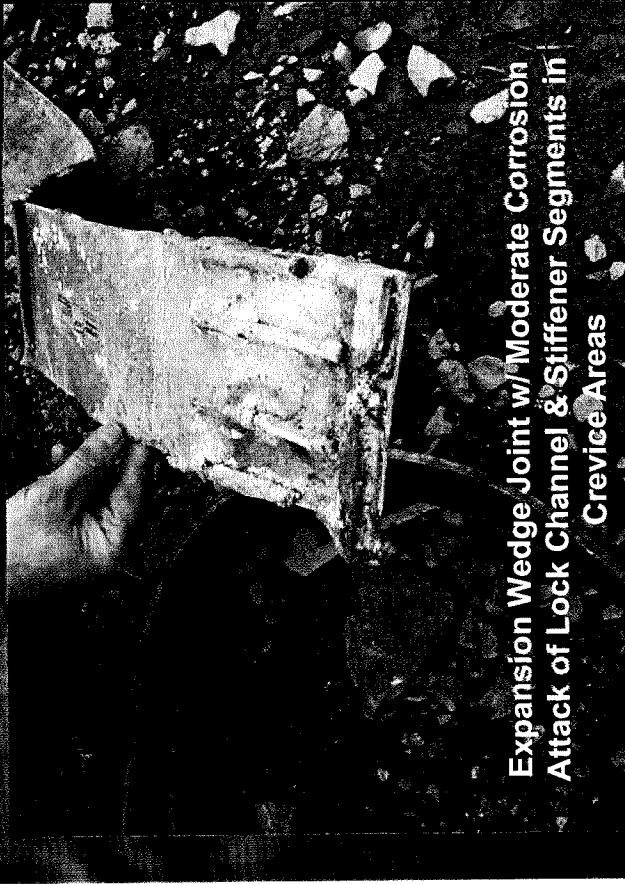
Failed End-Seal Details

Expansion Wedge Joint w/ Moderate Corrosion
Attack of Lock Channel & Stiffener Segments in
Crevice Areas

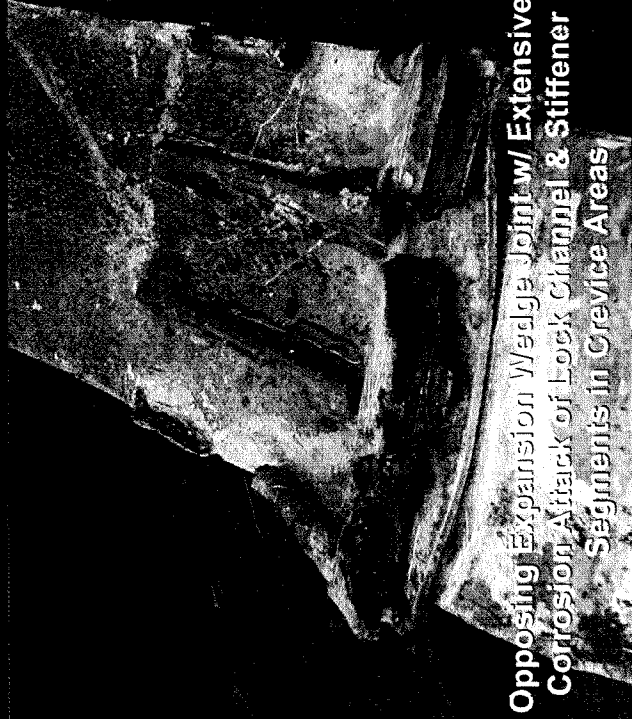
Opposing Expansion Wedge Joint w/ Extensive
Corrosion Attack of Lock Channel & Stiffener
Segments in Crevice Areas

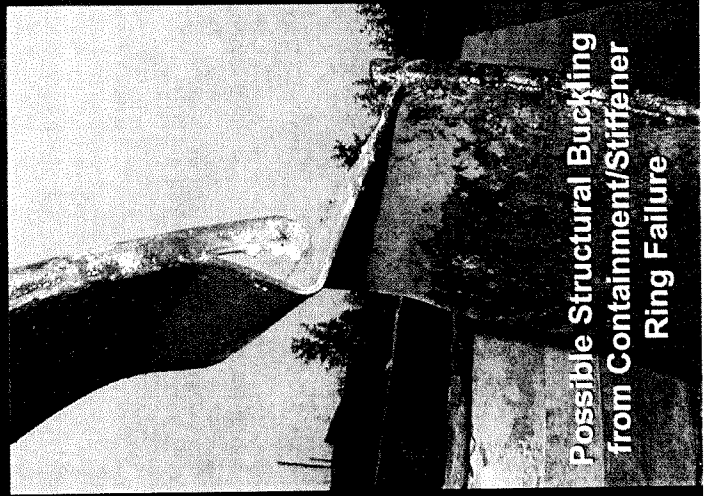
Possible Structural Buckling
from Containment/Stiffener
Ring Failure

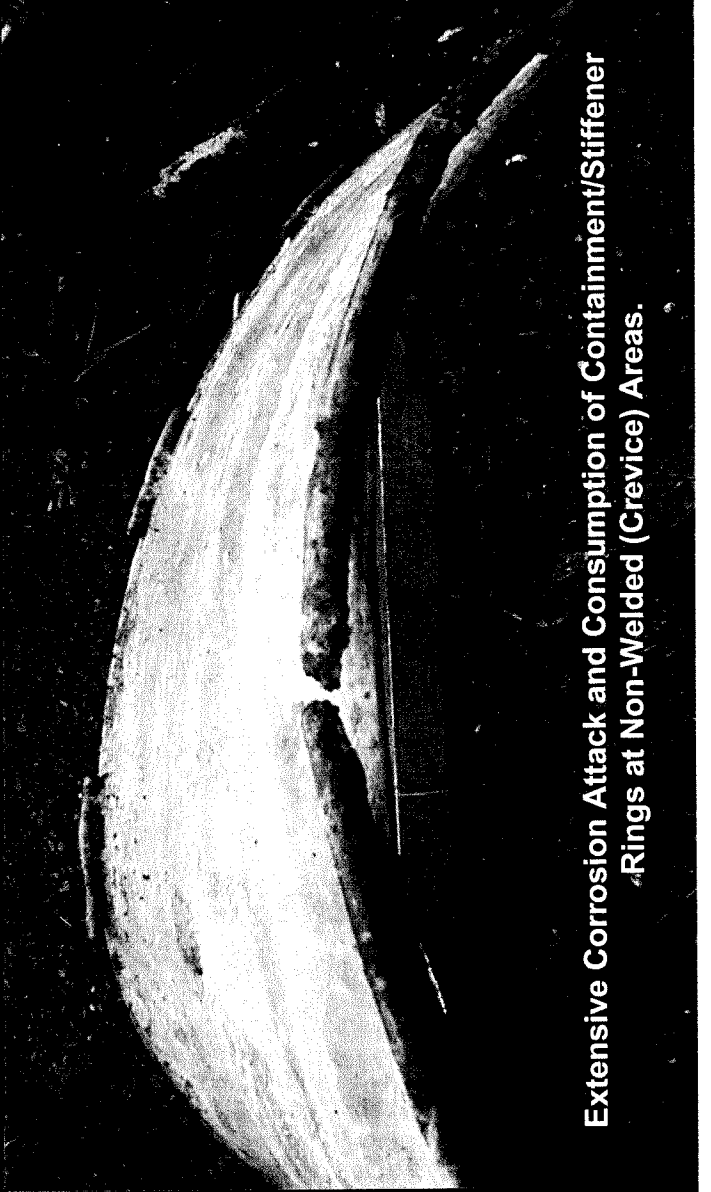
Extensive Corrosion Attack and Consumption of Containment/Stiffener
Rings at Non-Welded (Crevice) Areas.

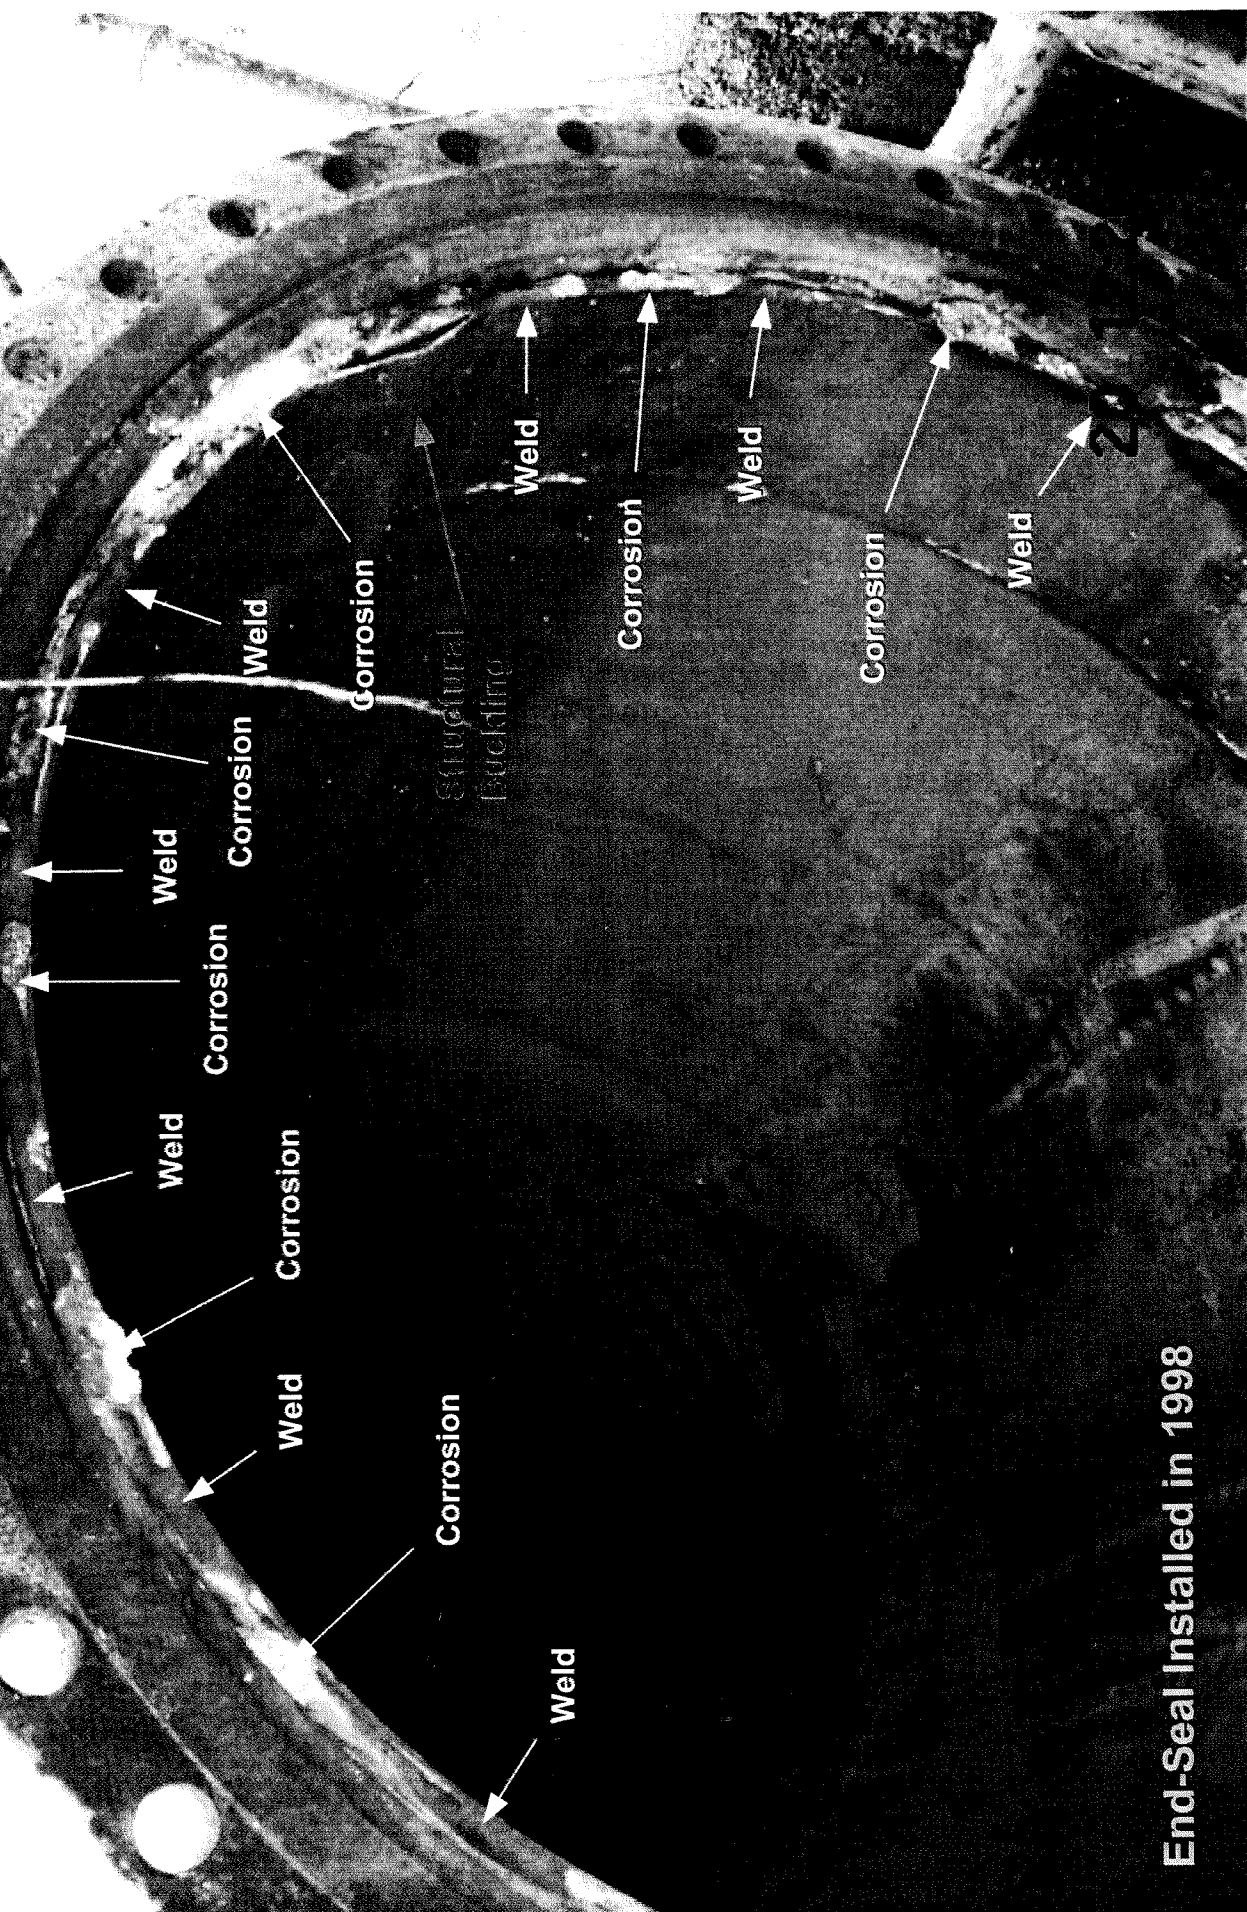
V189 Dig Site #1 - N. of BWT DAF Cell Bldg.

Anatomy of an In-Progress Failure

End-Seal Installed in 1998

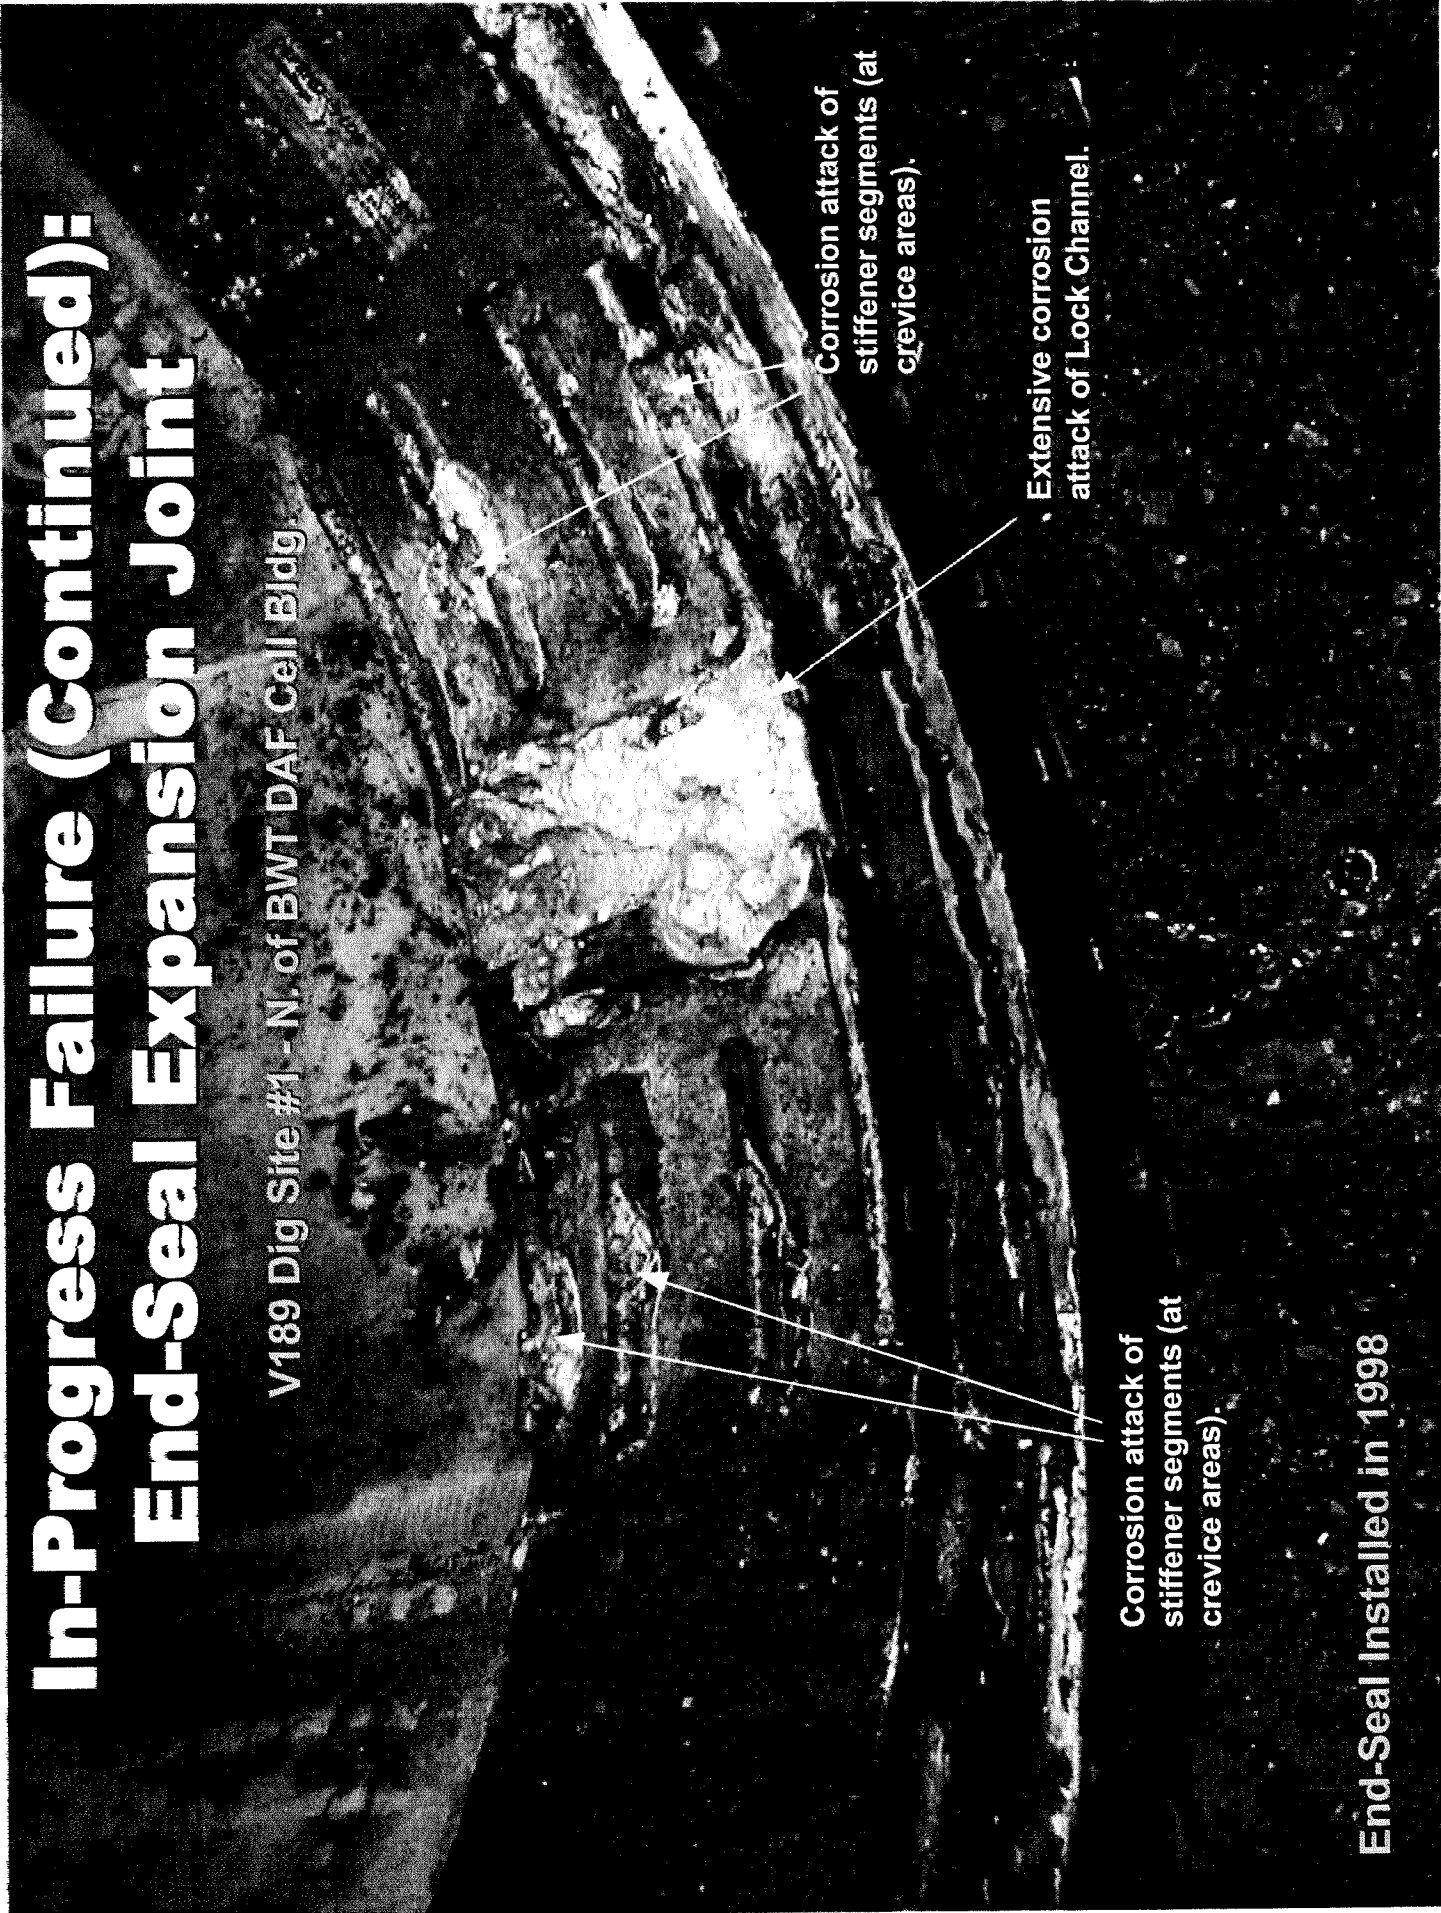
V189 Dig Site #1 - N. of BWT DAF Cell Bldg

In-Progress Failure (Continued): End-Seal Expansion Joint

Corrosion attack of stiffener segments (at crevice areas).

Extensive corrosion attack of Lock Channel.

End-Seal Installed in 1998

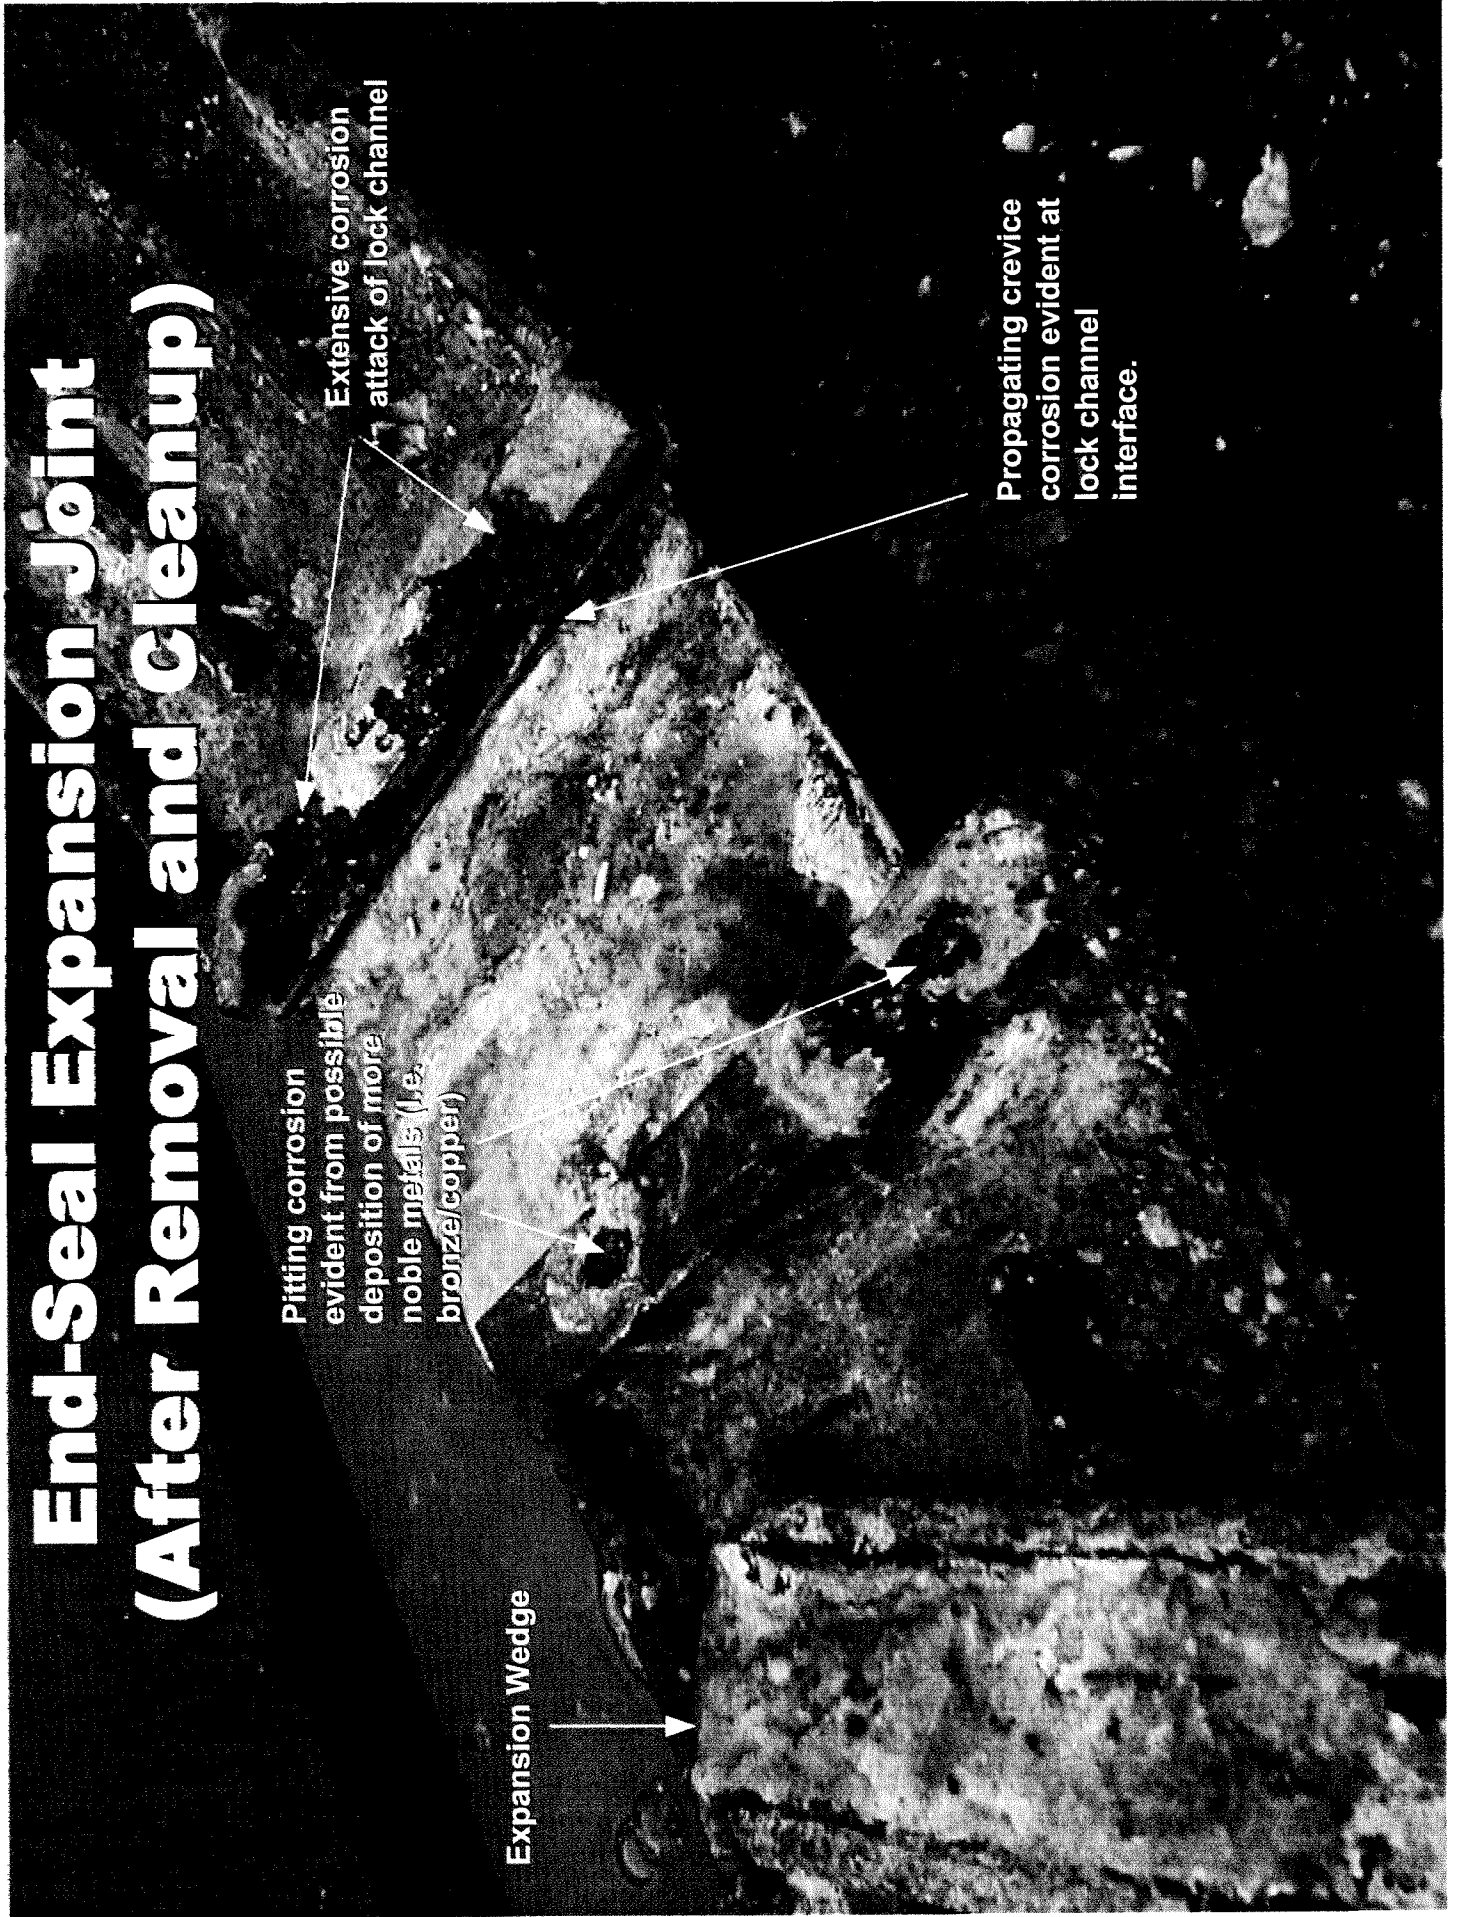
End-Seal Expansion Joint (After Removal and Cleanup)

Pitting corrosion
evident from possible
deposition of more
noble metals (i.e.,
bronze/copper)

Extensive corrosion
attack of lock channel

Expansion Wedge

Propagating crevice
corrosion evident at
lock channel
interface.
