FINAL REPORT

R-PWS-20141111

Review of Piping Inspection Programs at the Valdez Marine Terminal (5590.14.01)

Review of Piping Inspection at the Valdez Marine Terminal

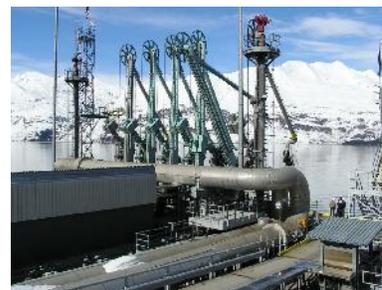
VMT Current PIT Program

Remove insulation and inspect using automated and hand Ultrasonic Techniques, X-ray, and Guided Wave

Needed for down stream of crude oil expansion loop under control rooms on outboard ends of berths 4 & 5

Over water
