Seismic Re-Engineering of the Valdez Marine Terminal (VMT)
Contract No. 556.07.0007

Rock Slope Stability of the VMT

**The Prince William Sound
Regional Citizen's Advisory Council (RCAC)**

September 2007

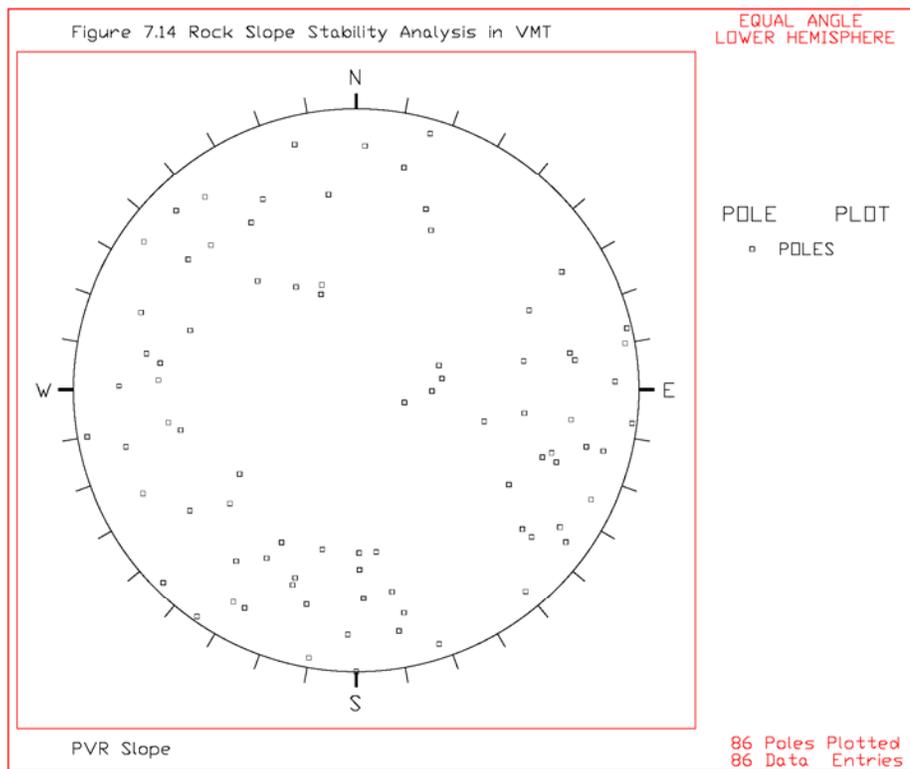
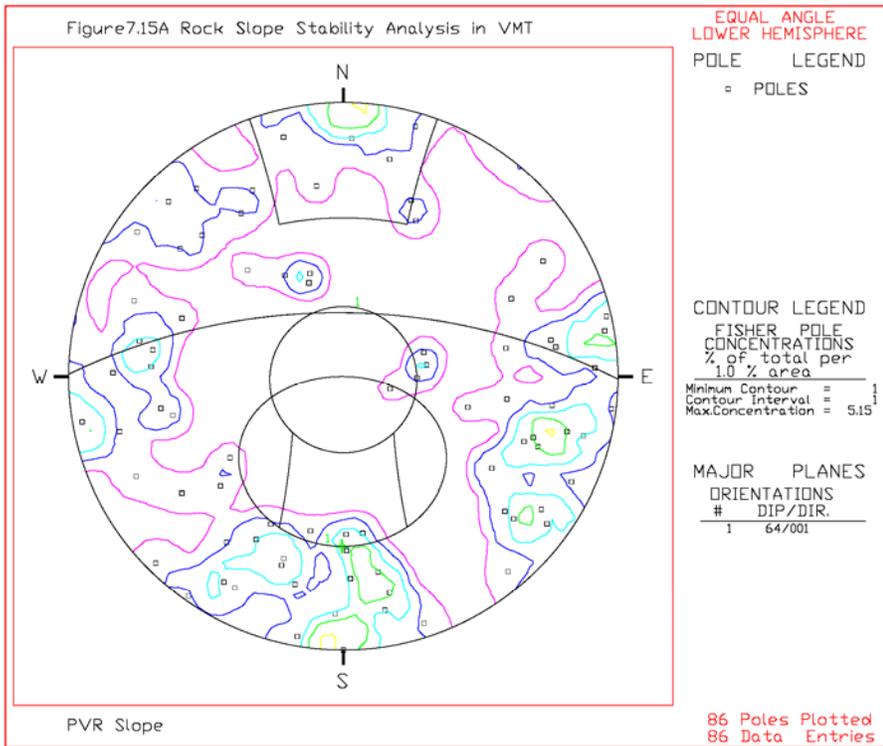
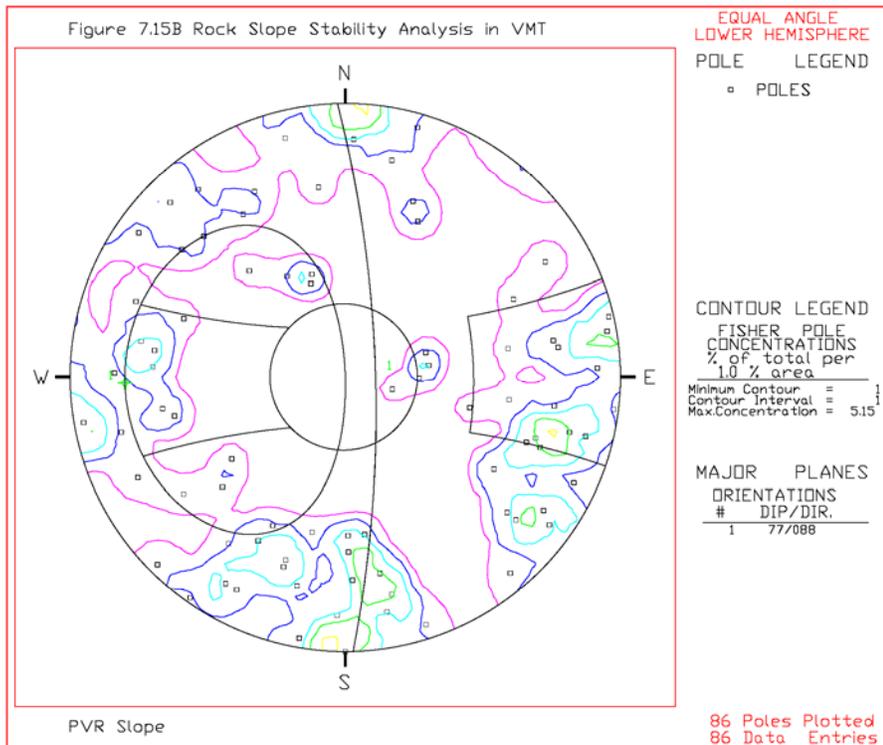
Based on the kinematic analysis shown in Figures 7.15A and 7.15B, and Figures 7.17A and 7.17B, it is anticipated that joint J5 (88/003) and the intersection of joint sets J3 (80/307) and J4 (73/096) are kinematically unstable with regard to planar and wedge failures along the slope south of the PVR facilities. It is also anticipated that local toppling along the south and west sides of the facilities and the local planar and wedge failures along the slope west of the facilities, can occur for this slope. However, it appears that toppling is not a major concern due to the lower height of the slope and the great distance to the facilities.

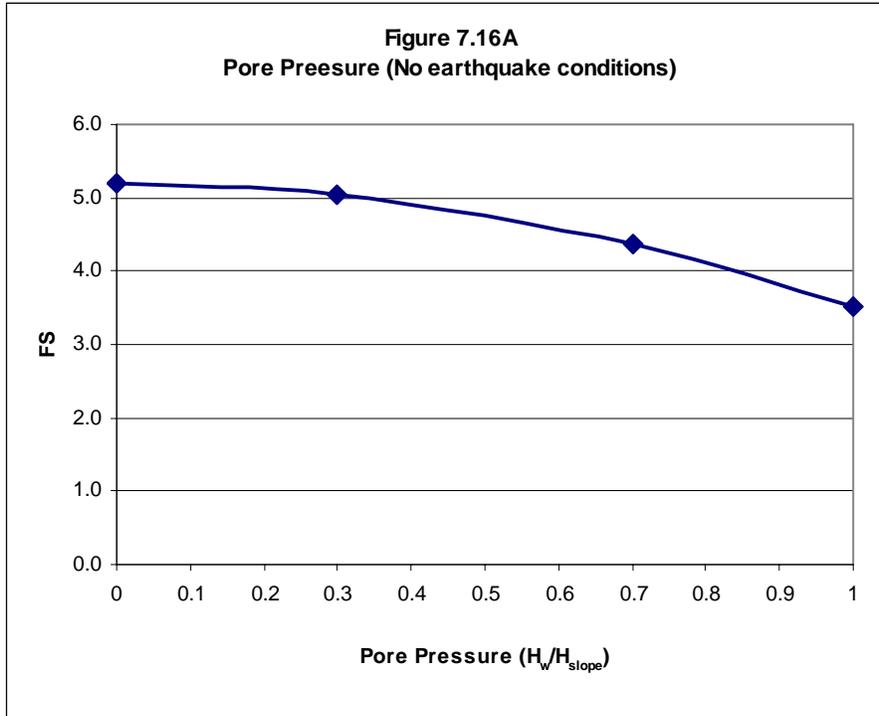
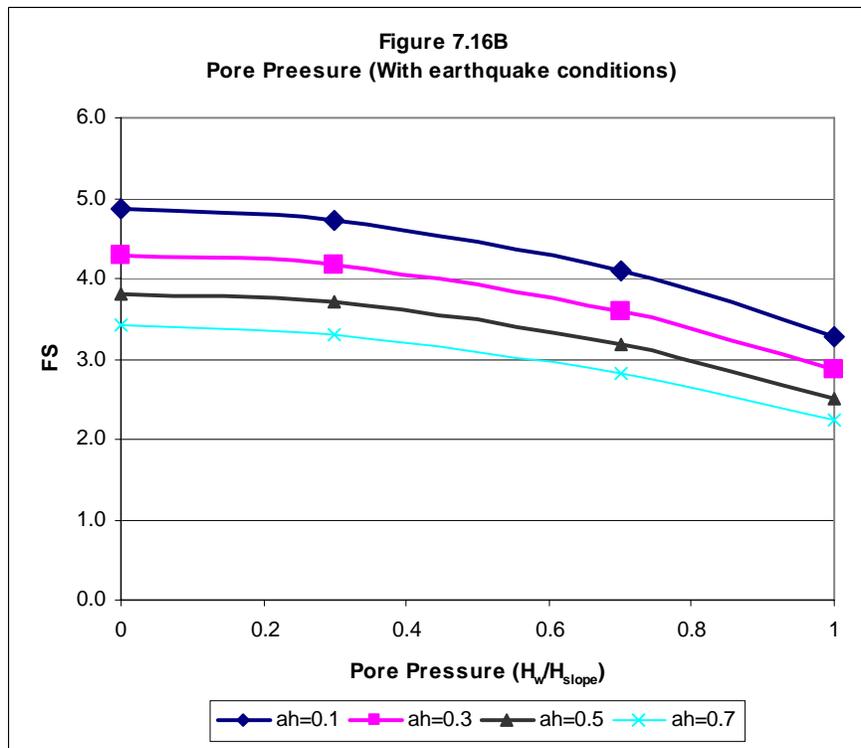
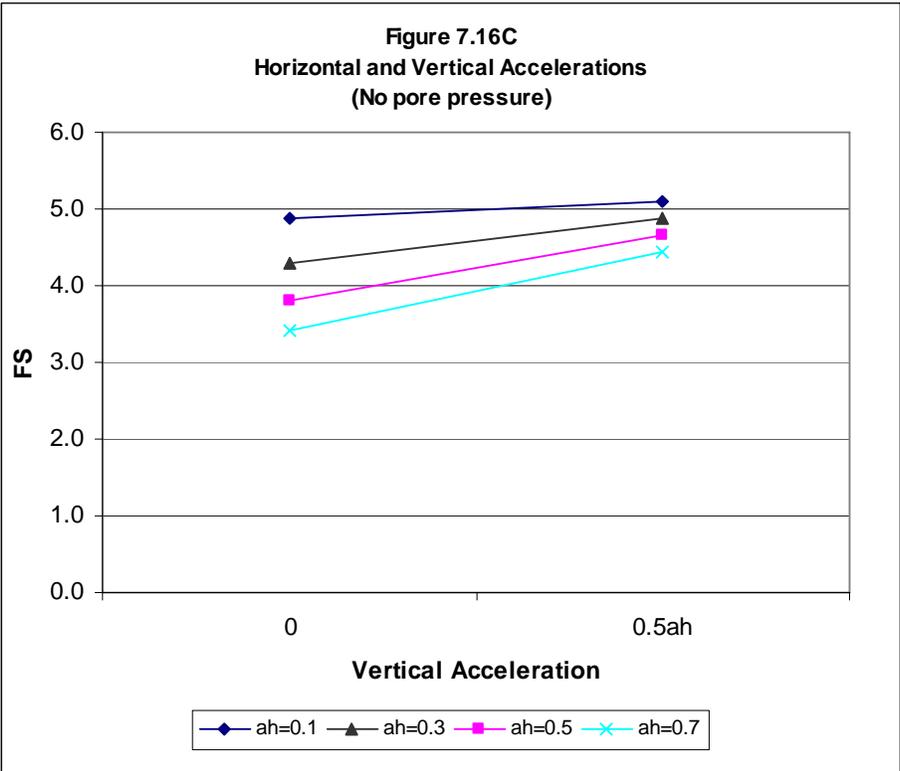
Based on the kinetic analysis on joint set J2 that was kinematically unstable in the planar failure mode, the factor of safety (FS) ranges from 5.20 to 3.53 under the pore pressure conditions of zero to saturated condition ($H_w/H_{\text{slope}} = 1$) without earthquake loading conditions. Under earthquake loading conditions ranging from 0.1g to 0.7g in addition to the pore pressure conditions, the FS ranges from 4.87 to 2.23 under various pore pressure conditions. Under the earthquake conditions considering both horizontal and vertical accelerations and dry conditions ($H_w/H_{\text{slope}} = 0$), the FS ranges from 5.09 to 3.42 under earthquake loading conditions ranging from 0.1g to 0.7g.

It appears that the PVR slope is stable with regards to the planar failure based on the parameters considered. The results of the kinetic analysis of the planar failure are shown in Figures 7.16A through 7.16C.

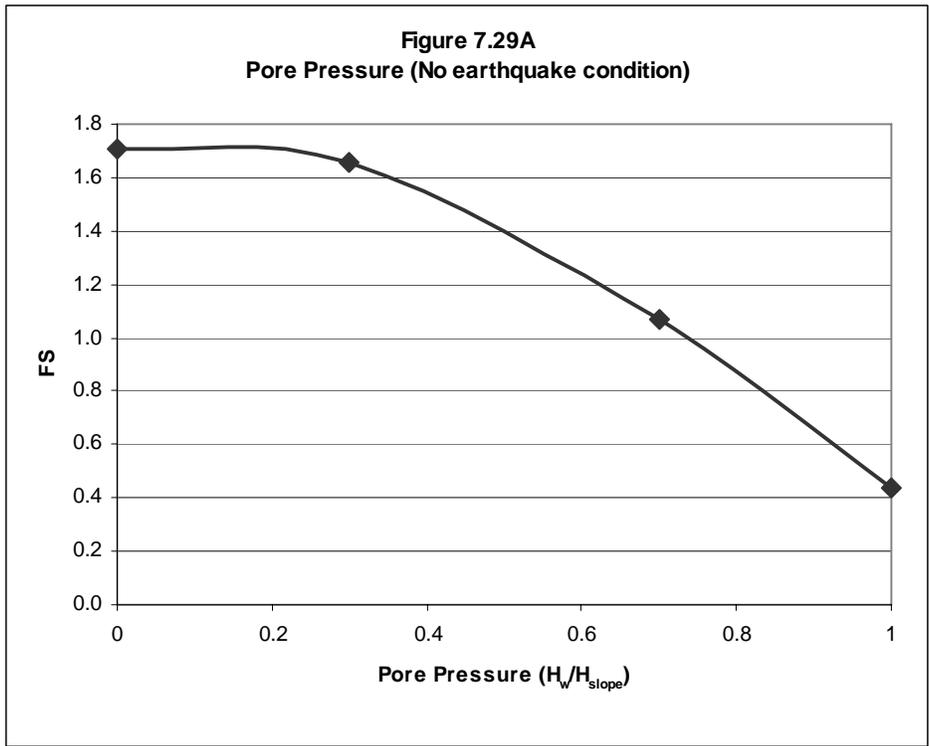
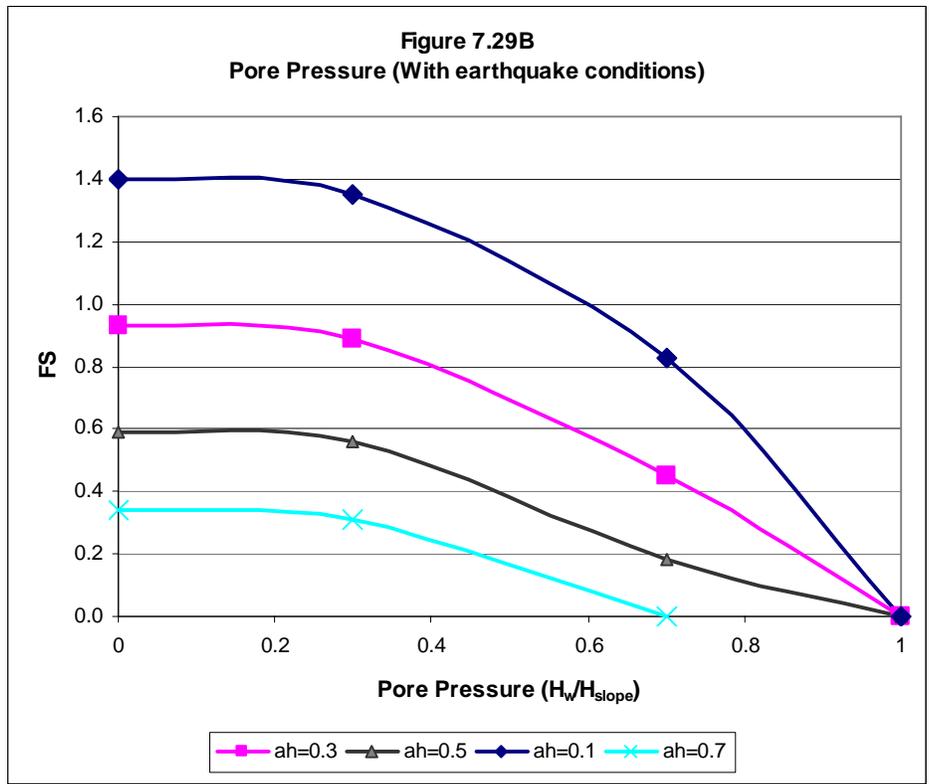
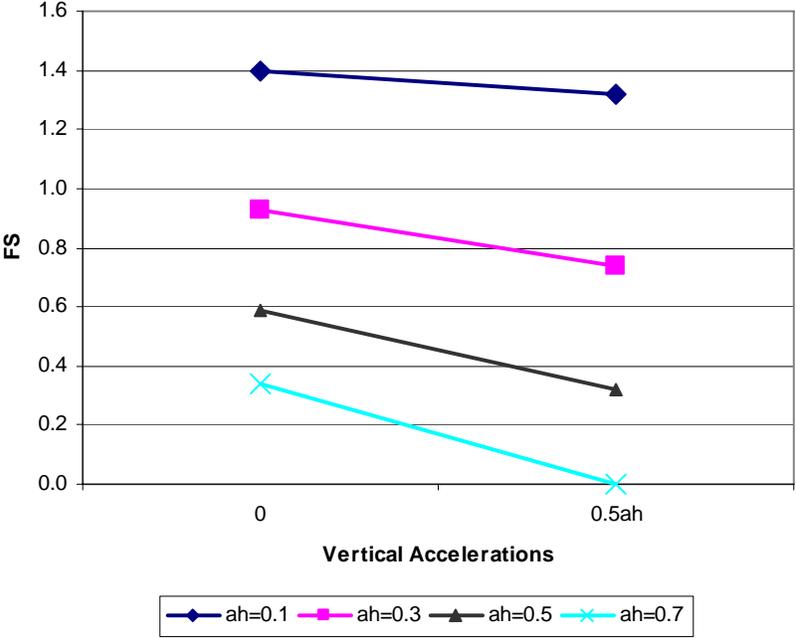
Figure 7.29C
Horizontal and Vertical Accelerations
(No pore pressure)

A kinetic analysis was performed on the joint sets of joints J3 and J4 that were kinematically unstable in the wedge failure mode. The FS ranges from 1.71 to 0.44 under the pore pressure conditions of zero to saturated condition ($H_w/H_{\text{slope}} = 1$) without an earthquake loading condition. Under earthquake loading effects ranging from 0.1g to 0.7g in addition to the pore pressure effects, FS ranges from 1.40 to zero under various pore pressure conditions. Under the earthquake conditions considering both horizontal and vertical accelerations and dry conditions ($H_w/H_{\text{slope}} = 0$), FS ranges from 1.40 to zero under earthquake loading conditions ranging from 0.1g to 0.7g. For this wedge failure mode, the minimum external loading condition that can cause a wedge failure is a pore pressure equal to $0.7H_w/H_{\text{slope}}$. If both earthquake and pore pressure loadings are considered together, the $0.6H_w/H_{\text{slope}}$ with 0.1g of horizontal acceleration will cause the wedge failure to occur. The results of the kinetic analysis of the wedge failure are shown in Figures 7.29A through 7.29C.
