**Seismic Re-Engineering of the Valdez Marine Terminal (VMT)  
Contract #556.08.01**

**The Prince William Sound  
Regional Citizen's Advisory Council  
(PWSRCAC)**

**December 2008**

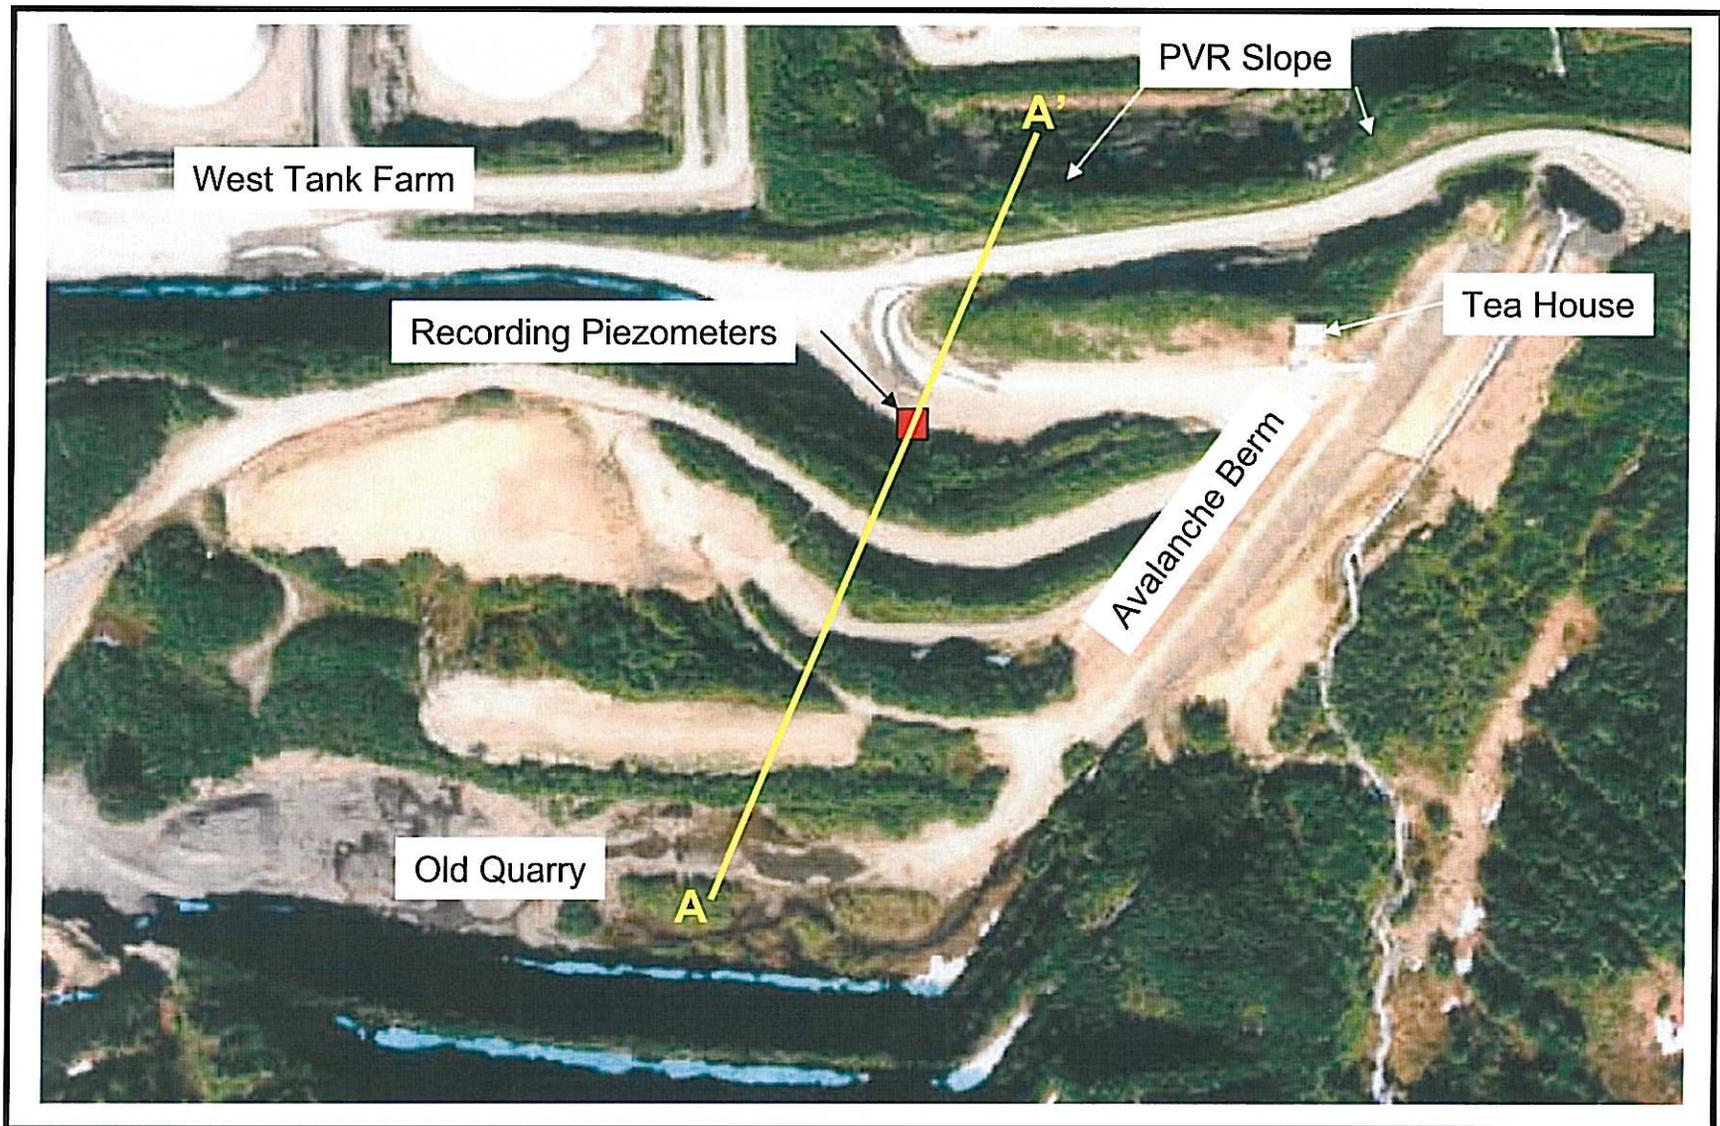
Figure 1

Location of Recording  
Piezometers and Profile A-A'

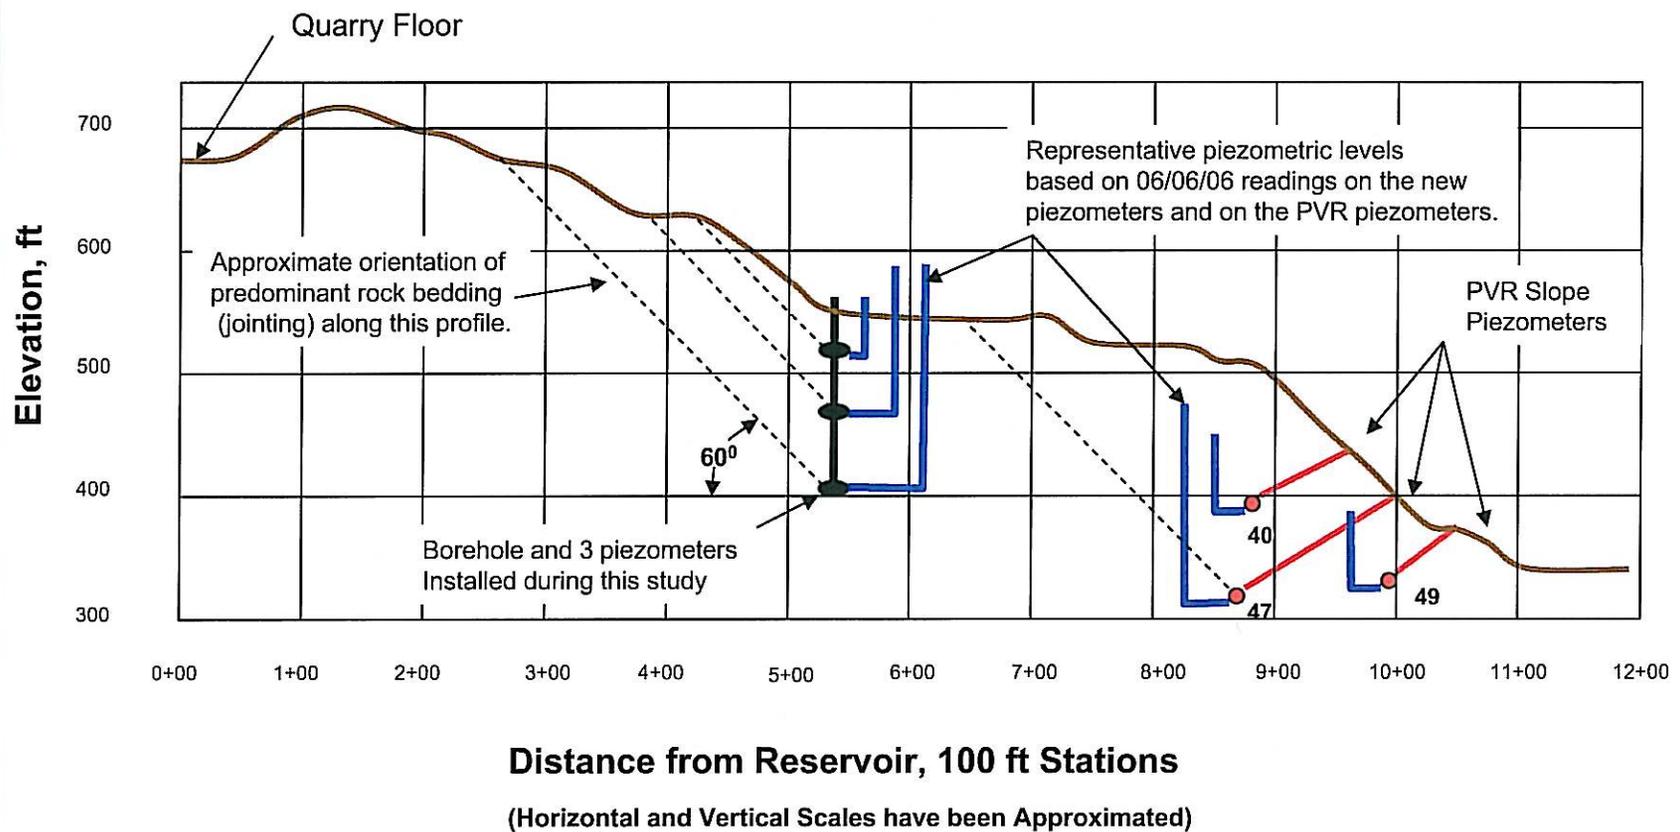
Figure 2

Approximate Profile A-A'  
Quarry to PVR Slope

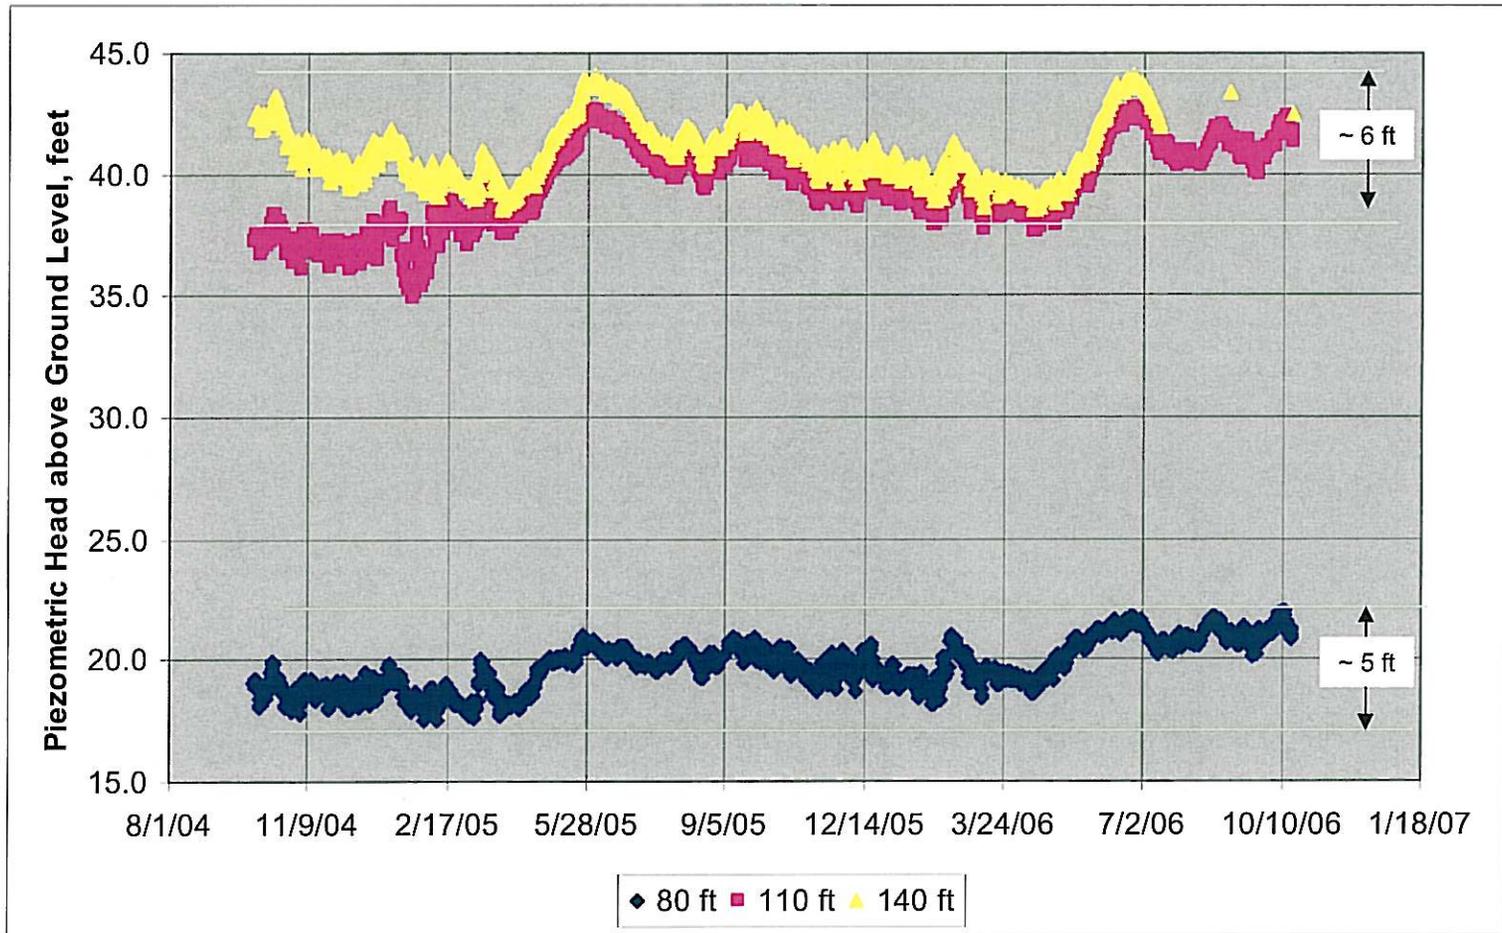
Figure 3

There is a concern about the piezometric levels for the PVR slope. Several values are above the flag levels established during construction. Also the three figures from the Golder, Dam report show a significant fluctuation in the levels over a two-year period. As the on-site piezometers are only read a few times per year, these values may not indicate the true range of water levels in the slope. Also the water levels could be higher between drain holes as a cone of depression exists relative to them much like that around a vertical water supply well. It is apparent that drainage of the rock slopes is difficult to accomplish as it was assumed that this could be done in 1975 but has not been accomplished to date.

Recording Piezometer Data  
from Aug 04 to Oct 06

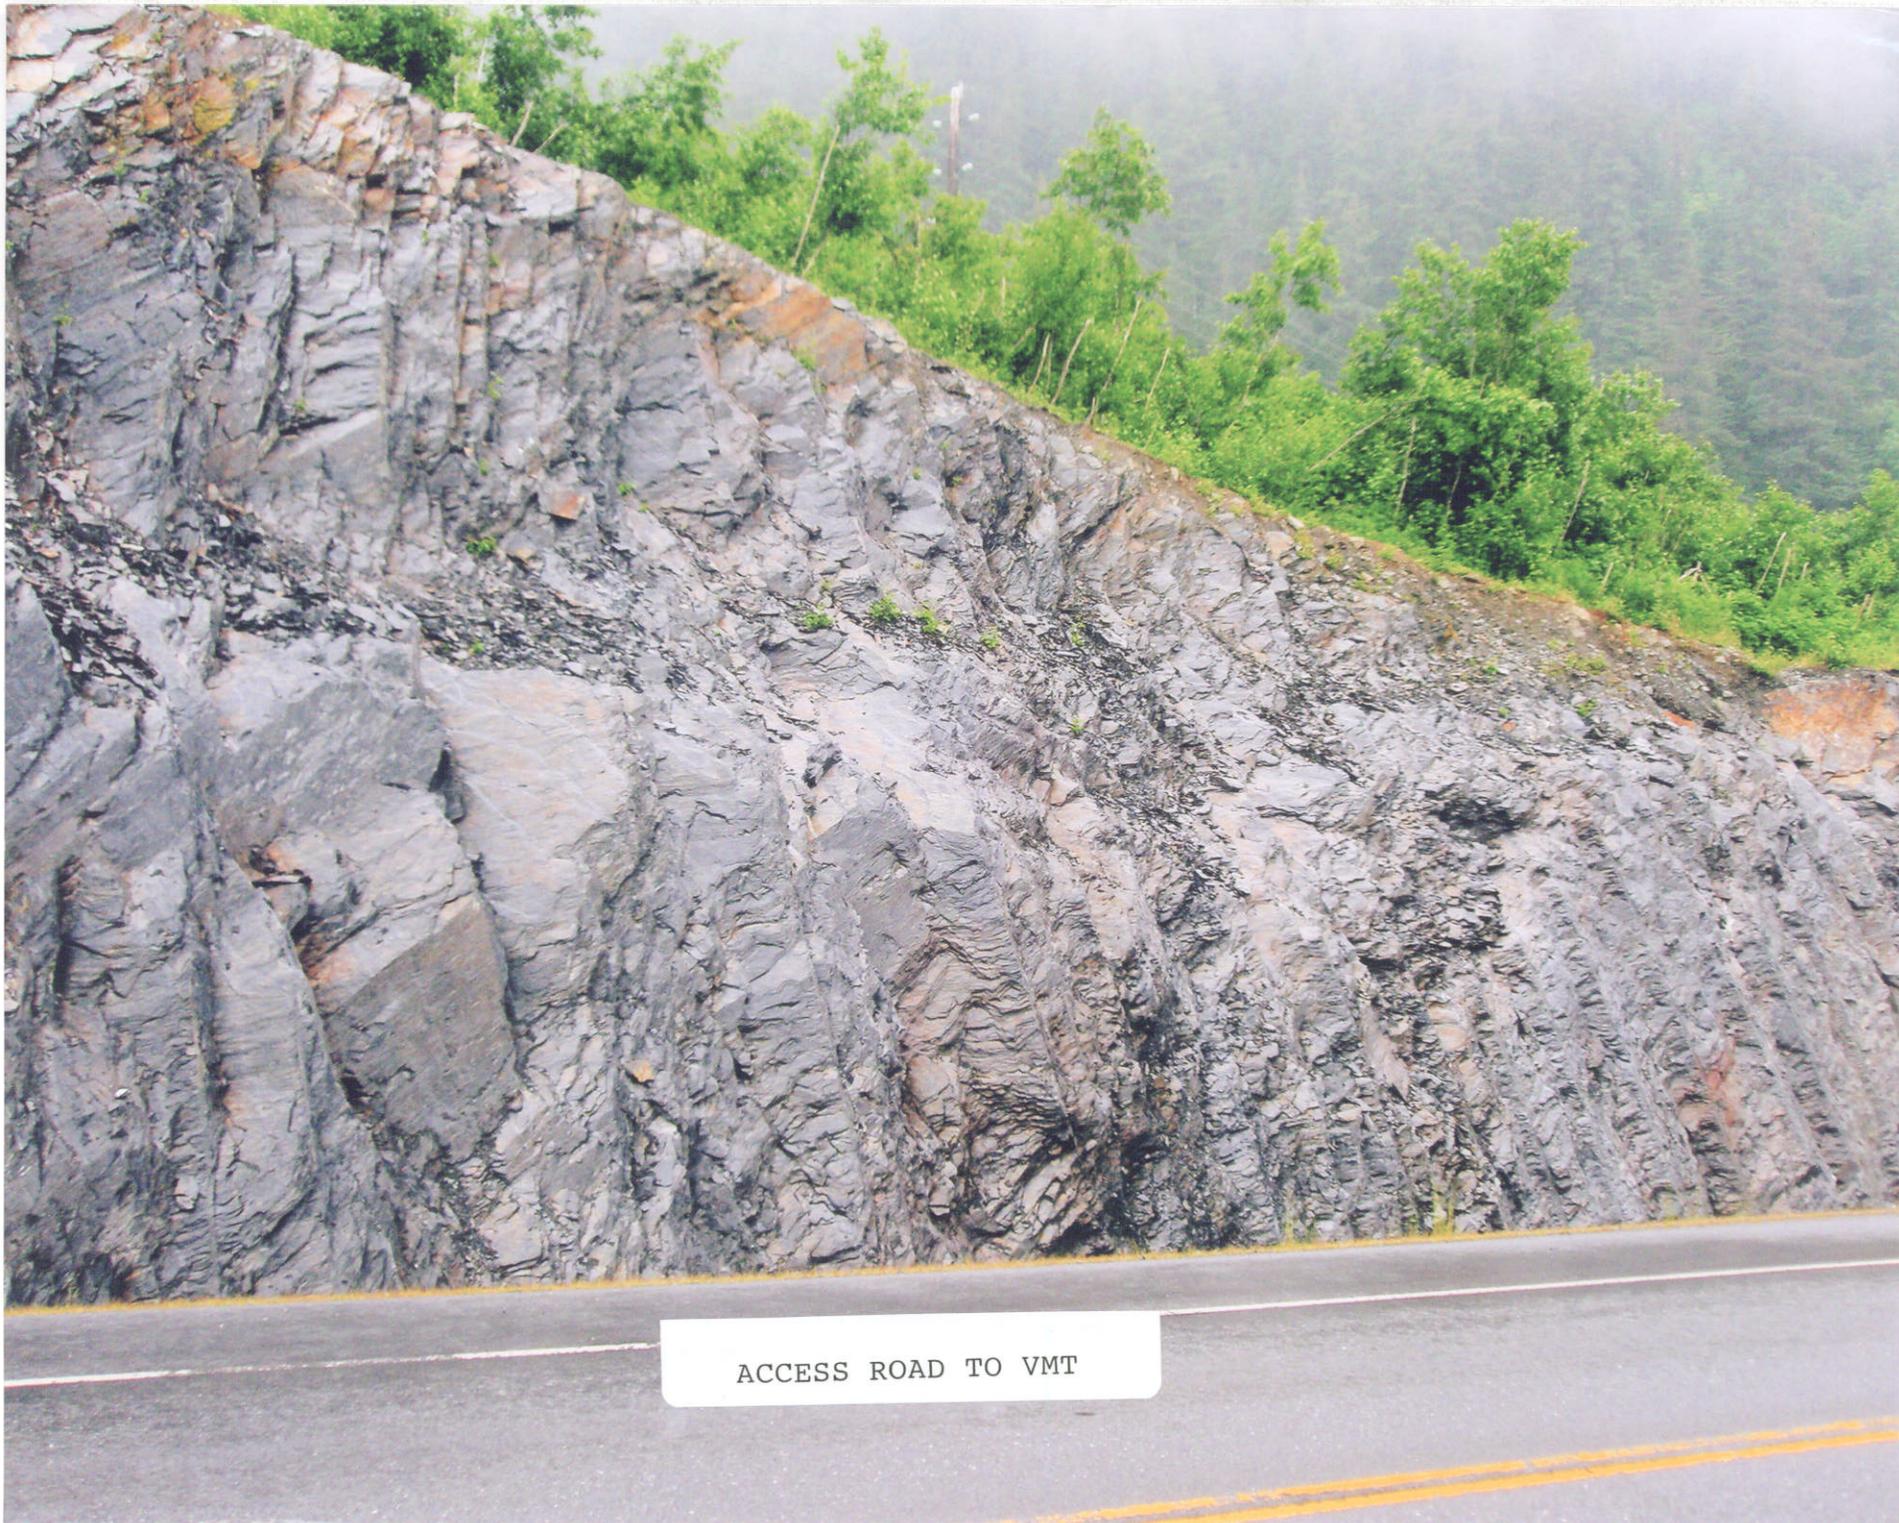
ACCESS ROAD TO VMT

Through-going versus continuous rock fractures were also considered. Two recent rock cuts in the Valdez area were examined, the slopes at the Valdez Ferry Terminal and the cut on the access road leading to the VMT site near the Solomon Gulch Dam. It is unlikely that a single fracture extends the full height of the slope but fractures tens of feet in extent are visible.

13. The concept of through-going versus discontinuous rock fractures is also considered. It is highly unlikely that a single fracture extends the full height of the slopes, 115 feet, but fractures tens of feet in extent are visible in the fresh rock excavations in Valdez. It is clear that a sizeable block of rock coming from between the 10 foot or 5 foot bolt spacing in the slope, could be liberated under a combination of high pore pressure and moderate seismic loading.

Appendix E. Photographs, Fresh Rock Cuts, Valdez Area, Showing Extensive Fracture Surfaces.
