**Consent Agenda Briefing for PWSRCAC Board of Directors – September 2025**

**Sponsor:** Joe Lally & TOEM Committee  
**Project number and name or topic:** 5081 – Storage Tank Maintenance Review

## Review of Ballast Water Tank 93 Out-of-Service Inspection Report and Tank Repairs

William Mott P.E.

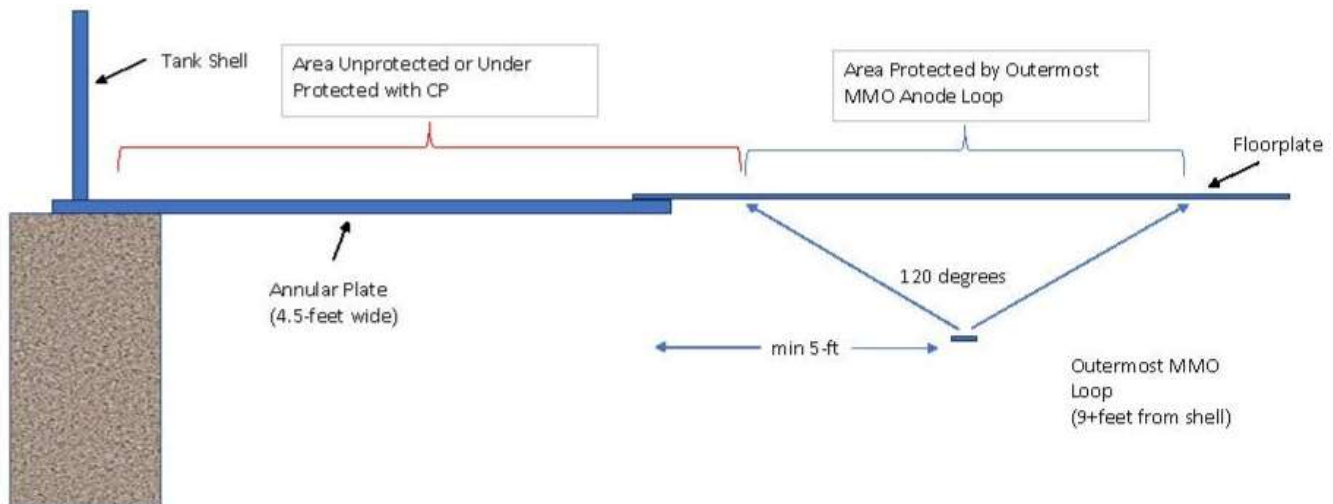
Figure 3 – Schematic of Tank 93 Perimeter Section

The CP ground bed for the Tank 93 CP system consists of an MMO grid distributed throughout the area beneath the tank floorplate. The CP design includes a separate MMO loop intended to protect the tank's annular plates. According to the design drawings, the outermost anode loop for the existing CP system is more than 9 feet from the tank shell. In this position, the perimeter anode is located beneath the floorplate and not beneath the annular plate (Figure 3).<sup>1</sup>

The location of the perimeter anode is such that it is not physically possible to provide sufficient CP current to the annular plate and first few feet of the perimeter plates.

The corrosion rate of the annular plate was significant enough to merit full replacement of the annular ring in 2023. Additionally, there were numerous perimeter plates that required patching or overlay (by new perimeter plates installed during annular plate replacement). This supports our finding that the CP current density provided to the annular plate and perimeter floor plates is insufficient to protect the floor from soil-side corrosion.

- Taku recommends the CP systems for Ballast Water Storage Tank 93 be upgraded in the perimeter areas to protect those areas from corrosion.
- Taku recommends the CP system monitoring tubes be slotted in the perimeter area to allow CP monitoring of that area, to ensure effective corrosion mitigation.

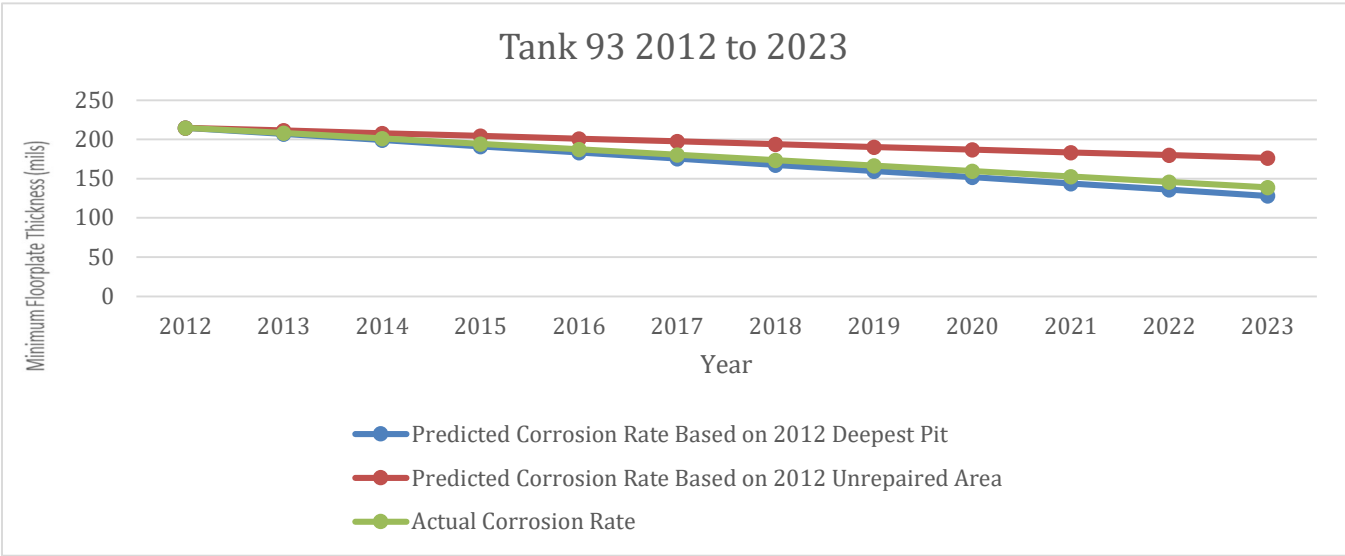
Figure 4 – Predicted Versus Actual Corrosion Depths for Tank 93

The red line in the graph represents the predicted corrosion rate using the deepest unrepaired pit from 2012 (as allowed by API 653). Based on the deepest unrepaired pit after the 2012 inspection (215 mils RFT), the predicted corrosion rate for the Tank 94 floorplate was 3.5 MPY and the predicted deepest pit in 2021 was 180 mils RFT.

The use of the deepest pit from the 2012 inspection (171 mils RFT) to calculate corrosion rate and predict the deepest pit in 2023, resulted in a 2012-2023 predicted corrosion rate of 7.9 MPY and a predicted deepest pit (in 2023) of 128 mils RFT. This is represented by the blue line in Figure 4.

The actual deepest floorplate pit identified in 2023 was 139 mils RFT, representing a corrosion rate of 6.9 MPY. This is represented by the green line in Figure 4.

Using the 2012 deepest pit to define the 2012-2023 corrosion rate, the actual rate of corrosion was over-estimated by 14%. Using the deepest unrepaired pit (from the 2012 inspection) to predict the Tank 93 floorplate corrosion rate between 2012 and 2023, the actual corrosion rate was underestimated by 49%.

Given that the tank is experiencing aggressive corrosion despite an active CP system, the operator should take immediate action to enable monitoring of CP on the outermost 10 feet and ensure the CP system is being accurately monitored in accordance with industry standards and Alyeska’s procedures.
