Background Tank 93 Information

Tank 93 Floorplate Inspection Findings

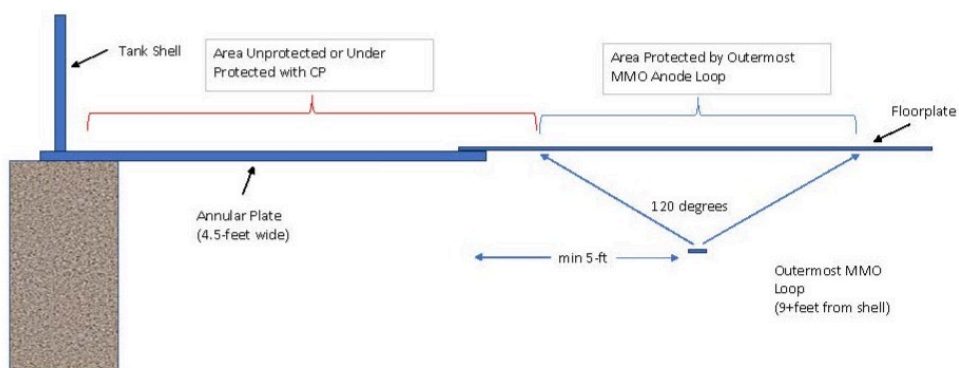
Tank 93 - Cathodic Protection System

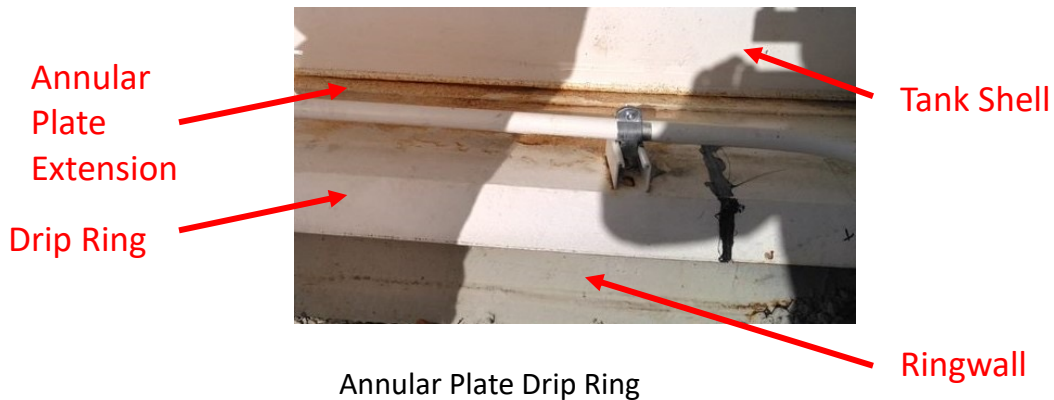
Annular Plate Extension Seal

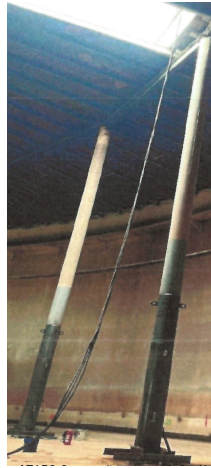
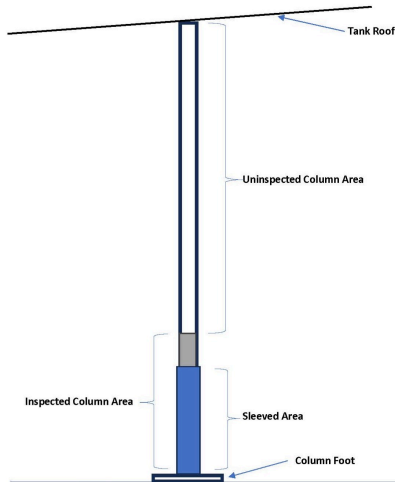
Tank 93 Roof Support Column Inspection & Repair Issues

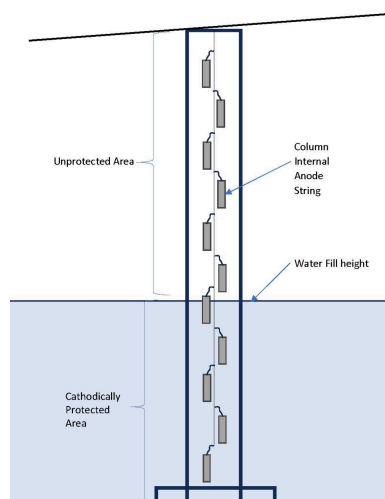
Tank 93 Roof Support Column Repair Issues

The Engineering Summary Report States
“The internal column anode strings are expected to significantly reduce the rate of corrosion within the columns”
