**Briefing for PWSRCAC Board of Directors – May 2025**

**Project number and name or topic:** 5057 - Air Quality Review of the VMT

1. **Description of agenda item:** The Board is being asked to accept the report titled “Volatile Organic Compound (VOC) Emissions from the Snow Removal Incident at the Alyeska Pipeline Service Company’s Valdez Marine Terminal East Tank Farm in Early 2022,” by Dr. Ranajit (Ron) Sahu.

## Report Acceptance: 2022 VMT Crude Oil Storage Tank Vent Incident 4-5

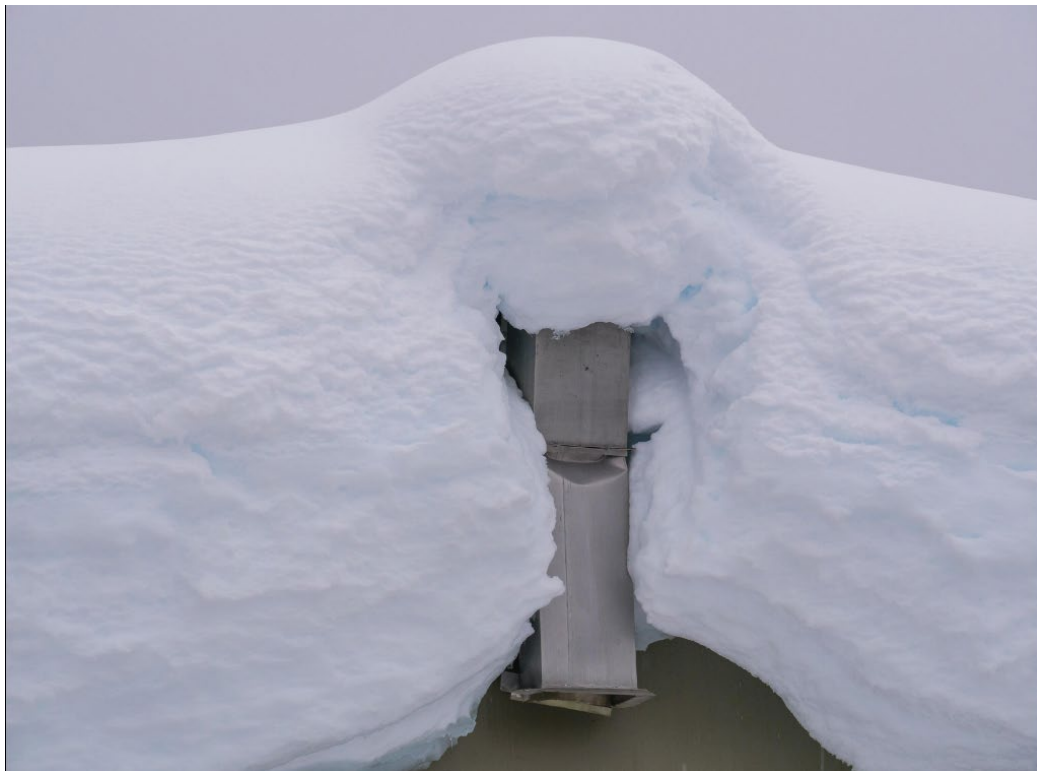
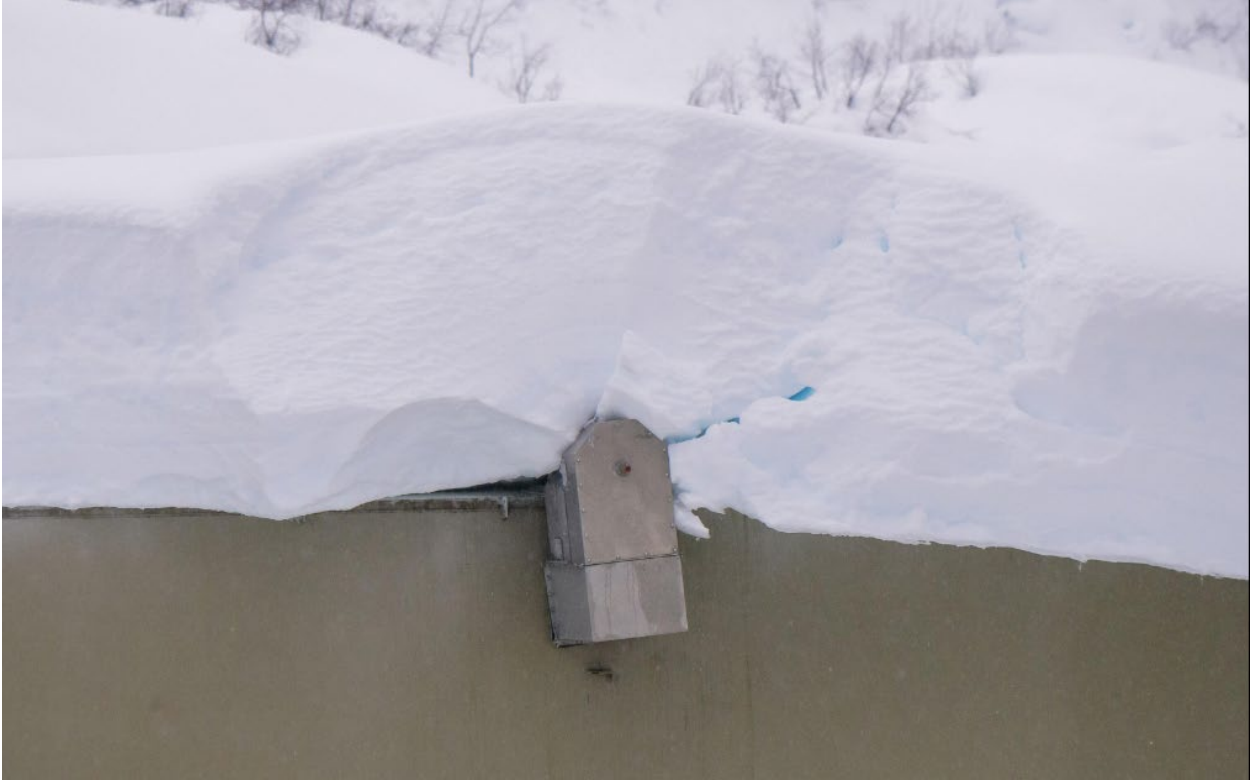
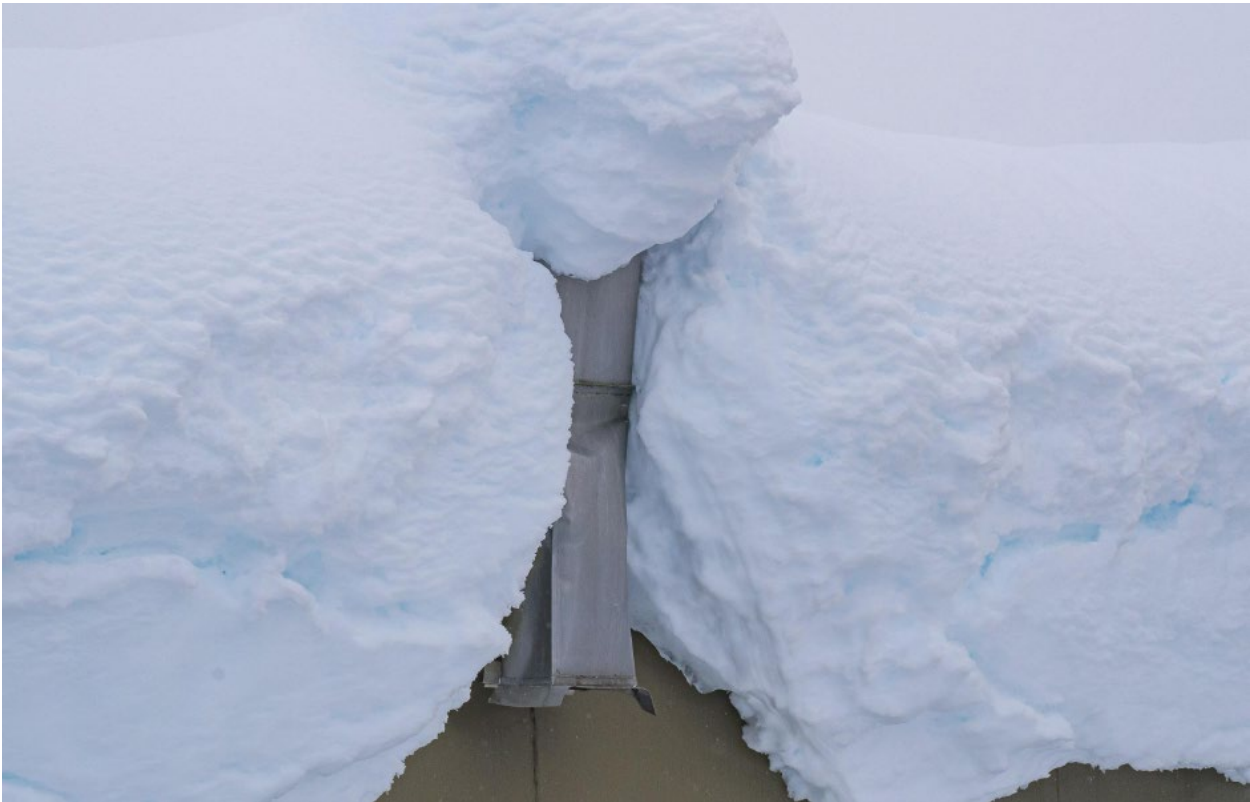
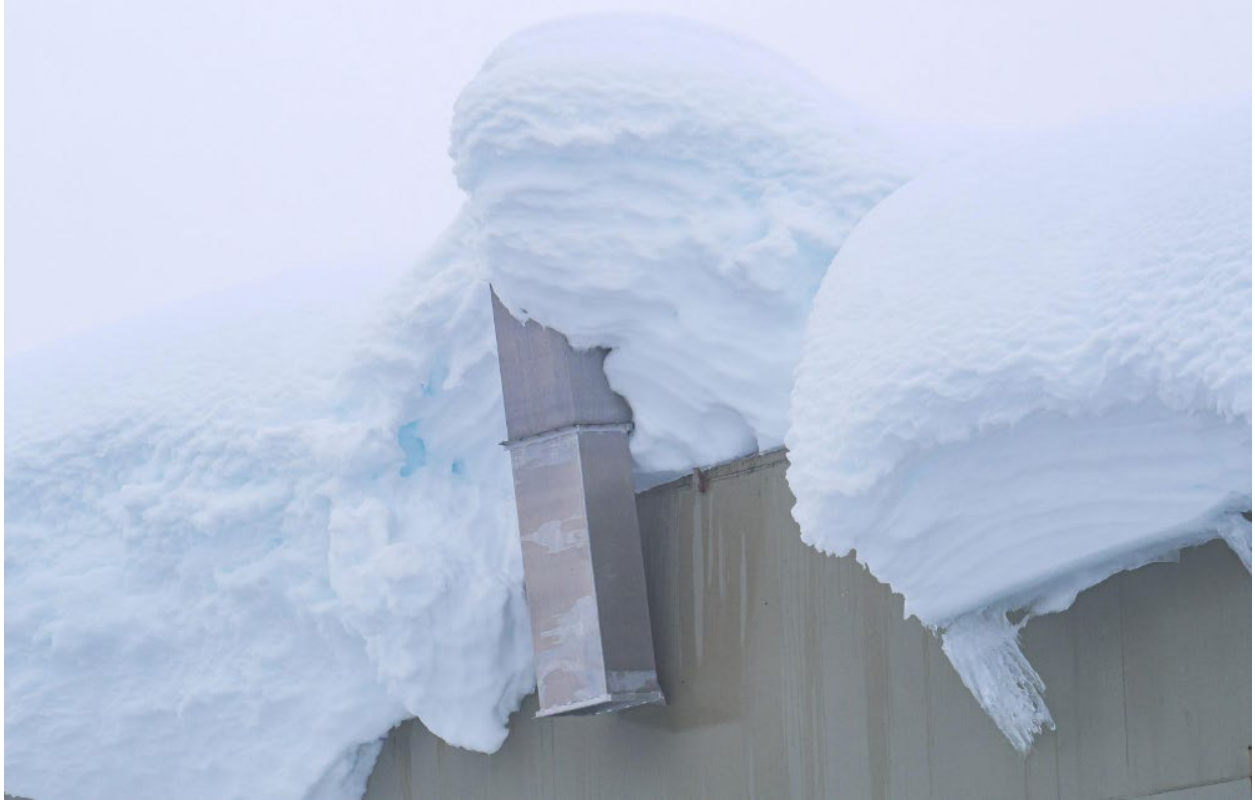
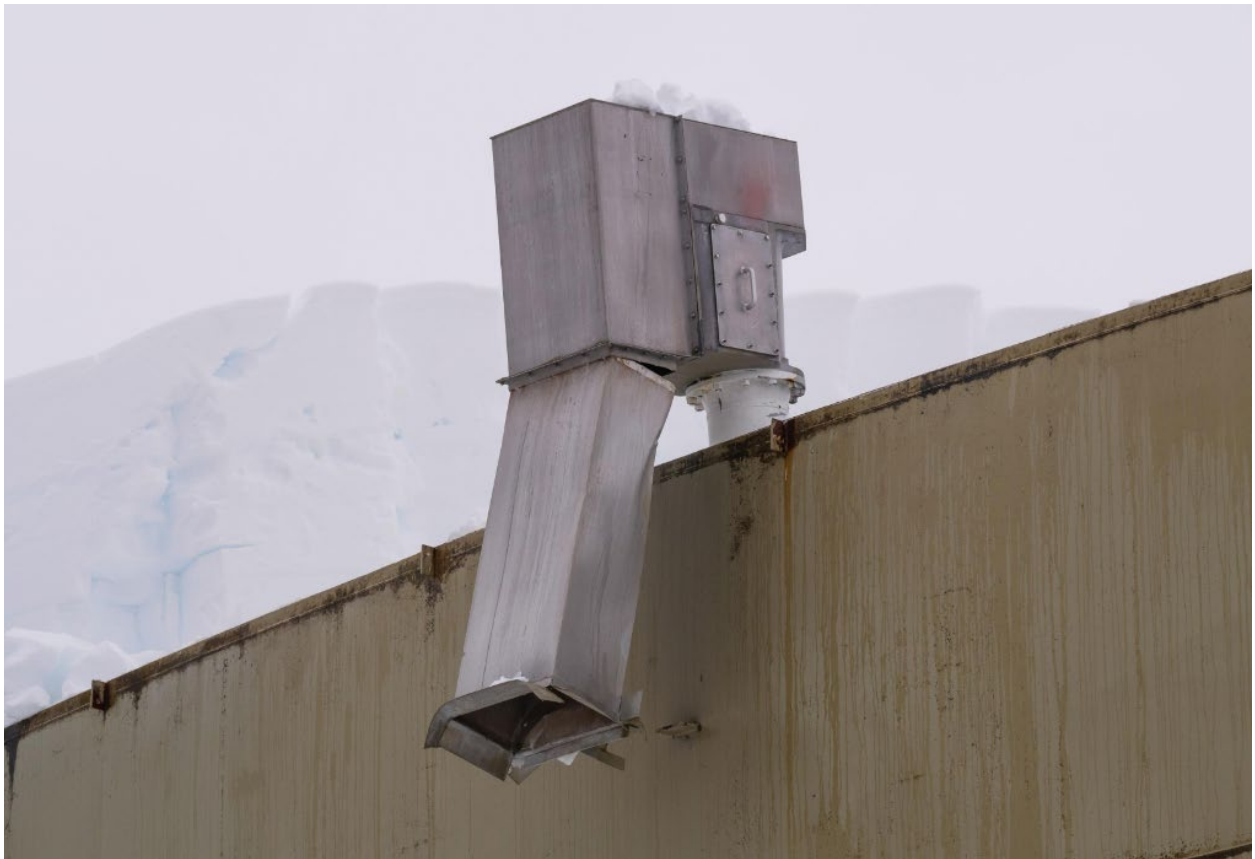
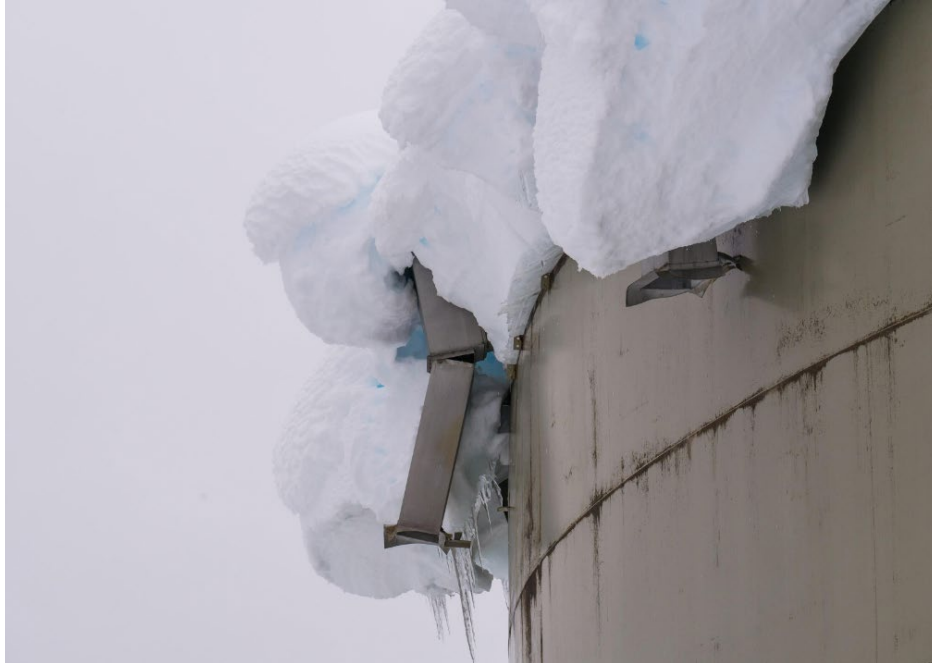
**Figures 6A through 6G – Examples of Snow Loading and Damaged Tank Vents**

After the vent damage detection in February 2022, Alyeska mobilized to begin shoveling off the accumulated snow and begin plugging/blinding the damaged vents. Operator data states that while most tanks were plugged/blinded by April 2022, Tank 2 is a marked exception, as pressure data indicates that despite tank vents C, F, and H being plugged/blinded in April, problems with the temporary repairs continued into May/June. **It is important to note here that simply plugging/blinding tanks does not assure there are no leaks.**

Crucially, the beginning of pressure management is not the same as when an actual vent on a specific tank first sustained damage and therefore began to leak (when the tank was at high pressure and likely being filled/emptied as would be the case typically). Thus, all VOC emissions – both from breathing/standing losses as well as from working losses – in the time period from when the first vent was damaged until pressure management was implemented on that tank – are unaccounted for in this estimate. This could be considerable. Examples of photographs showing the snow accumulation and resulting damage to the vent vents are shown in the Figures 6A through 6G below.

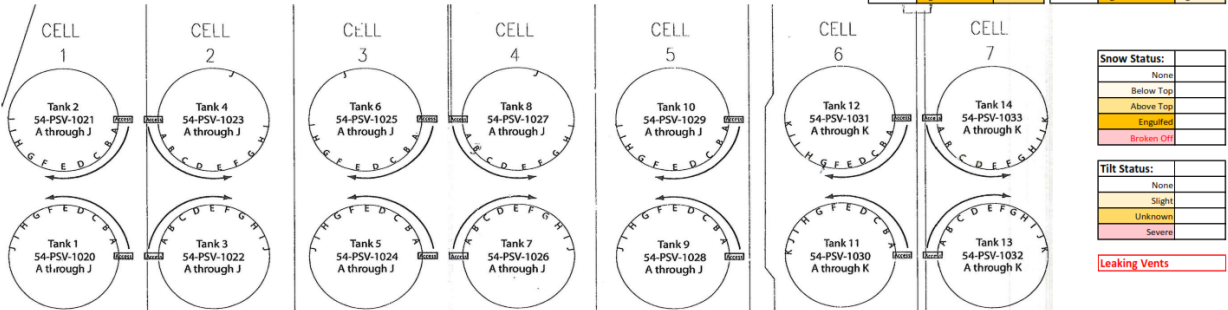
**Figure 7 – Tank Vent Damage Assessment in March 2022**

The extent of the damage to the various vents is also summarized in the excerpted charts and diagrams created by Alyeska in March 2022, shown in Figure 7.

Tank 2	Snow Cover	Tilt	Tank 4	Snow Cover	Tilt	Tank 6	Snow Cover	Tilt	Tank 8	Snow Cover	Tilt	Tank 10	Snow Cover	Tilt	Tank 12	Snow Cover	Tilt	Tank 14	Snow Cover	Tilt
A	None (no trunk)	None	A	Engulfed	Severe	A	Engulfed	Slight	A	Engulfed	Slight	A	Above Top	Slight	A	Above Top	Slight	A	Engulfed	Severe
B	None (no trunk)	Slight	B	Engulfed	Severe	B	None	None	B	Engulfed	Slight	B	Engulfed	Slight	B	Above Top	None	B	Above Top	None
C	Engulfed	Unknown	C	Engulfed	Severe	C	Engulfed	Severe	C	Above Top	None	C	Engulfed	Severe	C	Engulfed	Slight	C	Engulfed	Slight
D	Engulfed	Severe	D	Engulfed	Severe	D	Engulfed	Slight	D	Above Top	None	D	Engulfed	Severe	D	Engulfed	None	D	Engulfed	Slight
E	Engulfed	Unknown	E	Engulfed	Slight	E	Engulfed	Unknown	E	Engulfed	None	E	Engulfed	Slight	E	Engulfed	Slight	E	Above Top	Slight
F	Engulfed	Severe	F	Engulfed	Severe	F	Engulfed	Slight	F	Engulfed	None	F	Engulfed	Slight	F	Engulfed	Slight	F	Engulfed	Severe

G	Above Top	Severe	G	Above Top	Slight	G	Engulfed	Severe	G	Engulfed	Slight	G	Engulfed	Severe	G	Engulfed	Severe	G	Above Top	Slight
H	Broken off	None	H	Engulfed	Slight	H	None - Plugged	None	H	Engulfed	Slight	H	Broken Off	Severe	H	Above Top	Slight	H	Blinded	None
I	Engulfed	Severe	I	Broken Off	Severe	I	Engulfed	Severe	I	Engulfed	Severe	I	Engulfed	Severe	I	Engulfed	Severe	I	Engulfed	Severe
J	Engulfed	None	J	Below Top	None	J	None	None	J	Engulfed	Severe	J	Engulfed	Slight	J	Engulfed	None	J	Engulfed	Slight
															K	Engulfed	Unknown	K	Engulfed	Slight

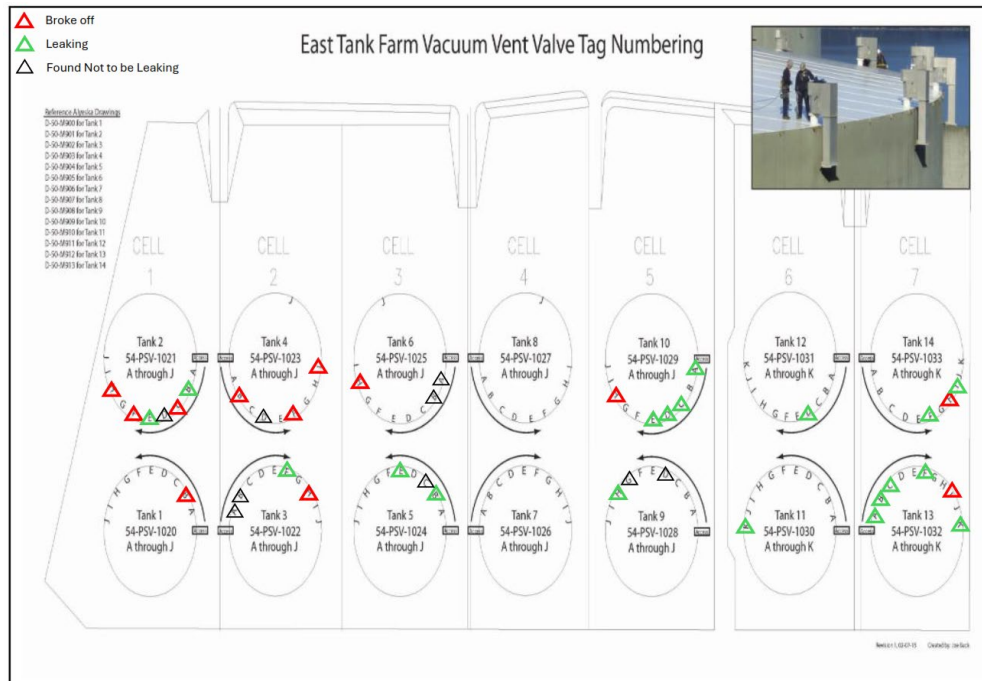
**Figure 8 – Tank Vent Numbering and Condition During 2022 Snow Removal**

shown in Figure 8. **Critically, the number of damaged vents is not identical across all tanks, requiring a tank-by-tank approach to calculating emissions estimates.**

Also, importantly, **Figure 8 shows the degree to which vents in each tank were damaged.** Red triangles denote vents that had completely broken or sheared off. Green triangles show vents which were compromised and leaking. Those that were suspected to be leaking, but found to not to be after further investigation, are shown as black triangles.

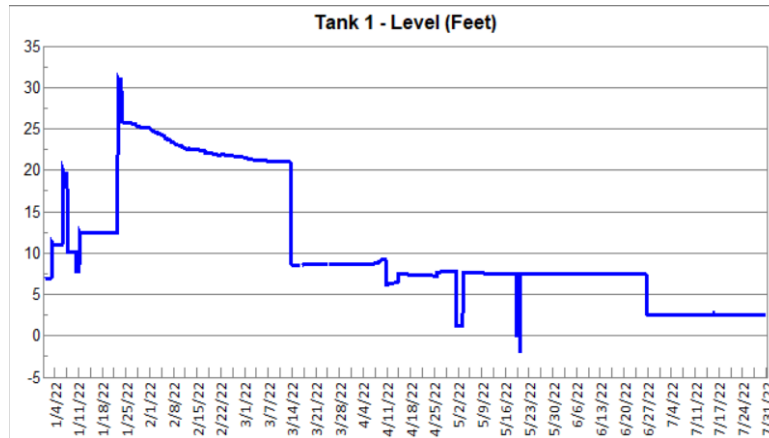
**Figure 10 – Tank 1 Liquid Level During January-July 2022.**

Thus, Figure 10 shows that at a certain point in time, the liquid level in Tank 1 was dropped to roughly 8 feet or so, or a bit lower, and was not increased (i.e., the tank was not filled back up). **In general, damaged tanks were not filled during the time period between when the tank vents were discovered to be damaged and temporary repairs to the tank vents were made.** There are exceptions to this, however, likely due to operative

While this was an attempt at reducing the emissions produced by working losses (filling the tanks with oil), this did not prevent emissions produced from breathing losses, as the tank was subject to ambient changes in the outside environment.

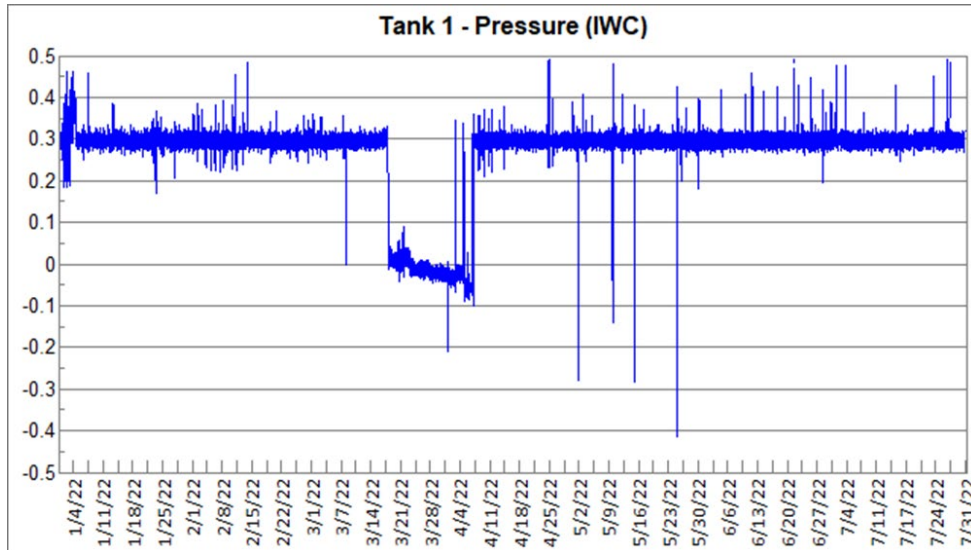
**Figure 11 – Tank 1 Pressure During January – July 2022**

Figure 11 provides an example to illustrate the attempted pressure management of a negative vacuum by depicting the corresponding pressure for Tank 1 in inches of water column (IWC) for the January – July 2022 time period. Normally, the tank operated with pressures around 0.3 IWC. However, the pressures were attempted to be reduced to a slight negative, as seen in the U-shaped dip in the pressure profile. Once the damaged vent(s) were repaired, tank pressures were brought back to the standard 0.3 IWC as shown in the Figure.

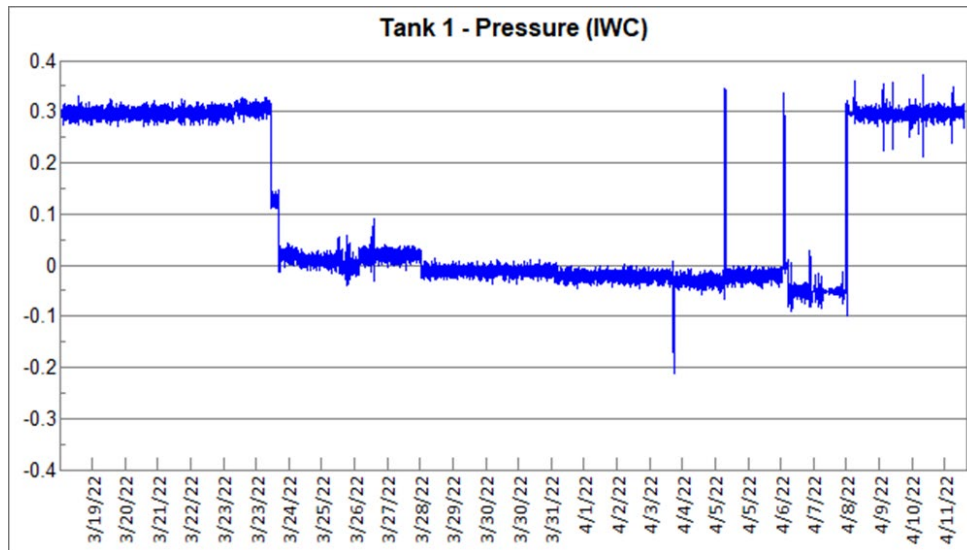
**Figure 12 – Tank 1 Pressure Management Detail**

Figure 12 shows the same data as Figure 11, with the tank pressure management time period expanded to show more detail. The start and end date/times in Figure 12 are the beginning and end of the pressure management period shown in Figure 11 previously.

Figure 12 makes it clear that while the goal of pressure management was to achieve negative pressure on the tank, this was difficult to achieve in reality. This is evidenced by periods of slight positive pressure seen in Figure 12. Positive pressure indicates that emissions of vapors are escaping from within the tank to the atmosphere.

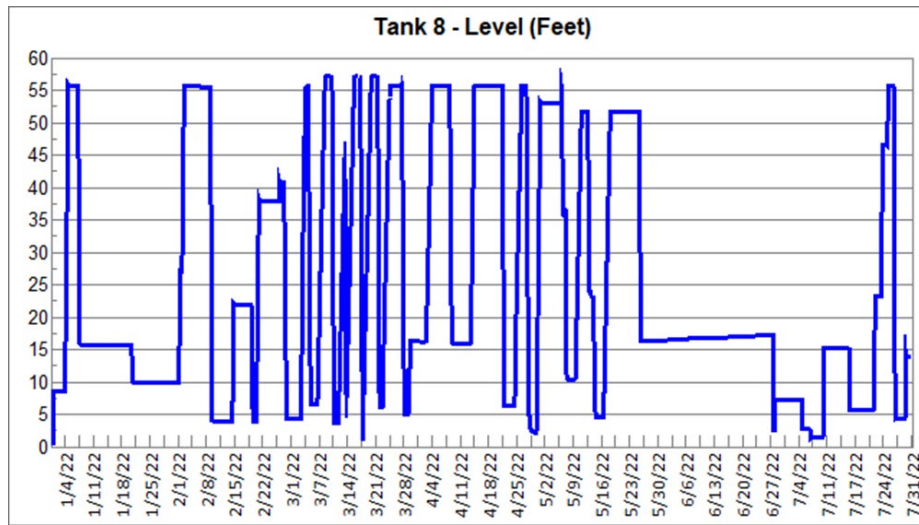
**Figure 13 – Tank 8 Liquid Levels During January – July 2022**

To close the discussion, Figures 13 and 14 show the liquid level and pressures in Tank 8. While Tank 8 vents supposedly did not leak even though some were damaged, as seen in Figure 7, there was no pressure management. The tank pressure was maintained at 0.3 IWC and liquid levels rose and fell as the tank was filled (from the pipeline) and emptied (into vessels), as needed. Even though the author did not include Tank 7 and 8 VOCs in these emission estimates, it is clear that there were such VOC emissions from these two tanks as well.
