2022 Tank Pressure/Vacuum Pallet Damage: Crude Oil Storage Tank Headspace Gas Assessment

PWSRCAC Contract # 5081.22-01

William Mott P.E.

907.562.1247
December 2024

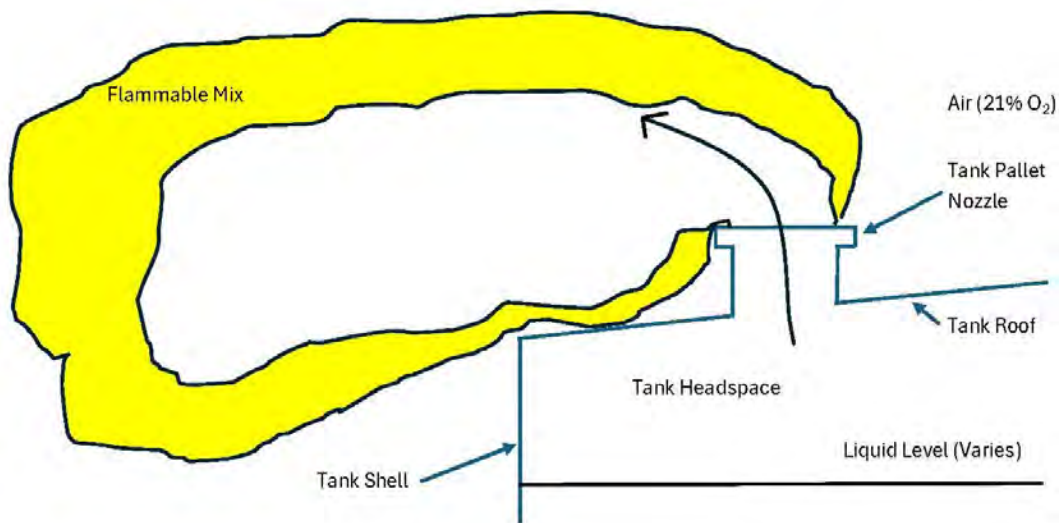
Alyeska indicated that the tanks are normally operated under a slight pressure. As depicted below, when a tank pallet is sheared off a tank operating at a slight pressure, the headspace is open to the atmosphere and hydrocarbon vapors migrate out of the tank resulting in fugitive emissions. These fugitive emissions are what Alyeska’s technicians detected in their “olfactory test.” When there is a leak and the tank is operating at a slight pressure, there will be a flammable region (depicted as yellow in Figure 1, below) in the emissions cloud. The size and magnitude of the flammable region will vary and be impacted by the leak rate, temperature, and outside wind speed.

Figure 1 - Tank Emissions at Sheared Pallet (Operating under positive pressure)

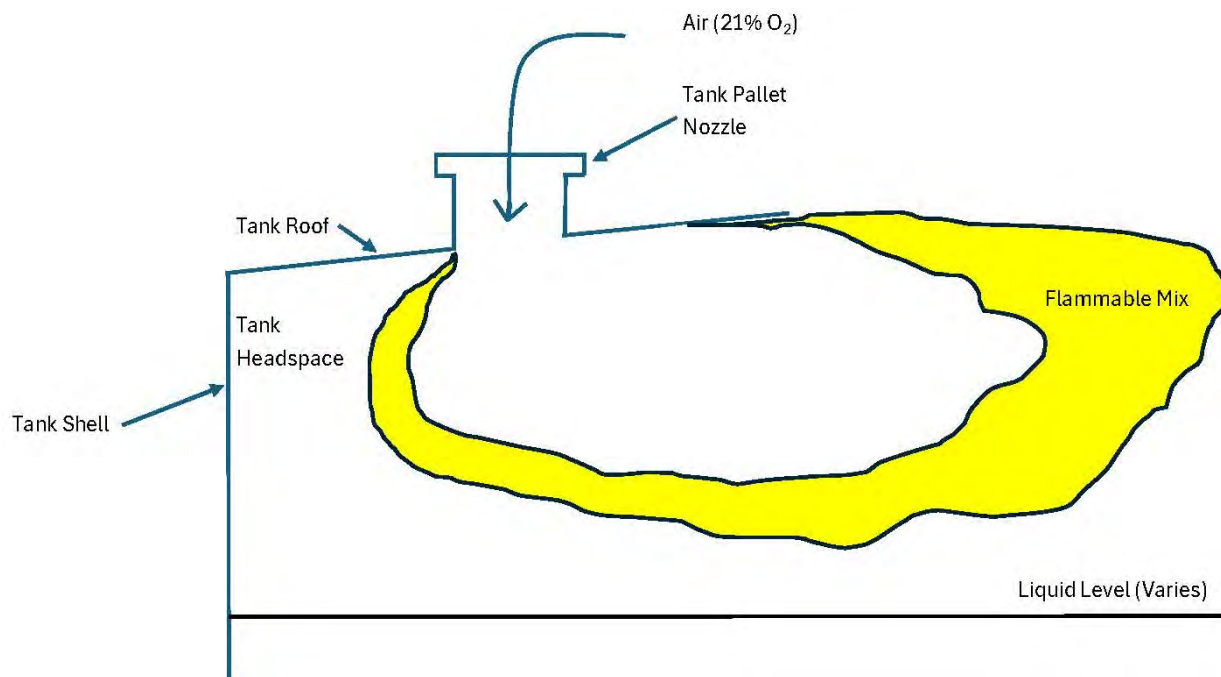
Alyeska noted that when leaking pallets were discovered on a subject tank, the operating mode for that tank was shifted to operate with the headspace under a slight negative pressure (vacuum) to limit the release of hydrocarbon vapors to the atmosphere. Whenever there is a significant tank leak and the tank headspace is

under a slight vacuum, the air migrating into the tank will create zones where the O₂ concentration is high enough for a flammable/explosive mixture to exist (depicted as yellow in Figure 2 below). Again, this is due to air moving into the tank and the fact that the current mechanisms for headspace gas mixing do not result in a homogeneous gaseous mixture. The size and magnitude of that flammable region will be impacted by the leak rate, temperature, the amount of mixing in the headspace, the volume and age of the oil in the tank, and the magnitude of the operating negative pressure (vacuum). A significant leak in a single tank will also increase the bulk average O₂ content of that tank headspace.

Figure 2 – Air Migration into a Sheared Pallet (Operating under negative pressure - vacuum)

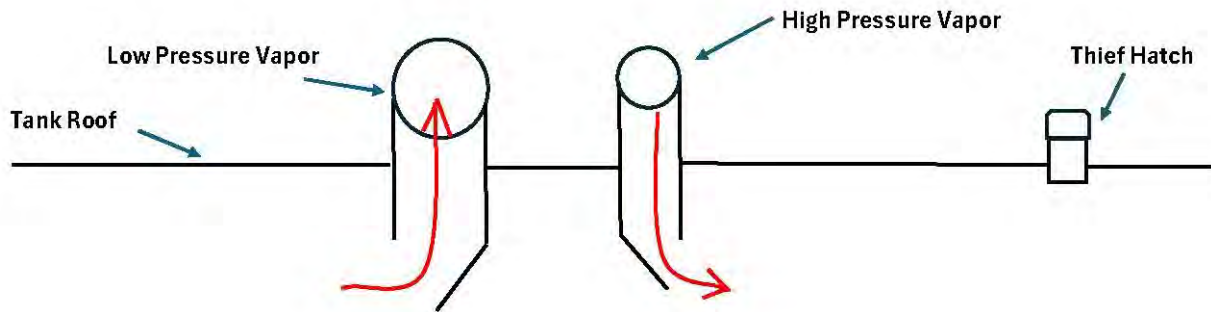
During the March 31, 2022 meeting, Alyeska reported that they used the tank thief hatches to sample headspace gases to determine if the tank headspaces were safe to put workers on top of the tanks for snow clearing. Reliance on testing at the thief hatches as the primary means of defining the headspace gas quality was imprudent as the thief hatches on the odd numbered tanks are located close to the high-pressure header between the high-pressure header and the closest pressure/vacuum pallets. That means that the

quality of the gases at the thief hatched on the odd numbered tanks will closely mirror the quality of the high-pressure header, not the bulk tank headspace.

Figure 3 – Vapor Nozzle/Thief Hatch Proximities for Odd Numbered Crude Tanks

Figure 3 presents a basic sketch showing the inert (high pressure or inert) nozzle, the vent (low pressure outlet) nozzle, and the thief hatch for the seven northern ETF tanks (odd # tanks). As seen from this visual representation, based on the tank vapor nozzle locations, the orientation of the vapor diverters (if installed on a given tank), and the relative location of the thief hatch, gas readings at the thief hatch will be similar to the quality of the high-pressure header gases entering the tank rather than representing the average or bulk quality of the tank headspace.

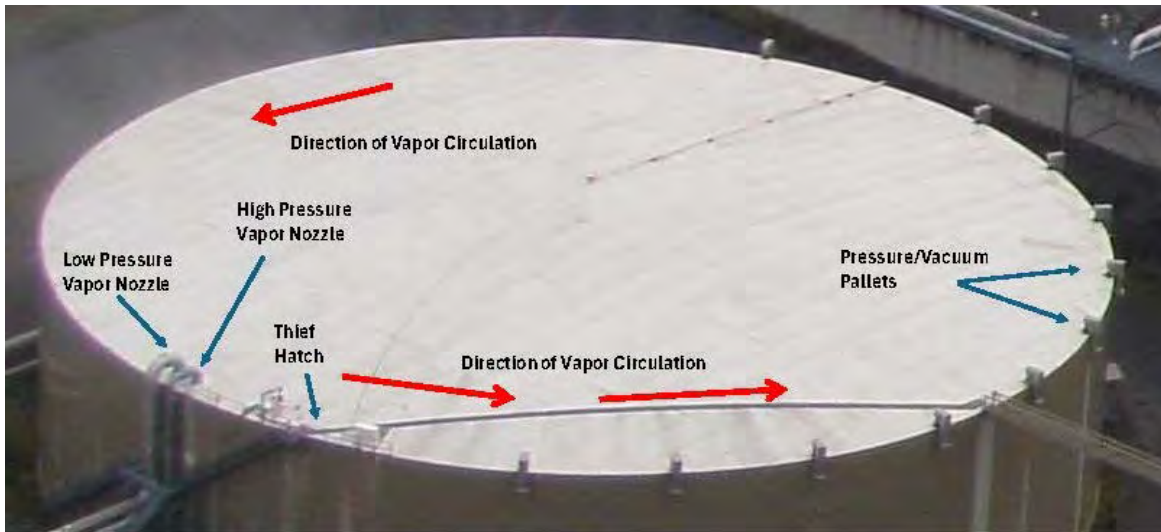
Figure 4 shows the roof of Crude Oil Storage Tank 11, depicting the locations of the inlet and outlet nozzles, the thief hatch, the pressure vacuum pallets, and the vapor flow direction that would be expected if vapor diverters were installed (red arrows). In this configuration, as seen visually in the diagram, the headspace gases at the thief hatch will be similar to the quality of the high pressure (inert) gas than the bulk of average quality of the tank headspace. Gas testing collected at thief hatches on the northern tanks (odd # tanks) is very unlikely to include O₂ that enters the tank through damaged pressure vacuum pallets.

Figure 4 – Tank 11 Roof Appurtenances

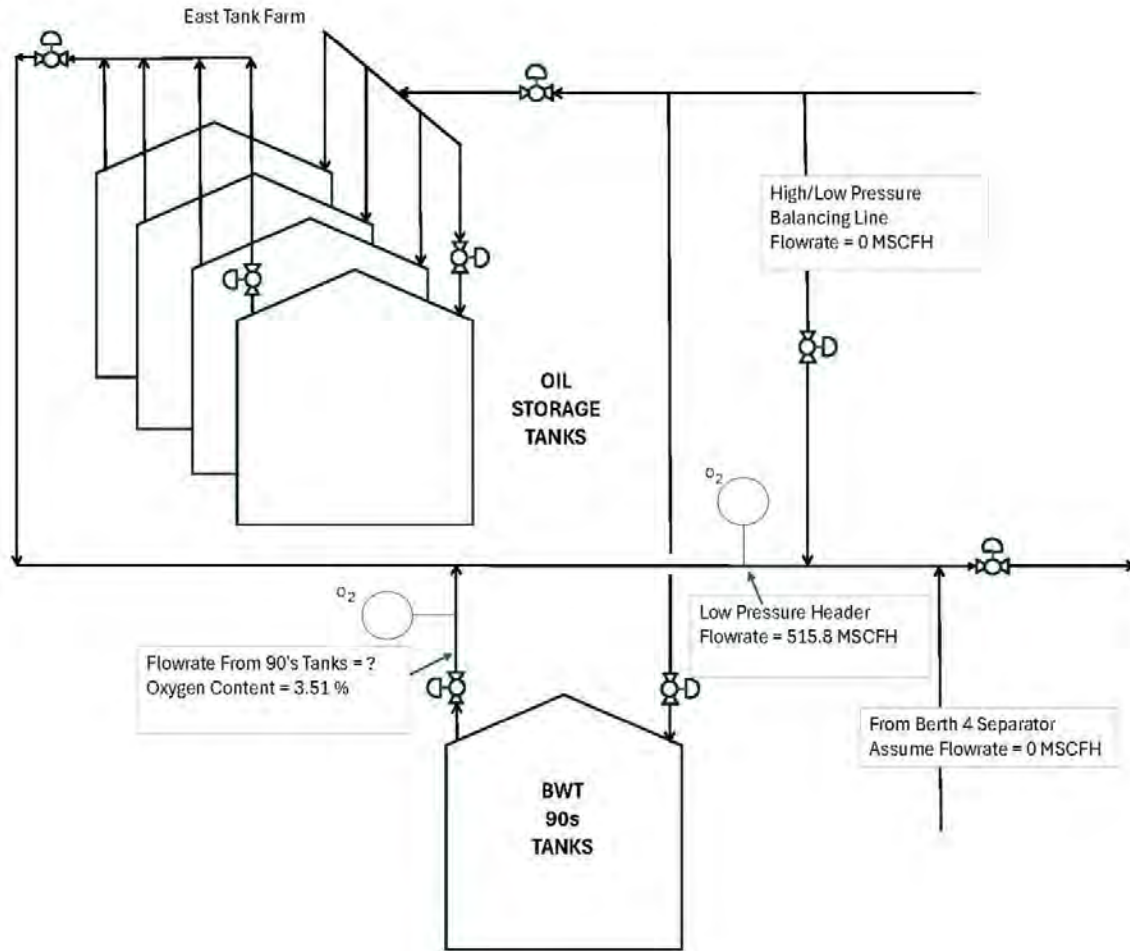
The flowrate into the compressors (641.8 MSCFH) is the sum of the flow from the LP header and the flue gas scrubber flow (126.0 MSCFH).

$$\text{The LP Header flowrate from the ETF \& BWT} = 641.8 \text{ MSCFH} - 126.0 \text{ MSCFH} = 515.8 \text{ MSCFH}$$

Figure 5 – LP Header Flow Diagram
