**Report on the
Volatile Organic Compound (VOC) Emissions from the
Snow Removal Incident at the
Alyeska Pipeline Service Company's
Valdez Marine Terminal East Tank Farm in Early 2022**

Dr. Ranajit (Ron) Sahu, Consultant¹

December 2024

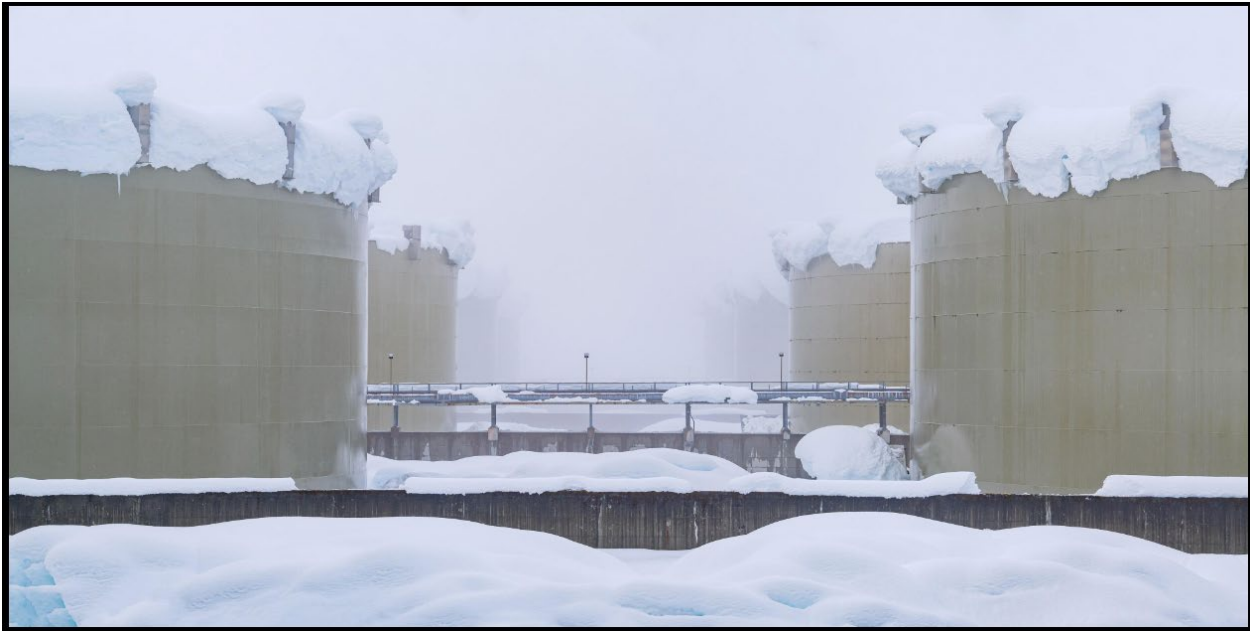
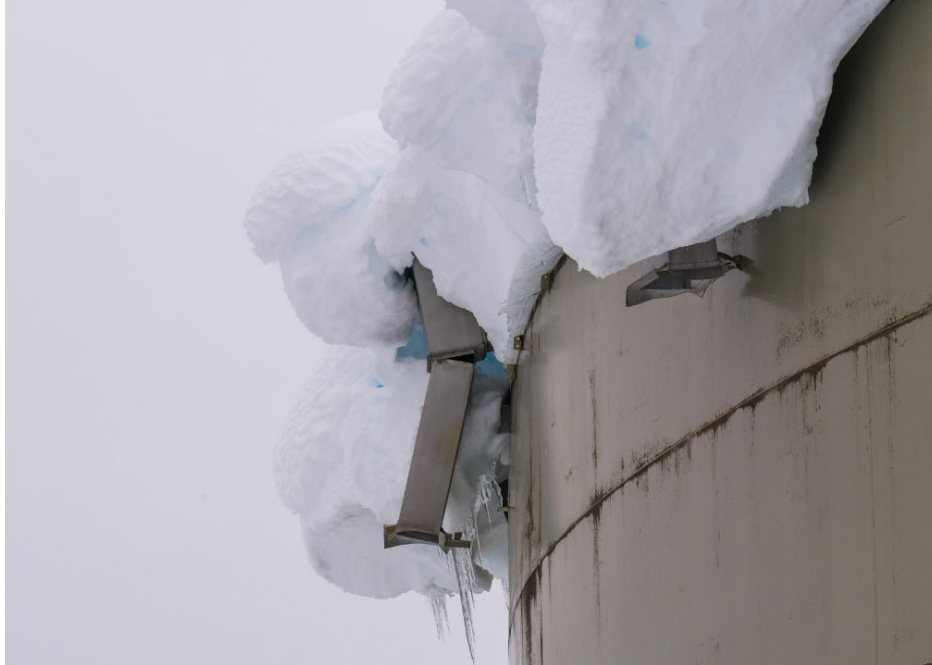
Figures 6A through 6G – Examples of Snow Loading and Damaged Tank Vents

After the vent damage detection in February 2022, Alyeska mobilized to begin shoveling off the accumulated snow and begin plugging/blinding the damaged vents. Operator data states that while most tanks were plugged/blinded by April 2022, Tank 2 is a marked exception, as pressure data indicates that despite tank vents C, F, and H being plugged/blinded in April, problems with the temporary repairs continued into May/June. **It is important to note here that simply plugging/blinding tanks does not assure there are no leaks.**

Crucially, the beginning of pressure management is not the same as when an actual vent on a specific tank first sustained damage and therefore began to leak (when the tank was at high pressure and likely being filled/emptied as would be the case typically). Thus, all VOC emissions – both from breathing/standing losses as well as from working losses – in the time period from when the first vent was damaged until pressure management was implemented on that tank – are unaccounted for in this estimate. This could be considerable. Examples of photographs showing the snow accumulation and resulting damage to the vent vents are shown in the Figures 6A through 6G below.

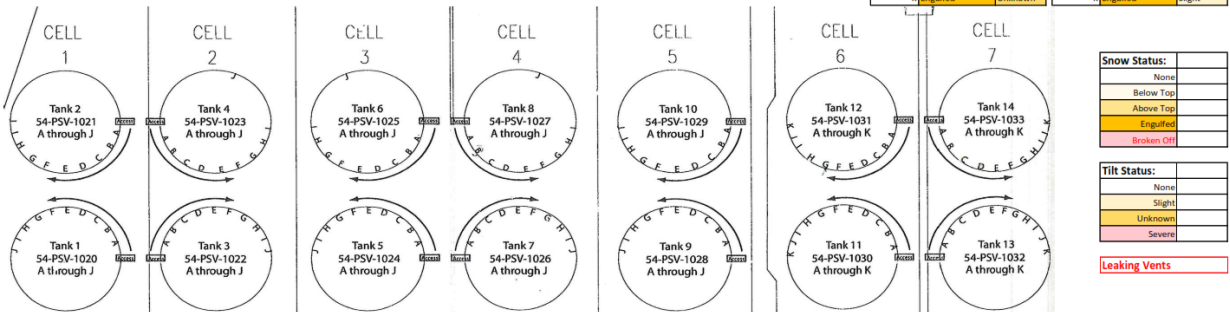
Figure 7 – Tank Vent Damage Assessment in March 2022

The extent of the damage to the various vents is also summarized in the excerpted charts and diagrams created by Alyeska in March 2022, shown in Figure 7.

Tank 2	Snow Cover	Tilt	Tank 4	Snow Cover	Tilt	Tank 6	Snow Cover	Tilt	Tank 8	Snow Cover	Tilt	Tank 10	Snow Cover	Tilt	Tank 12	Snow Cover	Tilt	Tank 14	Snow Cover	Tilt			
A	None (no trunk)	None	A	Engulfed	Severe	A	Engulfed	Slight	A	Engulfed	Slight	A	Above Top	Slight	A	Above Top	Slight	A	Above Top	Slight	A	Engulfed	Severe
B	None (no trunk)	Slight	B	Engulfed	Severe	B	None	None	B	Engulfed	Slight	B	Engulfed	Slight	B	Above Top	None	B	Above Top	None	B	Above Top	None
C	Engulfed	Unknown	C	Engulfed	Severe	C	Engulfed	Severe	C	Above Top	None	C	Engulfed	Severe	C	Engulfed	Slight	C	Engulfed	Slight	C	Engulfed	Slight
D	Engulfed	Severe	D	Engulfed	Severe	D	Engulfed	Slight	D	Above Top	None	D	Engulfed	Severe	D	Engulfed	None	D	Engulfed	Slight	D	Engulfed	Slight
E	Engulfed	Unknown	E	Engulfed	Slight	E	Engulfed	Unknown	E	Engulfed	None	E	Engulfed	Slight	E	Engulfed	Slight	E	Engulfed	Slight	E	Above Top	Slight
F	Engulfed	Severe	F	Engulfed	Severe	F	Engulfed	Slight	F	Engulfed	None	F	Engulfed	Slight	F	Engulfed	Slight	F	Engulfed	Slight	F	Engulfed	Severe

G	Above Top	Severe	G	Above Top	Slight	G	Engulfed	Severe	G	Engulfed	Slight	G	Engulfed	Severe	G	Engulfed	Severe	G	Engulfed	Severe	G	Above Top	Slight
H	Broke off	None	H	Engulfed	Slight	H	None - Plugged	None	H	Engulfed	Slight	H	Broken Off	Severe	H	Above Top	Slight	H	Blinded	None	H	Blinded	None
I	Engulfed	Severe	I	Broken Off	Severe	I	Engulfed	Severe	I	Engulfed	Severe	I	Engulfed	Severe	I	Engulfed	Severe	I	Engulfed	Severe	I	Engulfed	Severe
J	Engulfed	None	J	Below Top	None	J	None	None	J	Engulfed	Severe	J	Engulfed	Slight	J	Engulfed	None	J	Engulfed	Slight	J	Engulfed	Slight
K	None	None	K	None	None	K	None	None	K	None	None	K	None	None	K	Engulfed	Unknown	K	Engulfed	Slight

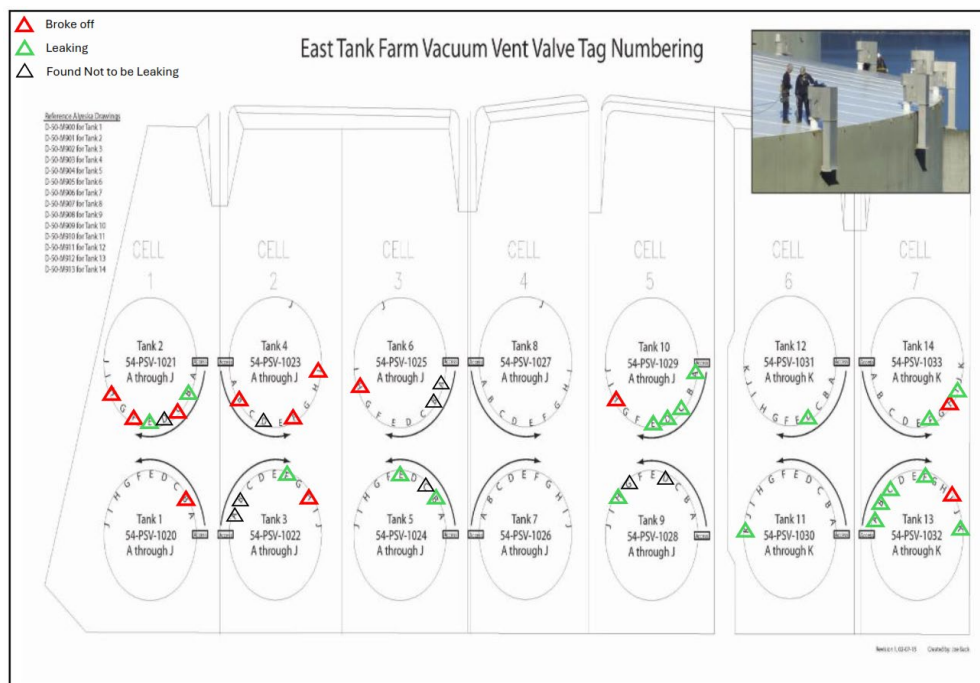
Figure 8 – Tank Vent Numbering and Condition During 2022 Snow Removal

shown in Figure 8. **Critically, the number of damaged vents is not identical across all tanks, requiring a tank-by-tank approach to calculating emissions estimates.**

Also, importantly, **Figure 8 shows the degree to which vents in each tank were damaged.** Red triangles denote vents that had completely broken or sheared off. Green triangles show vents which were compromised and leaking. Those that were suspected to be leaking, but found to not to be after further investigation, are shown as black triangles.

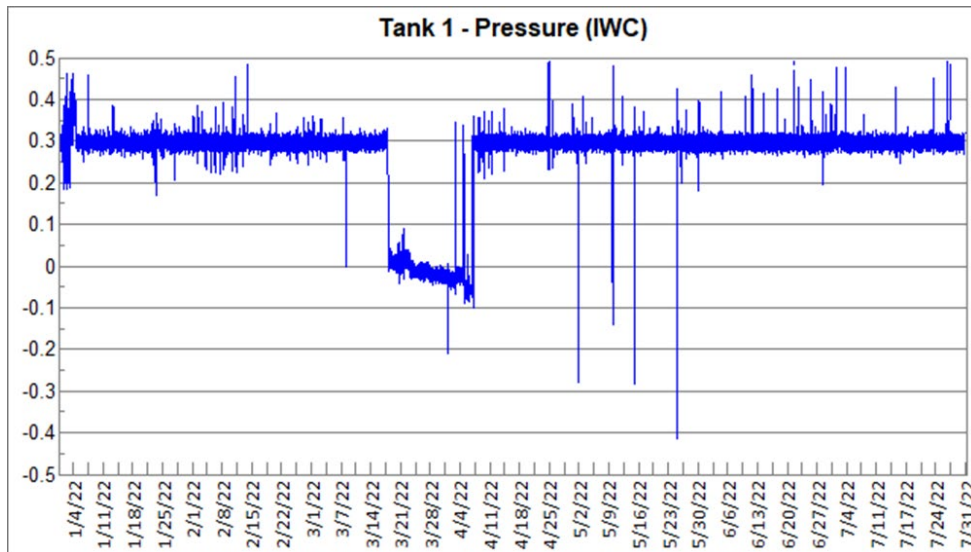
Figure 11 – Tank 1 Pressure During January – July 2022

Figure 11 provides an example to illustrate the attempted pressure management of a negative vacuum by depicting the corresponding pressure for Tank 1 in inches of water column (IWC) for the January – July 2022 time period. Normally, the tank operated with pressures around 0.3 IWC. However, the pressures were attempted to be reduced to a slight negative, as seen in the U-shaped dip in the pressure profile. Once the damaged vent(s) were repaired, tank pressures were brought back to the standard 0.3 IWC as shown in the Figure.
