# FINAL REPORT

## Review of Ballast Water Tank 93 Out-of-Service Inspection Report and Tank Repairs

PWSRCAC Contract # 5081.25.01

William Mott P.E.

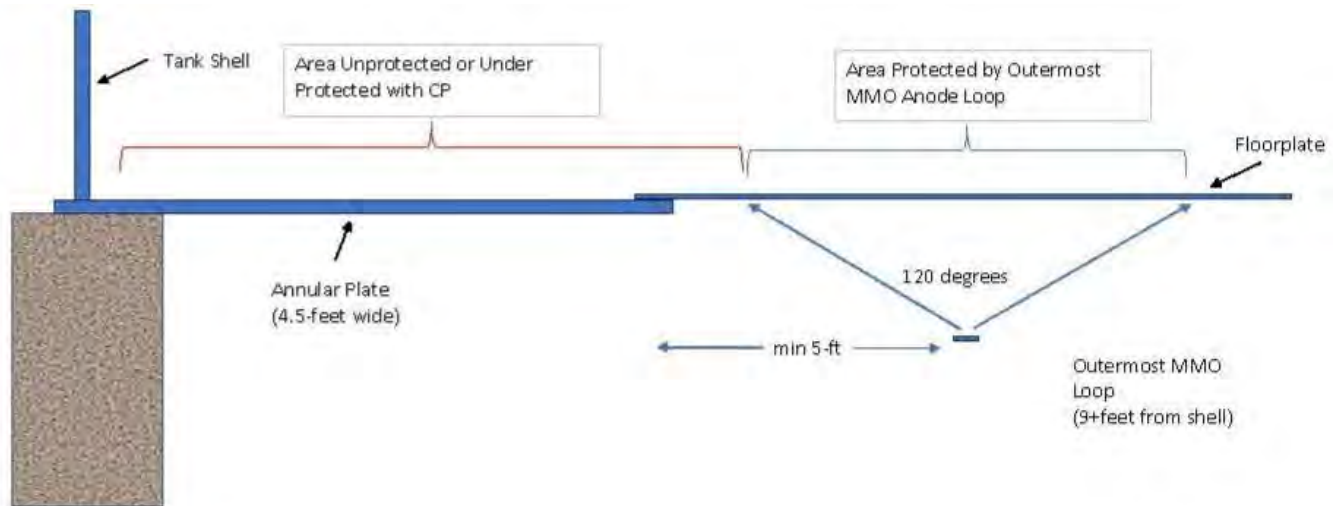
Figure 3 – Schematic of Tank 93 Perimeter Section

The CP ground bed for the Tank 93 CP system consists of an MMO grid distributed throughout the area beneath the tank floorplate. The CP design includes a separate MMO loop intended to protect the tank's annular plates. According to the design drawings, the outermost anode loop for the existing CP system is more than 9 feet from the tank shell. In this position, the perimeter anode is located beneath the floorplate and not beneath the annular plate (Figure 3).<sup>1</sup>

The location of the perimeter anode is such that it is not physically possible to provide sufficient CP current to the annular plate and first few feet of the perimeter plates.

The corrosion rate of the annular plate was significant enough to merit full replacement of the annular ring in 2023. Additionally, there were numerous perimeter plates that required patching or overlay (by new perimeter plates installed during annular plate replacement). This supports our finding that the CP current density provided to the annular plate and perimeter floor plates is insufficient to protect the floor from soil-side corrosion.

- Taku recommends the CP systems for Ballast Water Storage Tank 93 be upgraded in the perimeter areas to protect those areas from corrosion.
- Taku recommends the CP system monitoring tubes be slotted in the perimeter area to allow CP monitoring of that area, to ensure effective corrosion mitigation.

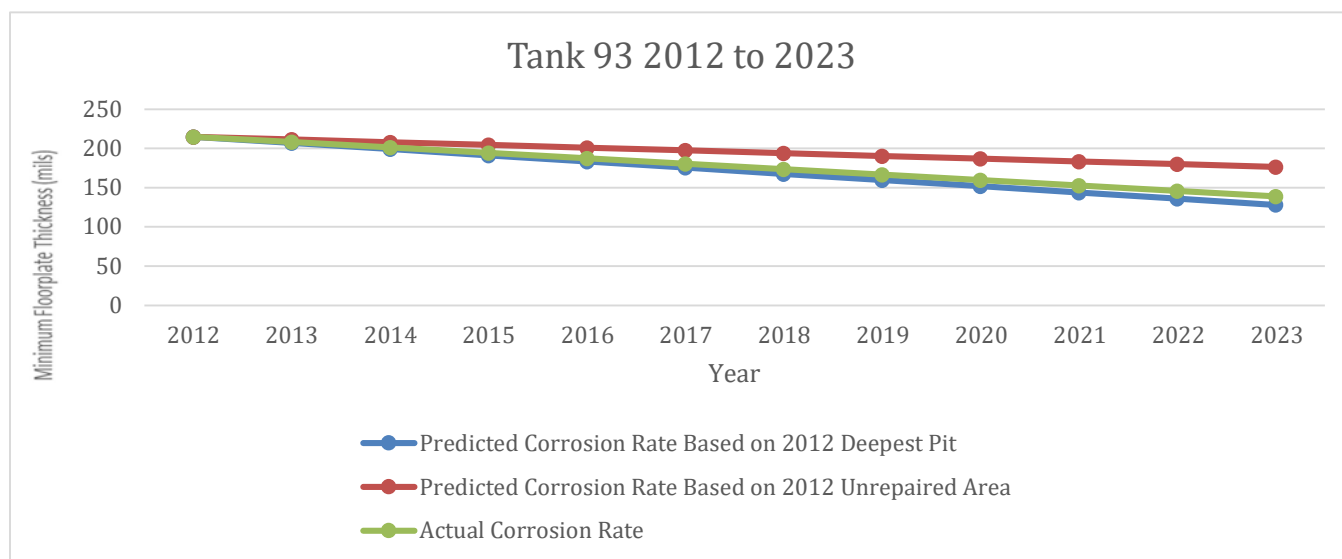
Figure 4 – Predicted Versus Actual Corrosion Depths for Tank 93

The red line in the graph represents the predicted corrosion rate using the deepest unrepaired pit from 2012 (as allowed by API 653). Based on the deepest unrepaired pit after the 2012 inspection (215 mils RFT), the predicted corrosion rate for the Tank 94 floorplate was 3.5 MPY and the predicted deepest pit in 2021 was 180 mils RFT.

The use of the deepest pit from the 2012 inspection (171 mils RFT) to calculate corrosion rate and predict the deepest pit in 2023, resulted in a 2012-2023 predicted corrosion rate of 7.9 MPY and a predicted deepest pit (in 2023) of 128 mils RFT. This is represented by the blue line in Figure 4.

The actual deepest floorplate pit identified in 2023 was 139 mils RFT, representing a corrosion rate of 6.9 MPY. This is represented by the green line in Figure 4.

Using the 2012 deepest pit to define the 2012-2023 corrosion rate, the actual rate of corrosion was over-estimated by 14%. Using the deepest unrepaired pit (from the 2012 inspection) to predict the Tank 93 floorplate corrosion rate between 2012 and 2023, the actual corrosion rate was underestimated by 49%.

The deepest pit discovered during a VMT tank inspection should be utilized to set the next service interval, regardless of repair thresholds. Revisiting the 2012 inspection and repair results provides another data point supporting this approach. Figure 4 graphically illustrates the predicted and actual corrosion rates for Tank 93 for the 2012-2023 period based on the 2012 inspection and current inspection findings.
