# FINAL REPORT

## Review of Crude Oil Storage Tank 2 Out-of-Service Inspection Documents

PWSRCAC Contract # 5081.22-01

May 2024

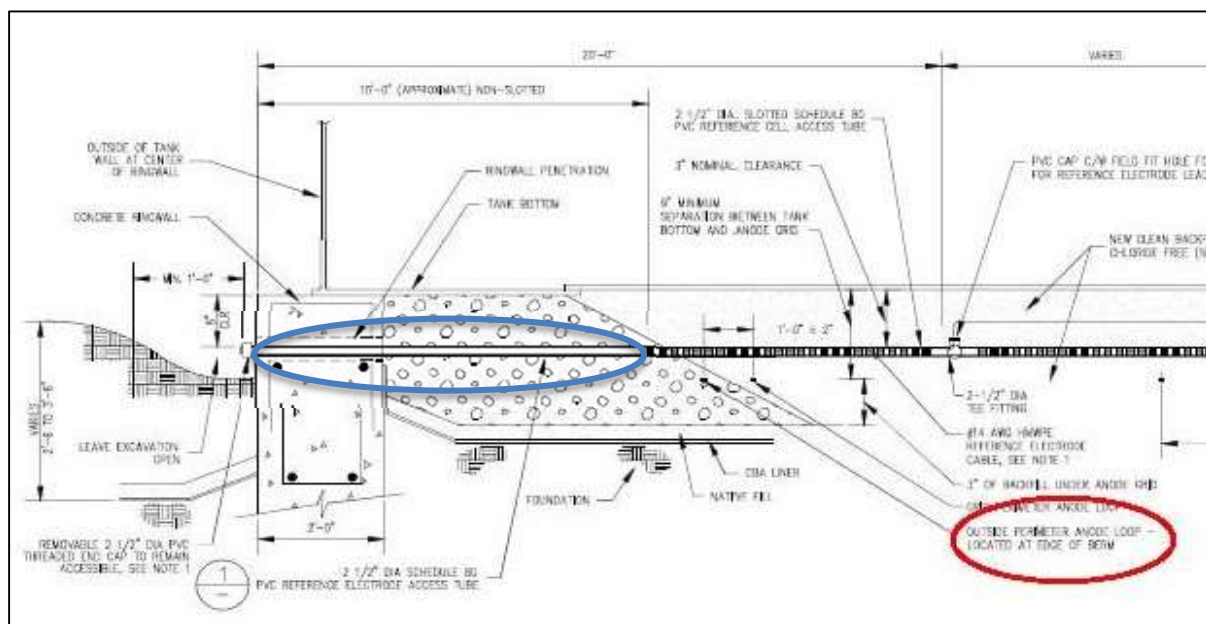
Figure 3 – Tank 2 Annular Ring CP Ground bed Design

The ground bed for the Tank 2 CP system consists of an MMO grid distributed throughout the area beneath the tank floorplate. The CP design includes a separate MMO loop intended to protect the tank's annular plates. However, in that design, the annular ring MMO loop is located beneath the floorplate and does not extend to the annular plate (red circle in Figure 3). It is located more than 10 feet from the tank shell and more than 3 feet from the innermost edge of the annular plate (see Figure 3, excerpted from drawing D-54-E806). Figure 3 also indicates that the CP monitoring tubes beneath the annular ring are not slotted for the first 10 feet (blue circle in Figure 3), negating the ability to monitor CP below the annular plate and outermost 3 feet of floorplate (also referred to as sketch plates).

This anode configuration does not protect the annular plates and perimeter floor plates for the following reasons.

- 1) The MMO loop intended to protect the annular plates will distribute current primarily via the lowest resistance pathways. However, the annular plate and floorplate are welded together, and are therefore electrically continuous. As such, assuming similar backfill resistivity and the flow of current on the lowest resistance pathways, the CP current intended for the annular plate will go to the closest steel, which is the regular floorplate steel. This means that insufficient CP is being provided to the annular plate and sketch plates. Most of the current intended for the annular plate is going instead to the floorplate immediately above the outermost anode loop.

- 4) The MMO loop that is dedicated for the annular plate and perimeter floorplates (circled in red in Figure 3) is tied to a single circuit that cannot be adjusted independently of the

floorplate system. Even if the system had the ability to independently power the MMO loop nearest to the annular plate, the resulting CP current will go predominantly to the perimeter floorplate and will not measurably impact the annular plate.

- 2) The outermost 10 feet of the CP monitoring tubes are not slotted (circled in blue on Figure 3), which prevents the CP tester from monitoring the level of CP in that area. Slots in the monitoring tubes, allow the CP monitoring reference cell to make electrolytic contact to the soil beneath the tank floor. That enables the CP tester to measure the electrical potential of the floor above the monitoring tube. Based on the insufficient CP current to the perimeter area (as discussion in point 1 above) and the lack of a perimeter seal, the perimeter areas are least likely to be sufficiently protected from corrosion. The high concentration of corrosion damage in the perimeter areas that required repair in 2022, confirms that the CP levels are insufficient in those areas.

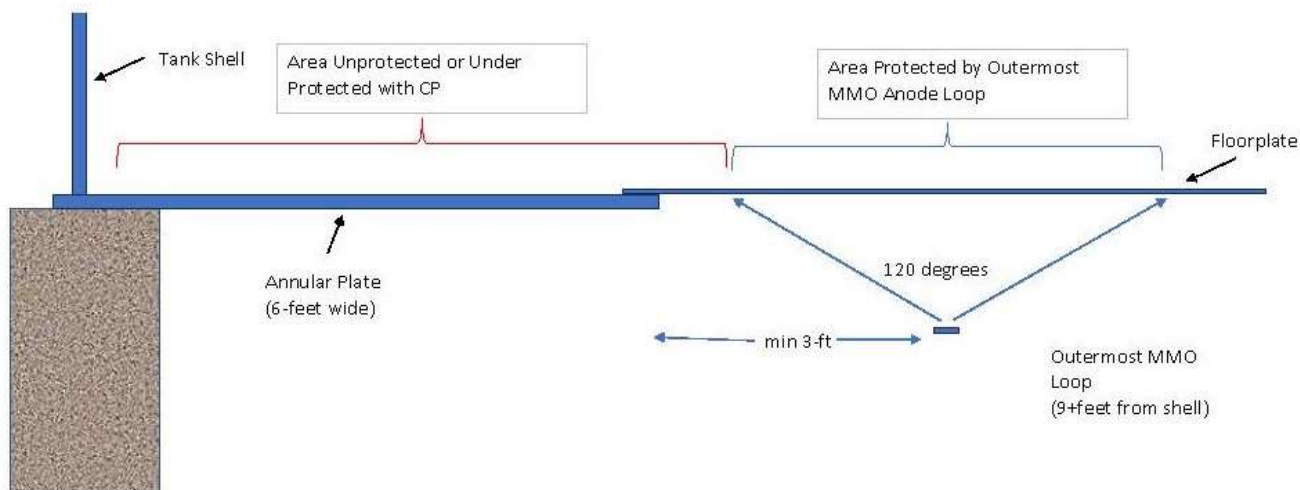
Figure 4 – Tank 2 CP System Perimeter Current Distribution

- 3) Finally, an industry rule of thumb used for designing ensuring uniform distribution of CP current for close coupled anodes, is to assume that the anode will distribute current to the steel surface in a (roughly) 120-degree arc of influence.<sup>2</sup> This rule of thumb is based on the resistance of the path length between the anode and structure. This is depicted below in Figure 4. However, as shown in the figure, the MMO loop intended to protect the annular plate will not provide protective current to the annular plate (also depicted in Figure 4) because the annular plate is beyond the 120-degree arc of influence from the CP system.
