Final Report: PWSRCAC Contract #6531.16.01, “Weather Buoy Demonstration Project”

Rob Campbell

Prince William Sound Science Center

August 15, 2018

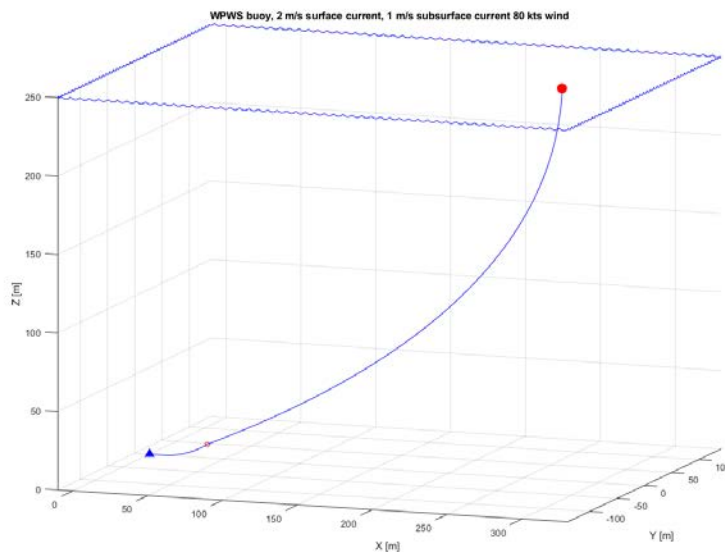
The performance of the mooring system was assessed with the Mooring Design and Dynamics toolbox (Fig. 2; Dewey, 1999). A worst case scenario of 2 m/s surface currents (0-10m), 1 meters per second subsurface currents (10 meter-bottom), and 80-knot winds was assessed. Calculations for that scenario indicated that 69 percent of the surface buoyancy would be used, and there would be -400 kilogram weight under the anchor. Those results, combined with a generous scope (float inverse catenary designs used by the National Data Buoy Center (NDBC) have a scope of 1 to 1.5, the mooring had a scope of approximately 1.63)

appeared to be an adequate margin for deployment (almost 500 pounds reserve buoyancy, around 850 pounds excess anchor weight).

Figure 2: Diagram of the resulting catenary calculated by the Mooring Design & Dynamics toolbox run with 2 meters per second surface currents, 1 meters per second subsurface currents, and 80-knot winds.

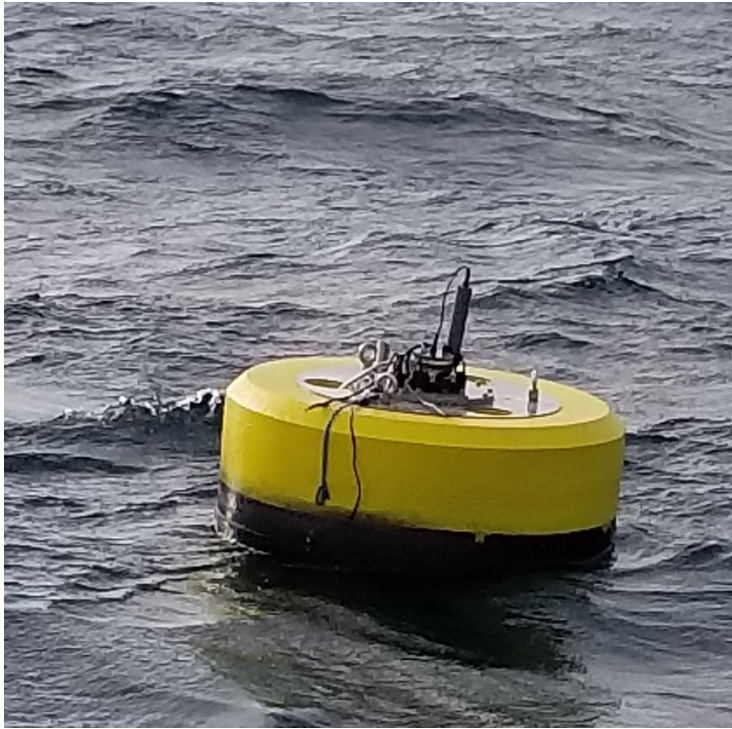
The webcam had transmitted images on April 22, but not on April 23. The April 24 photograph showed underwater and sky images, indicating that the tower on the top of the buoy had bent over or broken. Communications were permanently lost the afternoon of April 24, as wind and waves increased as a storm passed through. The buoy was visited following the storm on the morning of April 26, and only the hull remained (Fig. 3). The hull and mooring were recovered and brought back to Cordova. Upon inspection it was found that the wave sensor housing was broken open and

the bulkhead for the wave sensor data cable had broken, allowing seawater to enter the buoy hull. Most of the electronics were exposed to salt water while powered and were damaged beyond repair.

Figure 3: The buoy hull on site, April 26.

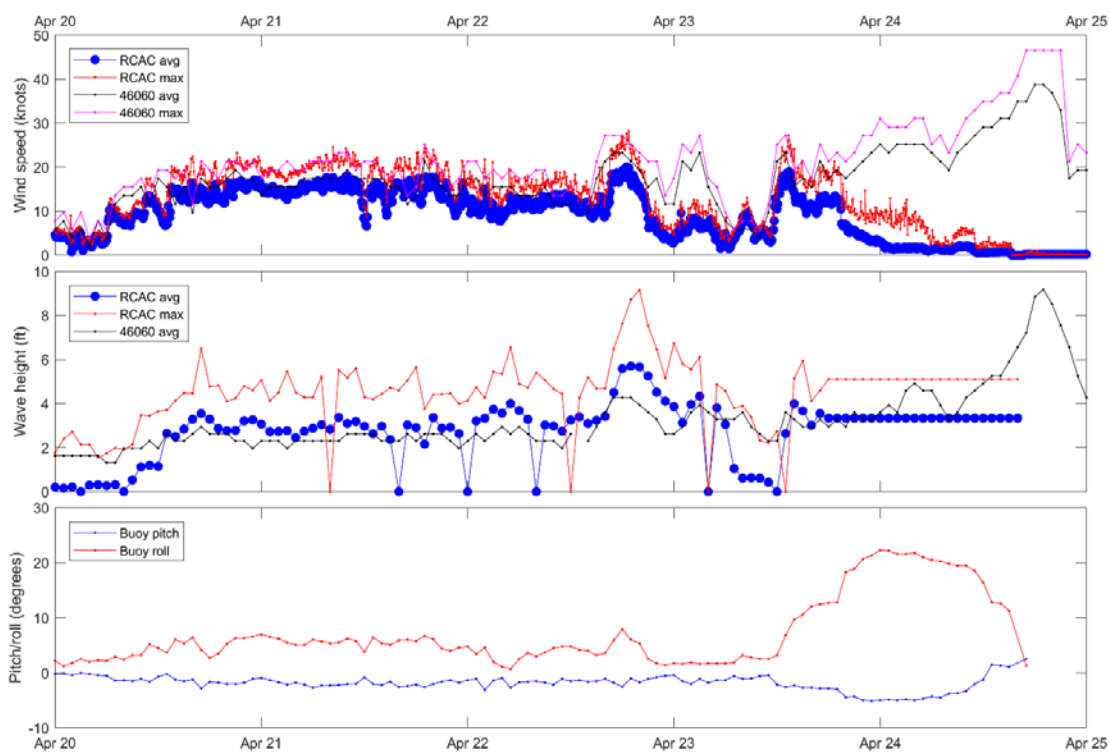
Figure 4: Conditions at the Western PWS buoy site and at NDBC buoy 46060 (Eastern PWS) in the days leading up to the failure, including average and gust wind speeds (top panel), wave heights (middle panel), and tilt and roll from the ADCP on the buoy.

The buoy appears to have been working as expected until at least April 22, and recorded similar wind speeds and wave heights to buoy 46060 in eastern PWS (Fig. 4). There was a difference in wind speeds early on April 23, which appears to have been due to wind shifts (the buoys measured winds from different directions). Wave heights were similar to buoy 46060 (if slightly higher, which would be expected from easterly winds). Wave heights dropped towards midday on April 23, then increased before settling at a constant 1 meter average height for the rest of the record. Those measurements are no doubt spurious. The tilt and roll recorded by the ADCP showed nothing abnormal until midday on April 23, when both departed from their regular values. That time (1300-1400) is likely when the tower began to fail, tilting the buoy over. As the tower tilted over, it probably hit the wave sensor, cracking open the housing and causing the spurious constant values.

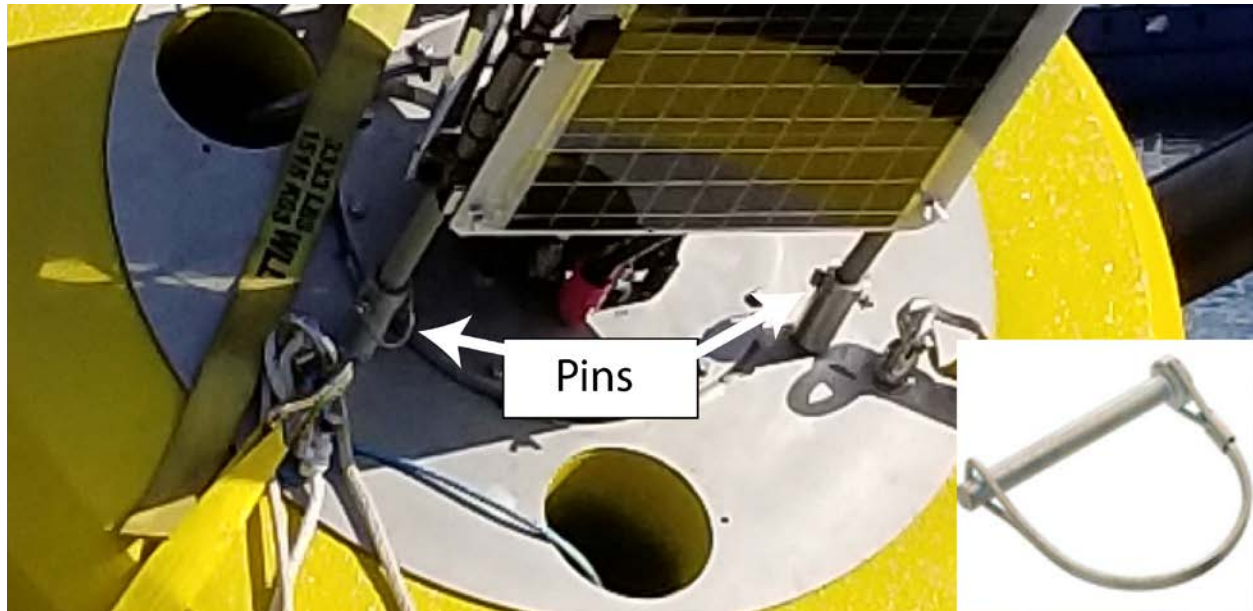
The buoy tower is in a tripod configuration, with the legs of the tripod fitting into mounts and held in place by clevis pins (Fig. 5).

Figure 5: Close up of the tower fastening arrangement on deck prior to deployment. Inset: A clevis pin of the type used to secure the tower.

The pins were installed on the buoy as instructed in the buoy manual, although they were installed from inside-out, because the arrangement of the lifting eyes on the buoy were so close that the pins could not be inserted from the outside (Fig. 5, 6).

I'm curious to know if you've had any other failures like this. You might want to recommend to other end users replace their clevis pins with something less likely to come off - bolts with nylock nuts perhaps? If you have any other thoughts about the mooring system or other recommendations I'd appreciate hearing them.

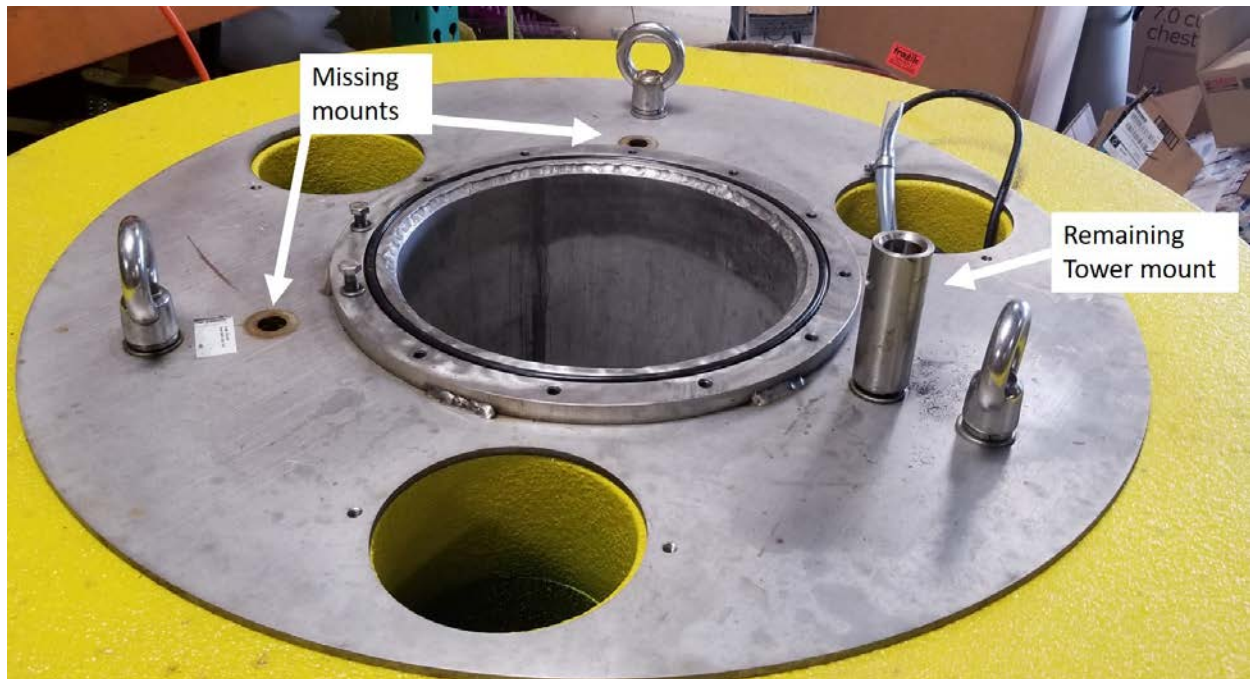
Following recovery two of the mounts affixing the tower to the hull were found to be missing (Fig. 7).

Figure 7: The top of the buoy hull post-failure.

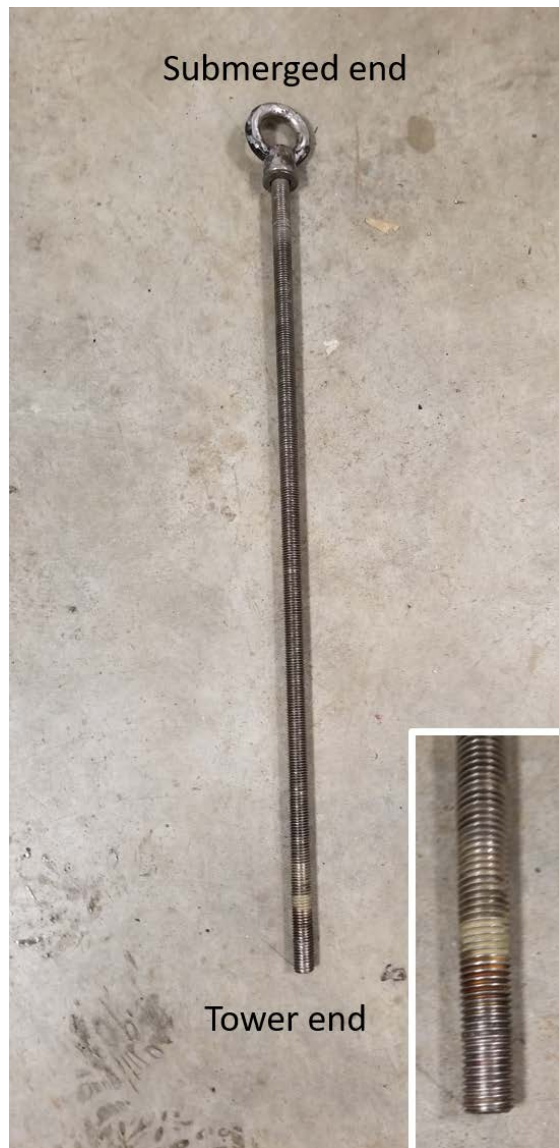
The mounts were secured to the buoy by long sections of 5/8 inch stainless steel threaded rod that pass through stainless steel plates on top and below the foam of the floatation section. The remaining threaded rod was removed and inspected, it had some minor surface corrosion but did not appear to be compromised (Fig. 8). Having noted some corrosion on the stainless portion of the buoy hull, all three rods had had sacrificial anodes affixed to ring on the submerged end prior to deployment.

Figure 8: The threaded rod to which the remaining mount was attached. Inset: a close-up of the section that was threaded into the tower mount. No major corrosion is evident.

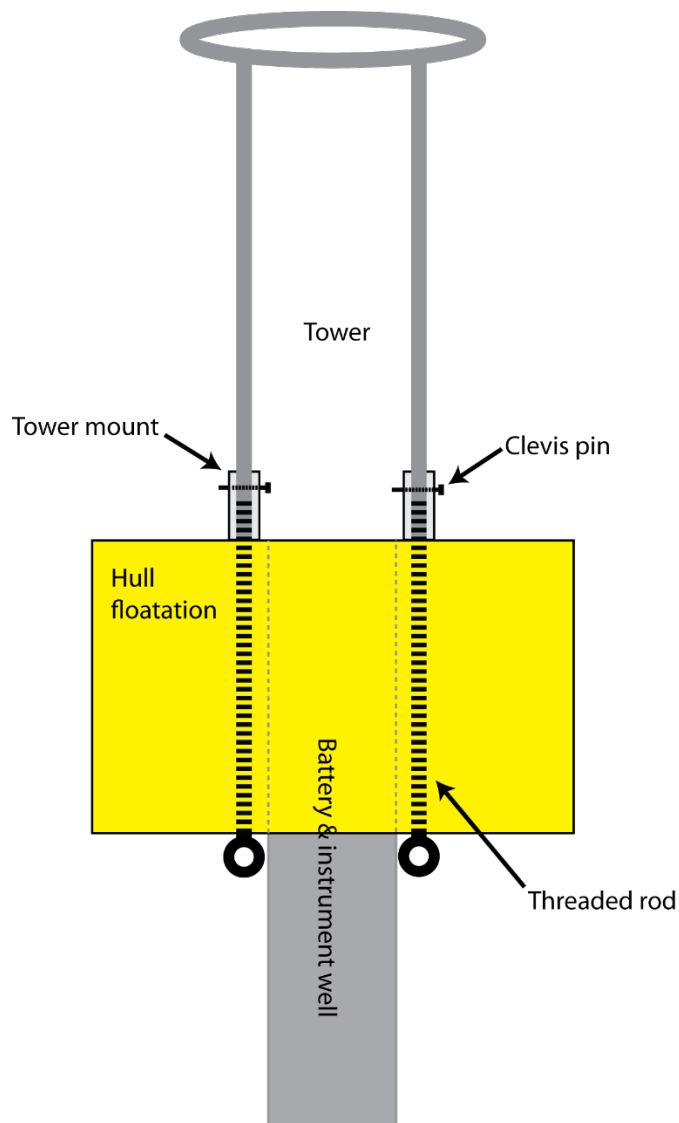
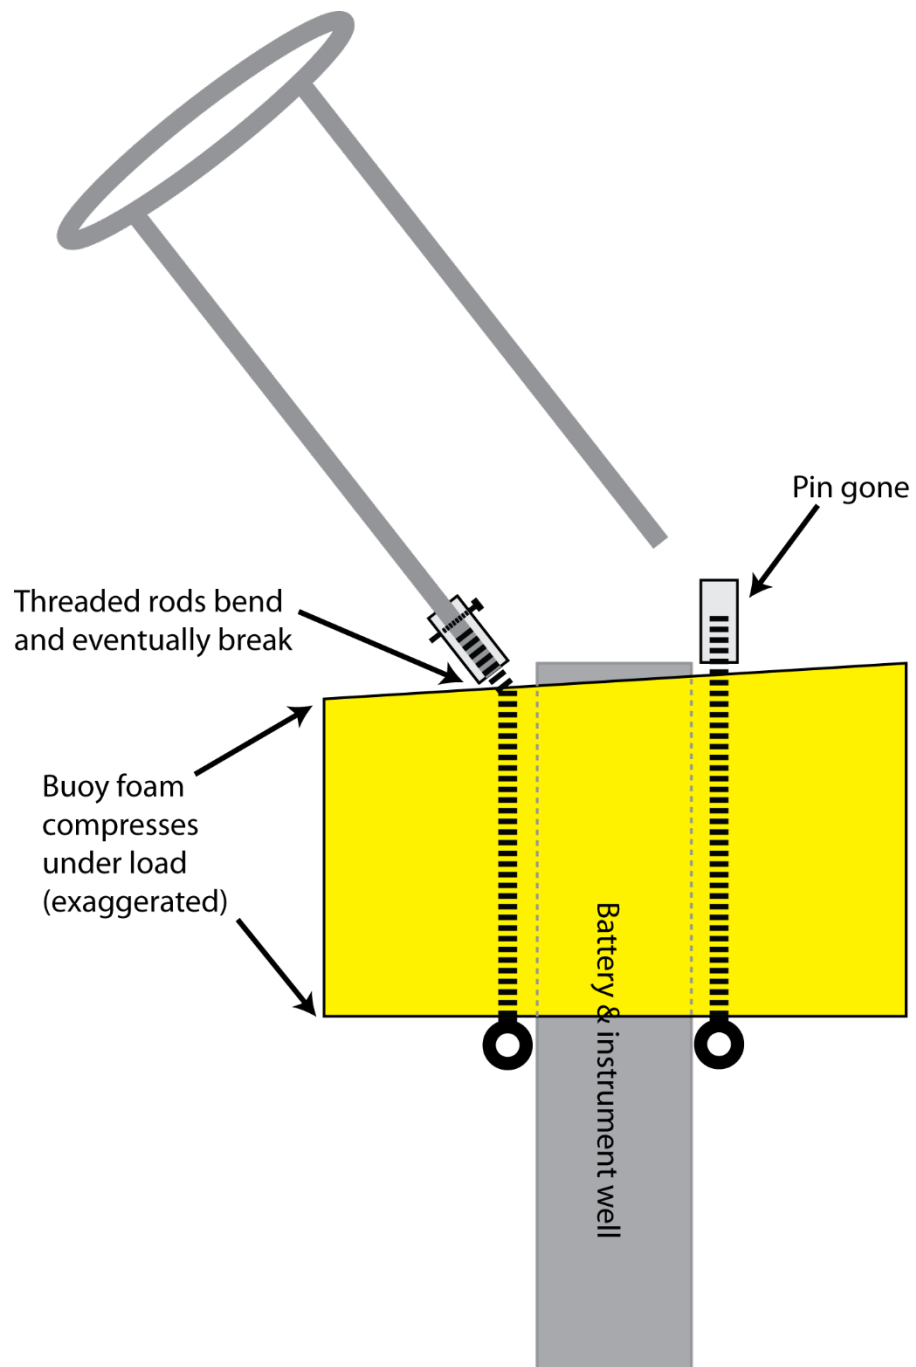
The most parsimonious explanation for the failure of the buoy tower is that one of the clevis pins failed or fell off, which allowed the buoy tower to bend the remaining threaded rods under wind and wave action. The buoy floatation is closed cell foam and would deflect as the threaded rods bent, failing to provide any structural buttressing to the tower. By April 24, the tower had fallen into the water and it broke off during the April 24-25 storm. An illustration of the mode of failure is shown in Figures 9 and 10.

Figure 9: A schematic of the buoy prior to the failure. Only two of the three tripod legs are shown for simplicity.

Figure 10: Failure of the buoy tower by loss of one of the clevis pins.

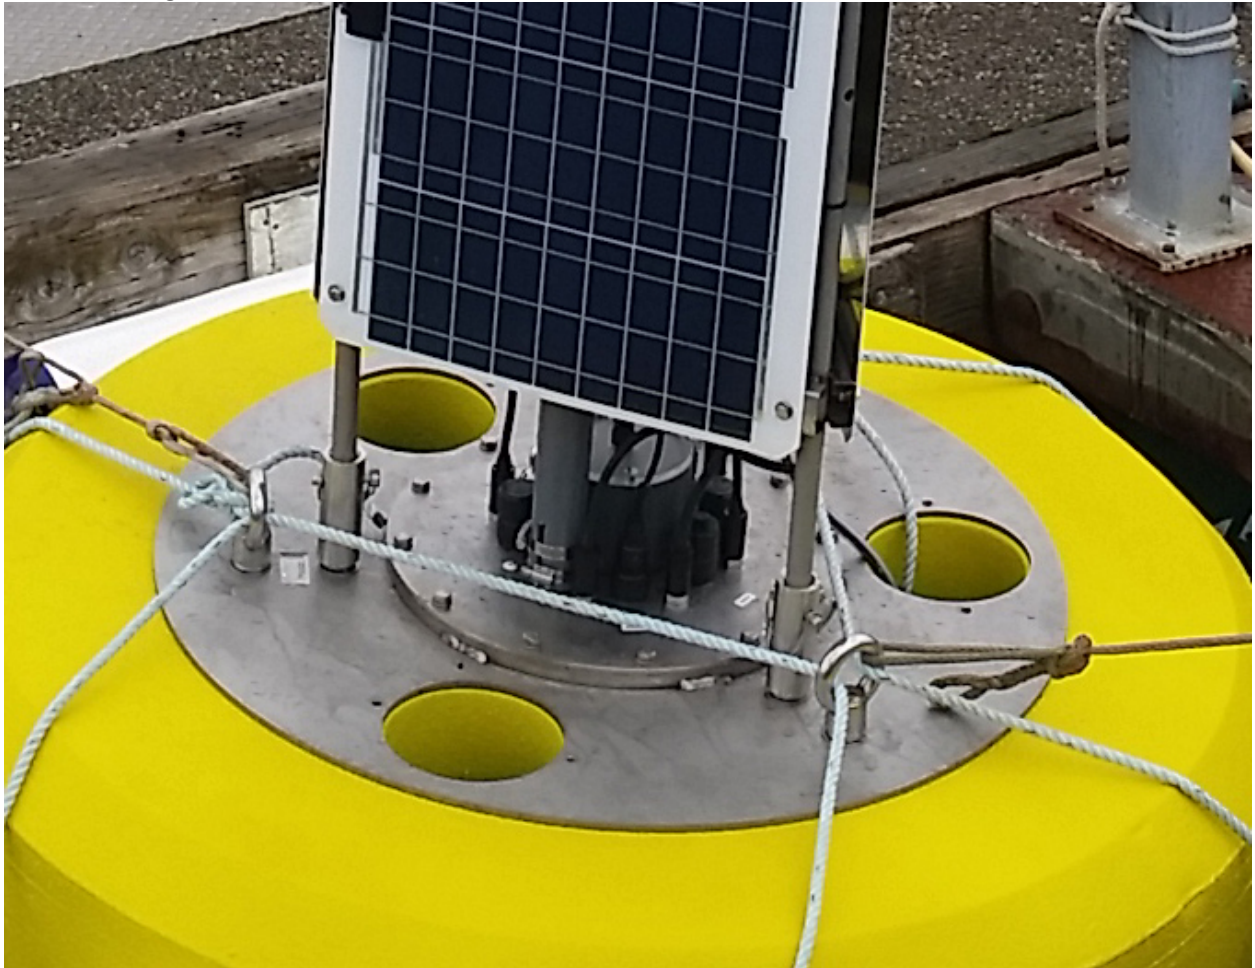
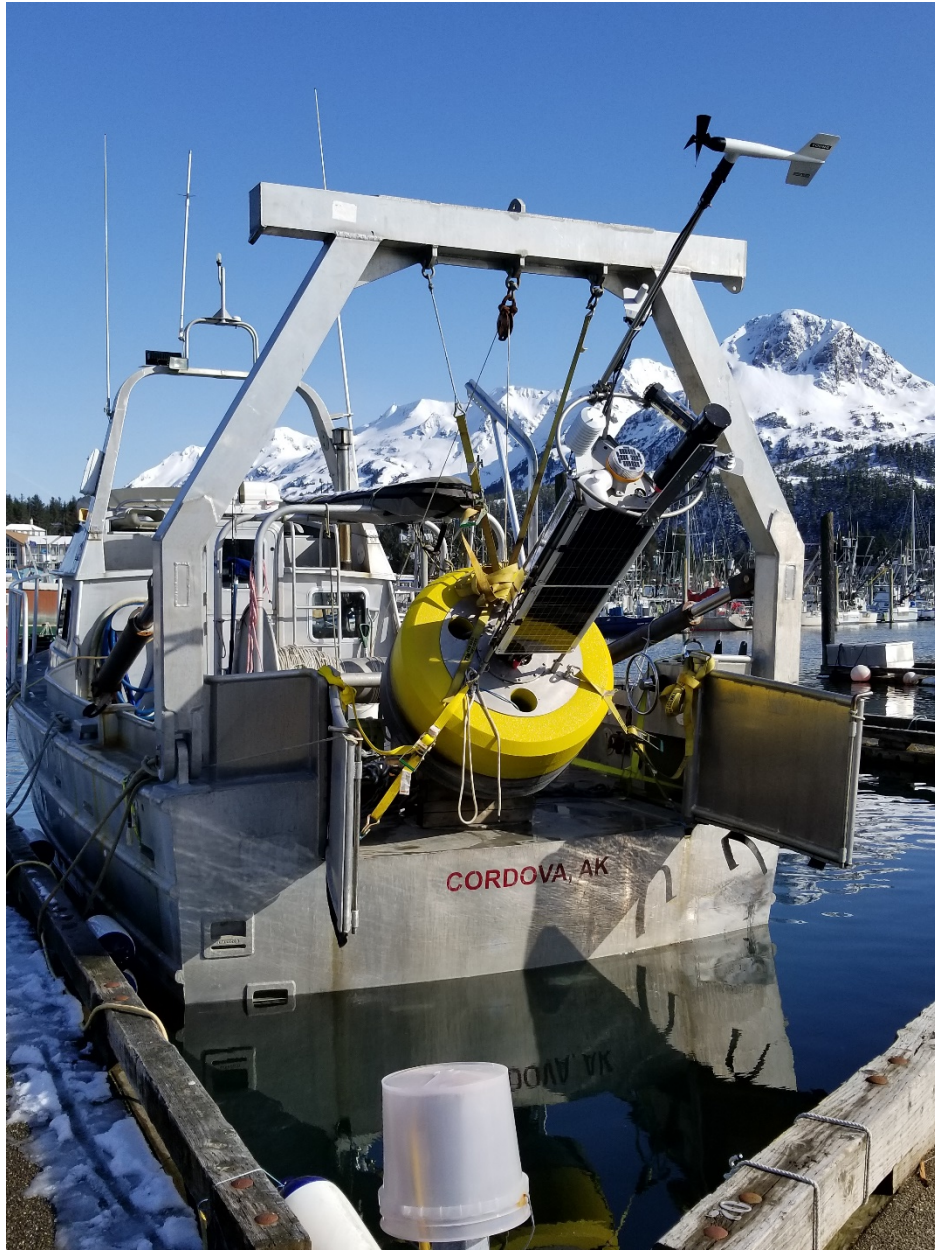
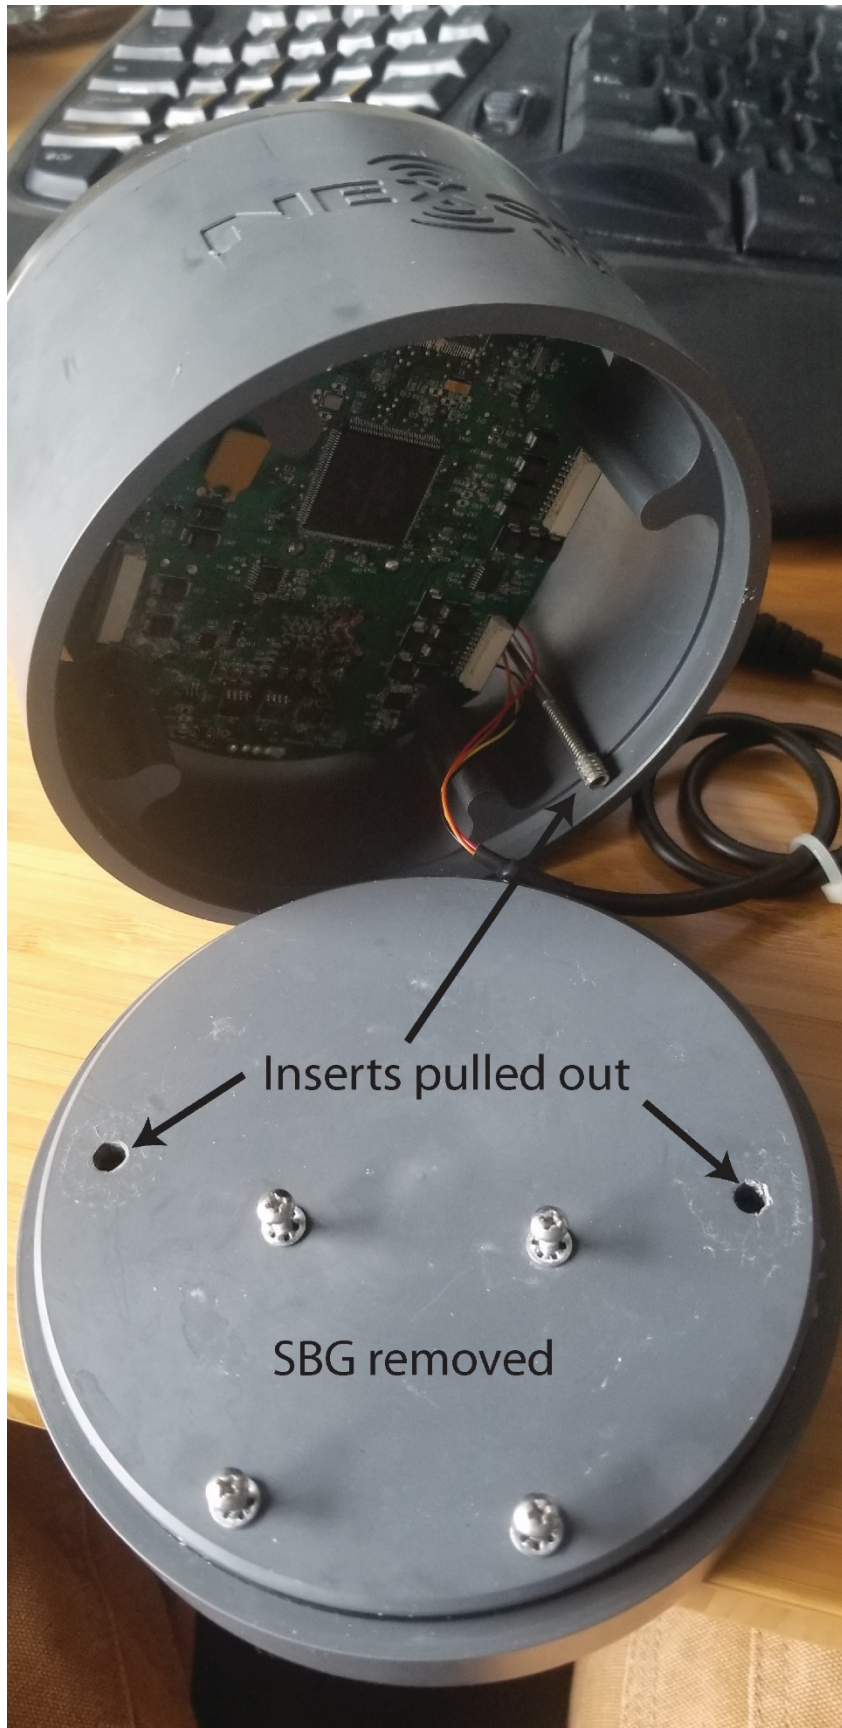
We had the RS485-RS232 converter on the wave sensor so to be able to have our Campbell Scientific logger talk to it. Given the size of the converter and my worry that it would flop around and get damaged, I had mounted it within a piece of PVC pipe that was secured to the bulkhead fitting and the side of the wave sensor - I made a 3D printed spacer between the two of them that matched the diameter of the wave sensor and the PVC pipe and held it all together with stainless hose clamps. When the tower tilted over, it hit the PVC pipe, which simultaneously broke the plastic bulkhead fitting and pulled the wave sensor off its base. That exposed the wave sensor electronics, and the broken bulkhead fitting let water into the hull. It didn't let in a lot of water (there was less than a gallon in the hull when I recovered it), but it dripped right onto the electronics and killed most of it. I don't have a super great picture of that arrangement, I've attached what I have.
