CRUDE OIL STORAGE TANK 8 INTERNAL INSPECTION REVIEW

William Mott, PE

PWSRCAC Board Meeting

May, 2021

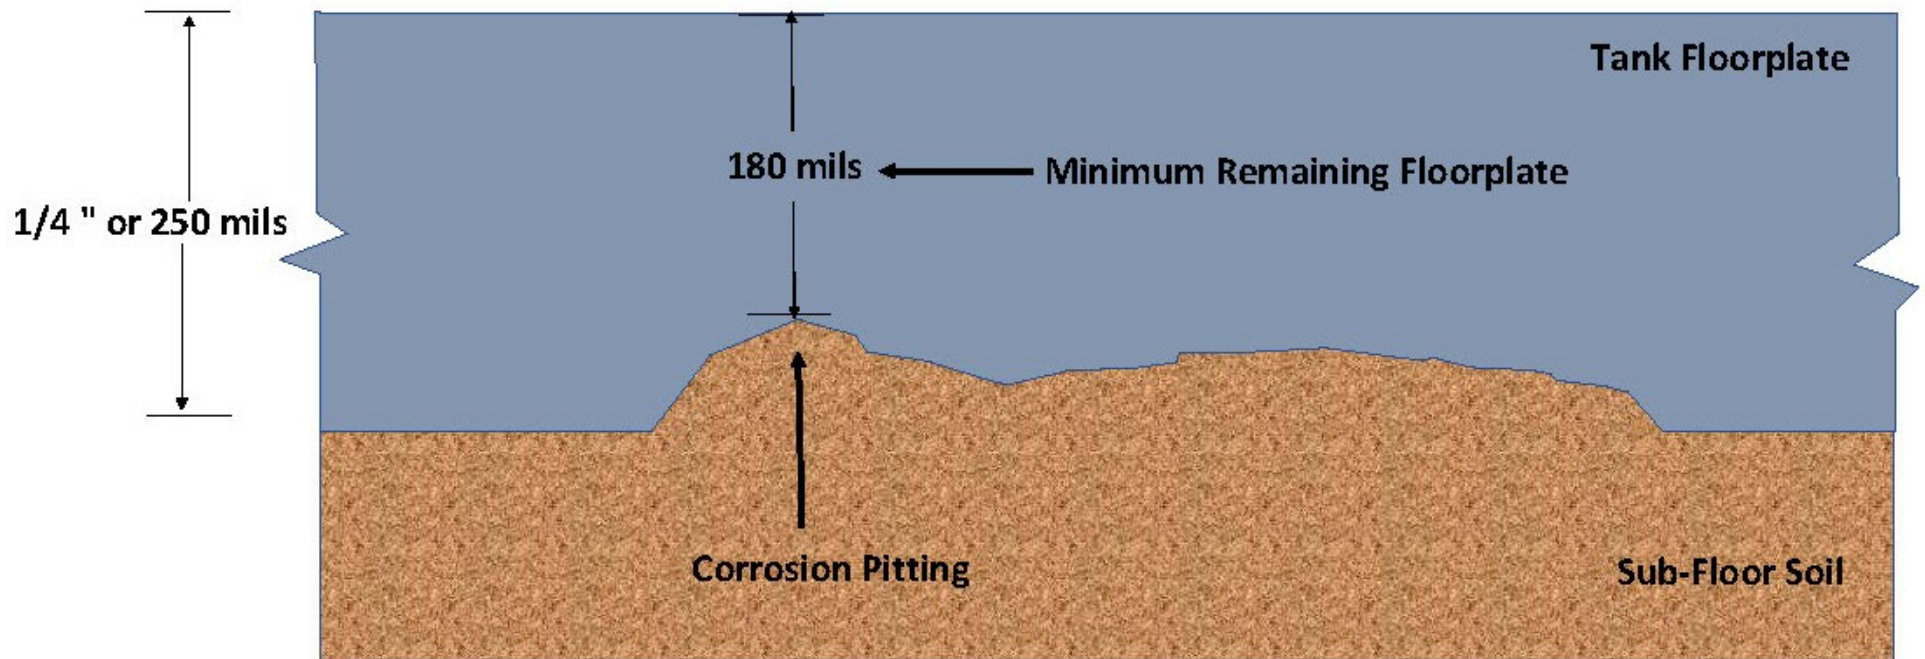
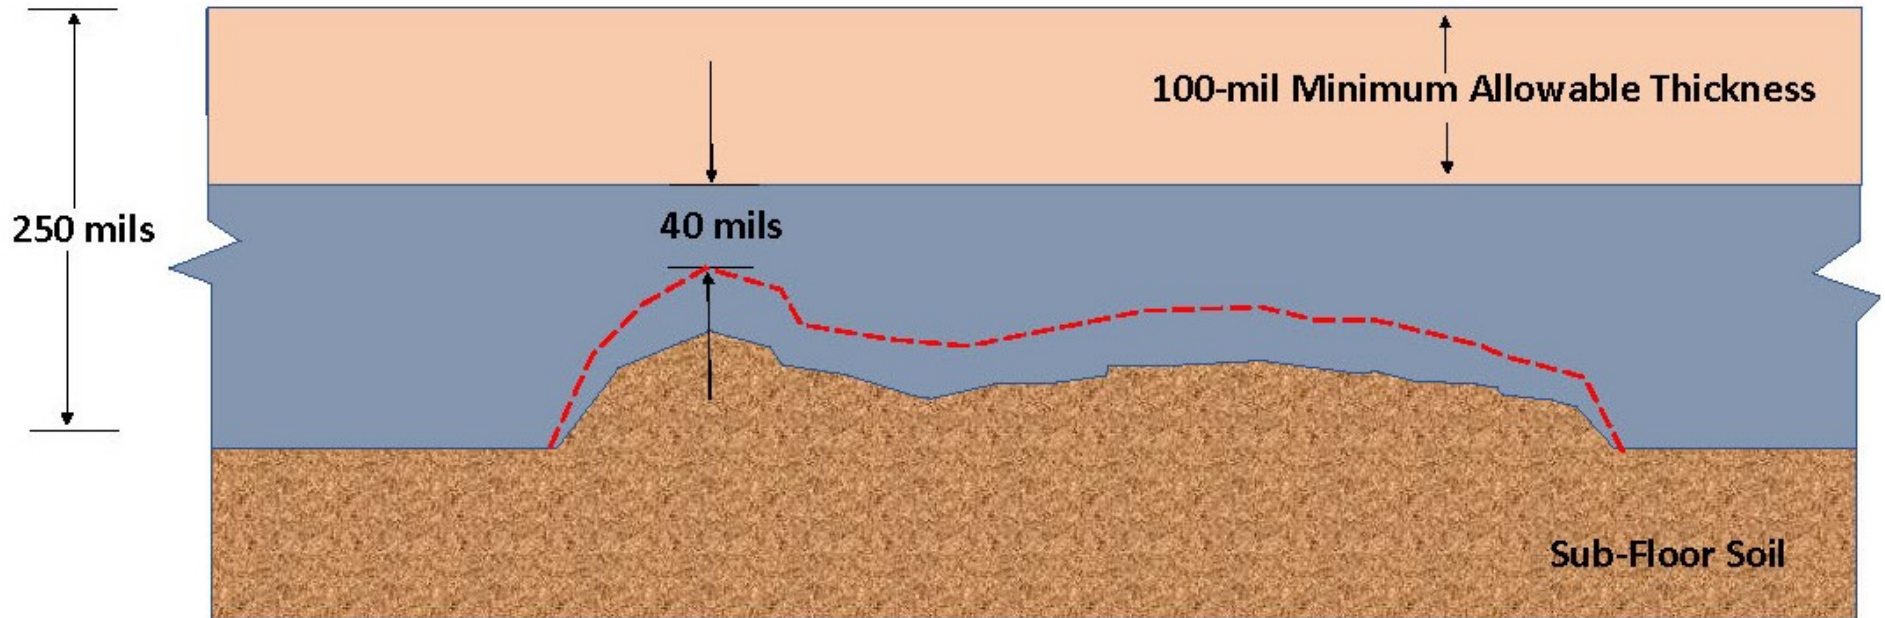
Finding #1 – 2020 API 653 Report/Return to Temporary Service

- There is very low risk of a corrosion failure during the current service interval (2020-2023).

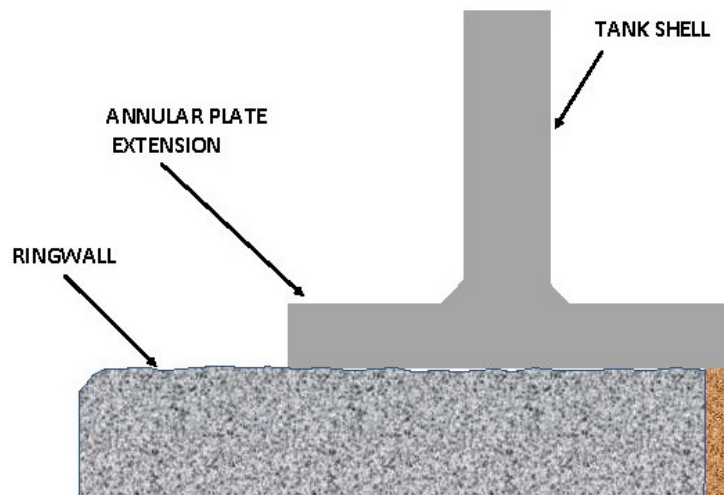
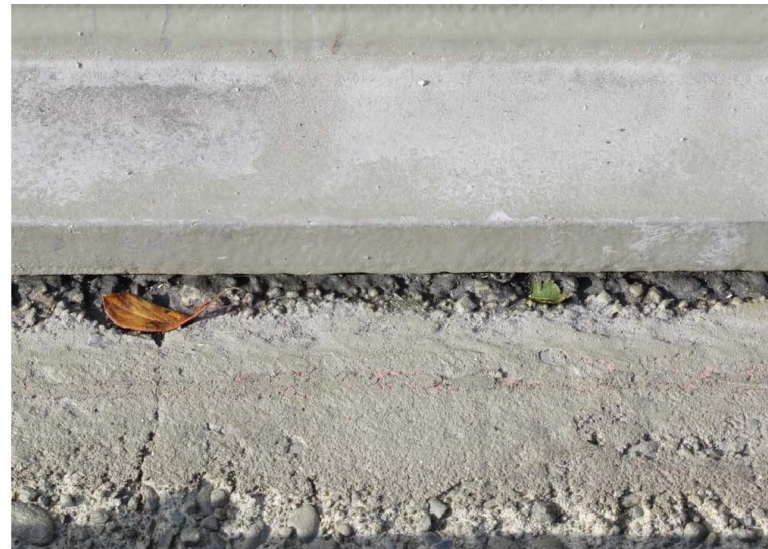
Ringwall/Floorplate Extension
without a seal

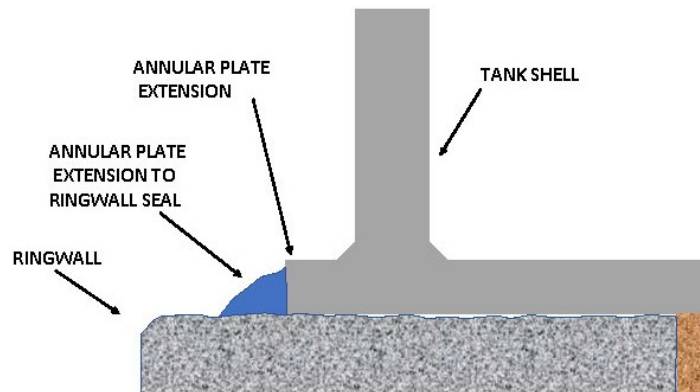
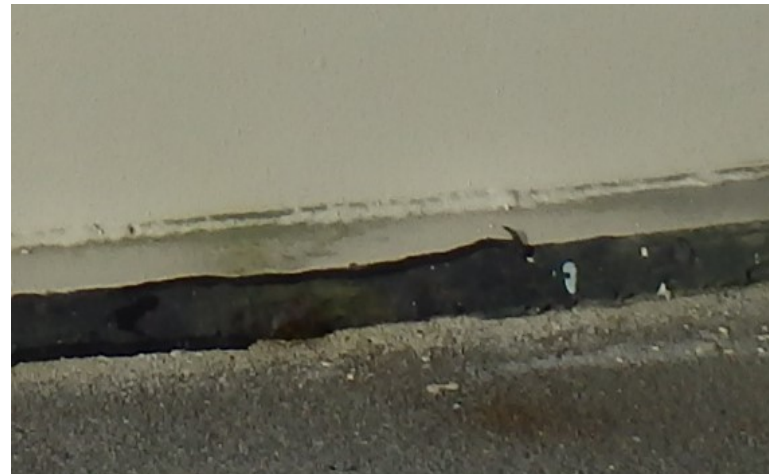
Typical Ringwall/Floorplate
Extension Seal

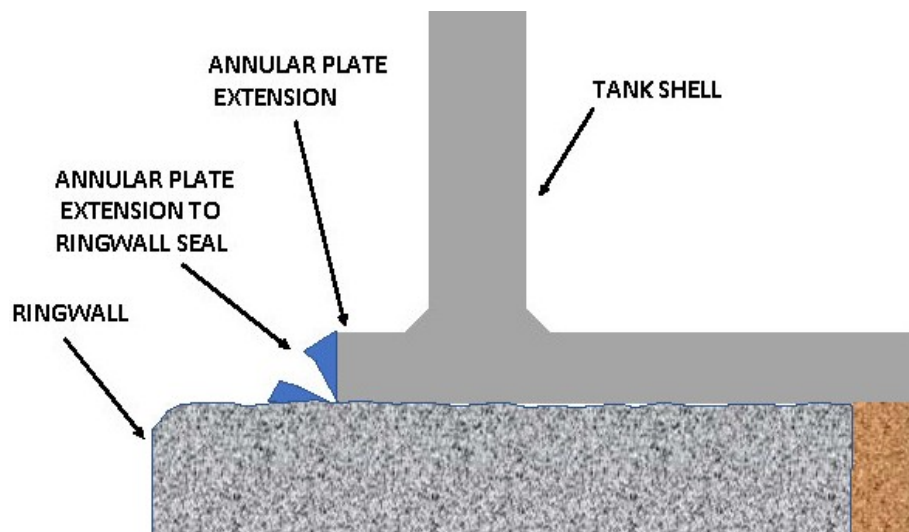
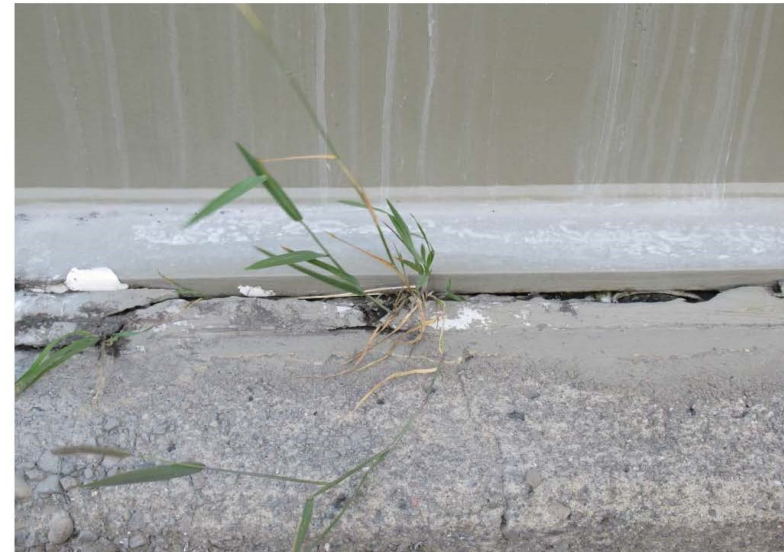
Finding # 2 – Annular Plate Extension Seal Failure

Damaged Ringwall/Floorplate
Extension Seal
