Briefing for PWSRCAC Board of Directors – May 2021

Project number and name or topic: 5056 – Tank 8 Internal Inspection Review

Crude Oil Storage Tank 8 Maintenance Review

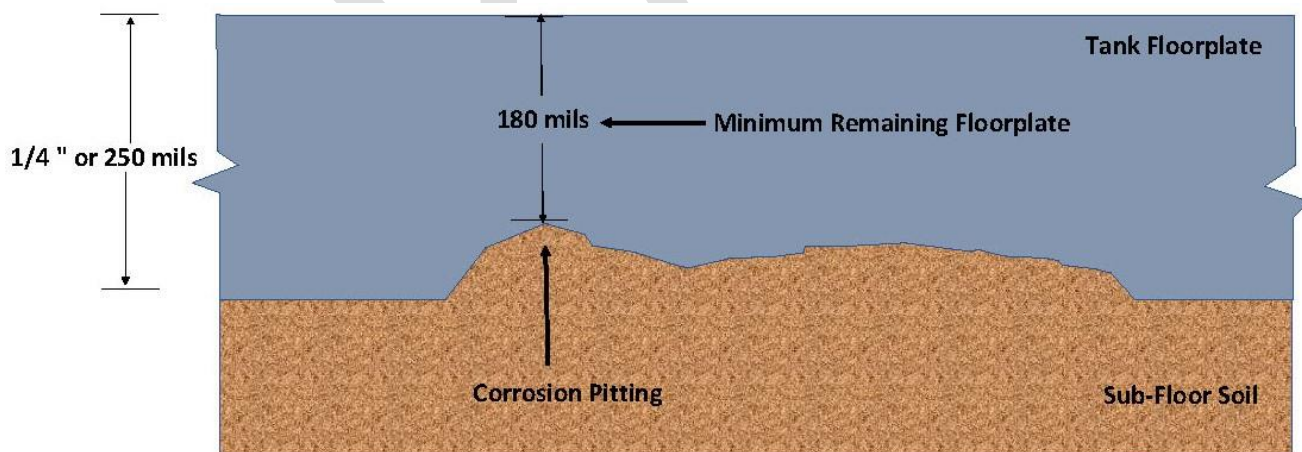
Figure 5 - Minimum Remaining Floorplate After 2019/2020 Repairs

The Tank 8 floorplate is comprised of ¼-inch (250-mil) steel plate. The top surface is coated, and no topside corrosion was reported during the 2019/2020 internal inspection. After the 2020 repairs, the minimum remaining floorplate should be no less than 180-mils thick. Figure 5 shows how a cross section of the thinnest remaining (unrepaired) floor in Tank 8 might appear.

The code requires that the floor still have a minimum of 100-mils of thickness remaining at the end of the planned service interval. That left APSC's engineers an 80-mil corrosion allowance to bridge the 4-year period between the inspection (2019) and removal from service again (2023). APSC used a corrosion rate of 20-mils per year as justification to bridge the 4-year service interval.

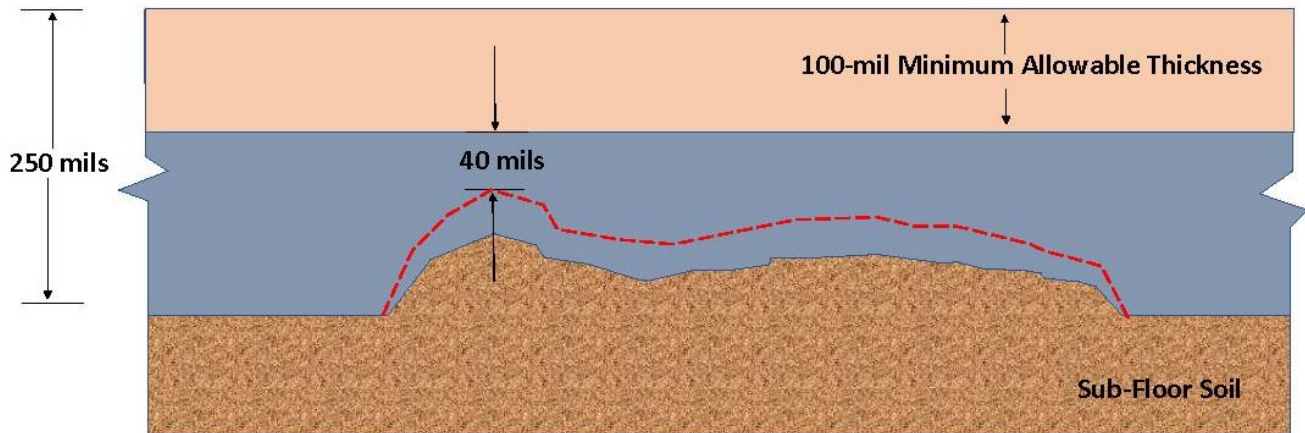
Figure 6 - Predicted Minimum Remaining Floorplate in 2023

The actual corrosion rate experienced on the tank floor is closer to 11 mils-per year. The red dotted line in Figure 6 depicts the probable deepest pitting in the floorplate that will exist in 2023 (approximately 140-mils remaining wall thickness). The beige area represents the 100-mil minimum allowable floorplate thickness after the service interval.

APSC's approach to the 2020 return-to-service is relatively conservative. The assumed corrosion rate of the service interval calculations is significantly higher than the measured rate. There is very little risk of a corrosion failure from Tank 8 before the tank is removed from service again in 2023.

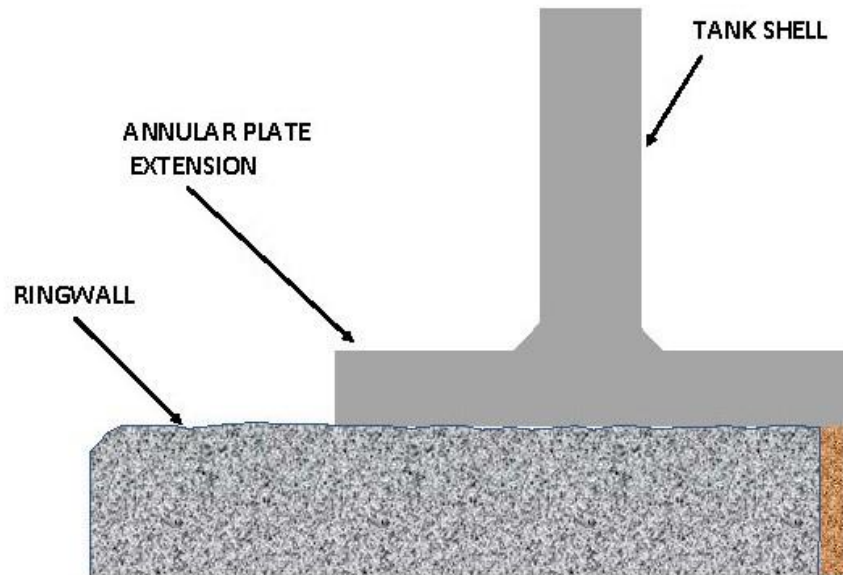
Figure 8 - Annular Plate Extension (No Seal)

Figure 8 represents an enlarged section view of the area in the red circle from Figure 7. The tank annular plate extension (or floorplate extension) rests directly on top of the concrete ringwall. The floorplate extension is not sealed to the concrete ringwall. Any rainwater running down the side of the tank can collect on the top of the ringwall and either run off the outer diameter of the foundation or seep under the annular plate extension and into the soils between the floorplate and secondary containment liner. This can exacerbate corrosion of the tank

floor and potentially lead to buoyancy forces pushing up on the tank floor and damaging it and/or the tank roof column supports – which is discussed in detail later.

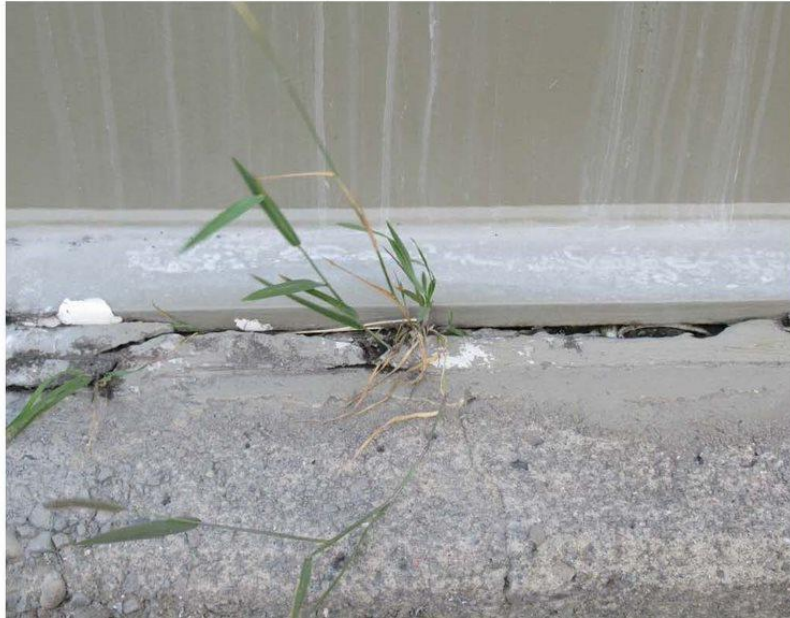
Figure 10 - Tank 8 Ringwall/Annular Plate Seal

The seals between the VMT tank annular plate extensions and the concrete ringwalls are still not maintained. Figure 10 is a photo depicting the condition of the Tank 8 annular plate extension/ringwall seal in 2019-2020. It is obvious from the photo that the seal has failed and is no longer preventing water from seeping beneath the tank floor.

Rather than preventing water from seeping beneath the tank floor, the cracked seals may be exacerbating the water migration into that area. Figure 11 depicts a section of the ringwall/annular plate with a cracked seal. The presence of a crack in that joint forms a gap that may funnel more rainwater beneath the floor than would be caused by the lack of any seal.

APSC should drain as much water as possible from beneath the tanks through the available drainage piping and CP monitoring tubes. They should replace and maintain the ringwall/floorplate seals to prevent further water intrusion beneath the floors of storage tanks at the VMT.

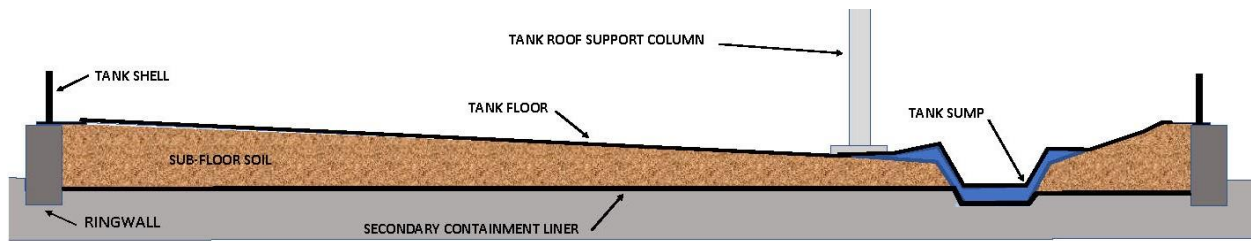
Figure 12 – Tank Sump Flotation

Water-saturated soils beneath the crude tanks increase the risk of bottomsides corrosion and impart buoyant (upward) forces on the tank sump and surrounding floorplate. When the tank is fully emptied of oil, these forces can cause the sump to float and be displaced vertically (Figure 12). There are four roof support columns in relatively close proximity to the sump. Any upward motion of the sump can cause high stresses on the adjacent columns, risking damage to the floor or column footing.

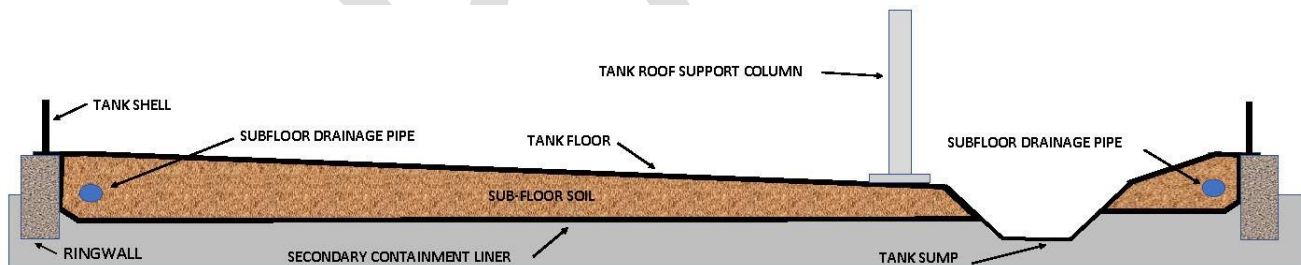
Figure 13 – Subfloor Drainage System Location

On some of the crude storage tanks, APSC installed subfloor drain piping between the tank floor and secondary containment liner (Figure 13). We have not received a record of exactly which tanks have that drainage system. However, the drain piping was installed at a level that is significantly higher than the bottom of the tank sump. While the drain piping will reduce the buoyant forces acting on the sump, it will not totally alleviate those forces.

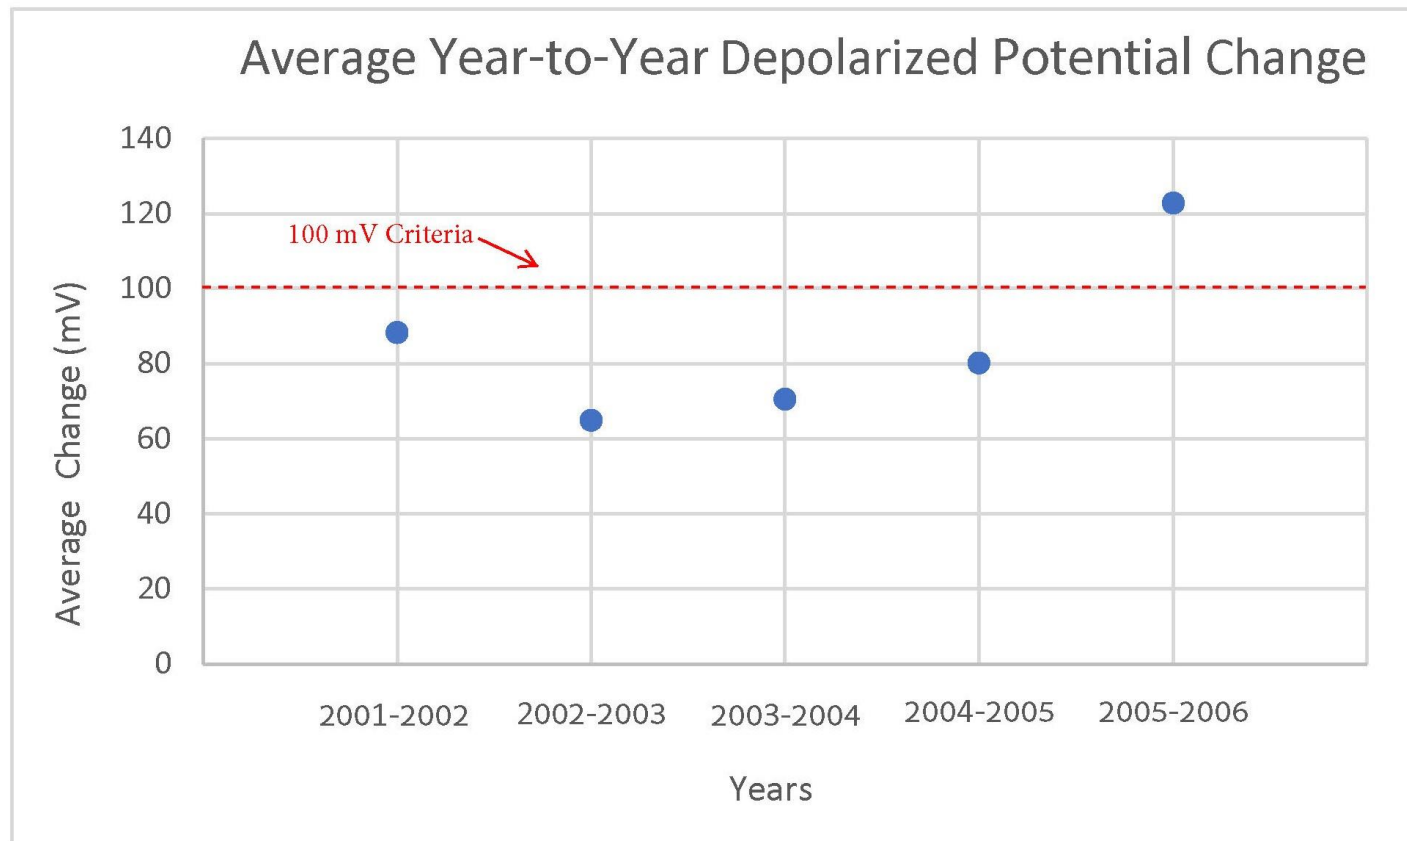
Figure 17 – 2001-2006 Average Change in Tank 8 Depolarized Potential Readings

Figure 17 presents a graph of the 2001-2006 year-to-year average change in depolarized potentials for Tank 8. A line showing the 100 mV criteria was added to the graph for reference. This clearly illustrates that the annual changes in the depolarized potentials on the tank are similar in magnitude to the criteria that is being measured against. In fact, between 2005 and 2006, the average change in depolarization potentials was greater than the 100 mV criteria that is being measured against.

The depolarized potential is used (with the instant off potential) to ascertain if the structure has 100 mV of polarization. These year-to-year changes in the depolarized readings on Tank 8, clearly illustrate why the standard requires that the operator measure the formation or decay or polarization each year. This data provides clear, empirical evidence that the practice of using depolarized data from past years will result in errors and invalid CP data. This supports the NACE SP0169 requirement that the formation or decay of polarization be measured in order to utilize the 100 mV criteria. The depolarized readings should be collected in the same relative timeframe (within weeks) of the collection of instant off or IR-free data.

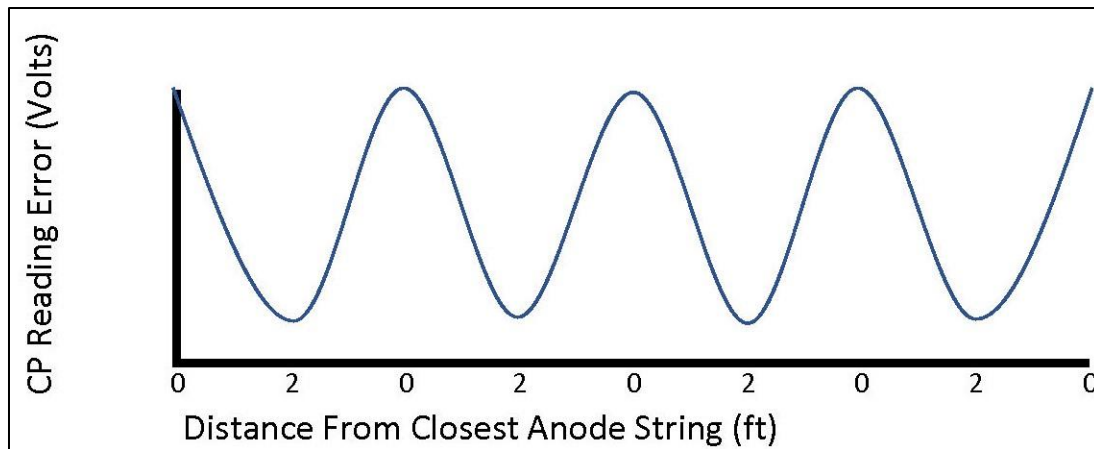
Figure 19 – CP Reading Error/Distance from Anode

If the CP reading errors were caused by proximity to the anodes, then the magnitude of that error would gradually decrease as the distance from the anode increases. This decrease would continue until the reading was taken at the midpoint between two anode wires (as depicted in Figure 19), at which point the error would begin to increase again. If APSC's statement regarding proximity to the anode is accurate, this means that all CP readings collected beneath the tank are likely to be impacted by the same causal error, although the magnitude of that error may vary relative to the distance from the anode.

In our professional opinion, the reasoning for the error that is cited may not be entirely correct. If all impacting CP systems are properly interrupted, then the field around the anode should collapse and the potential readings should not be impacted by the relative proximity to the anode.

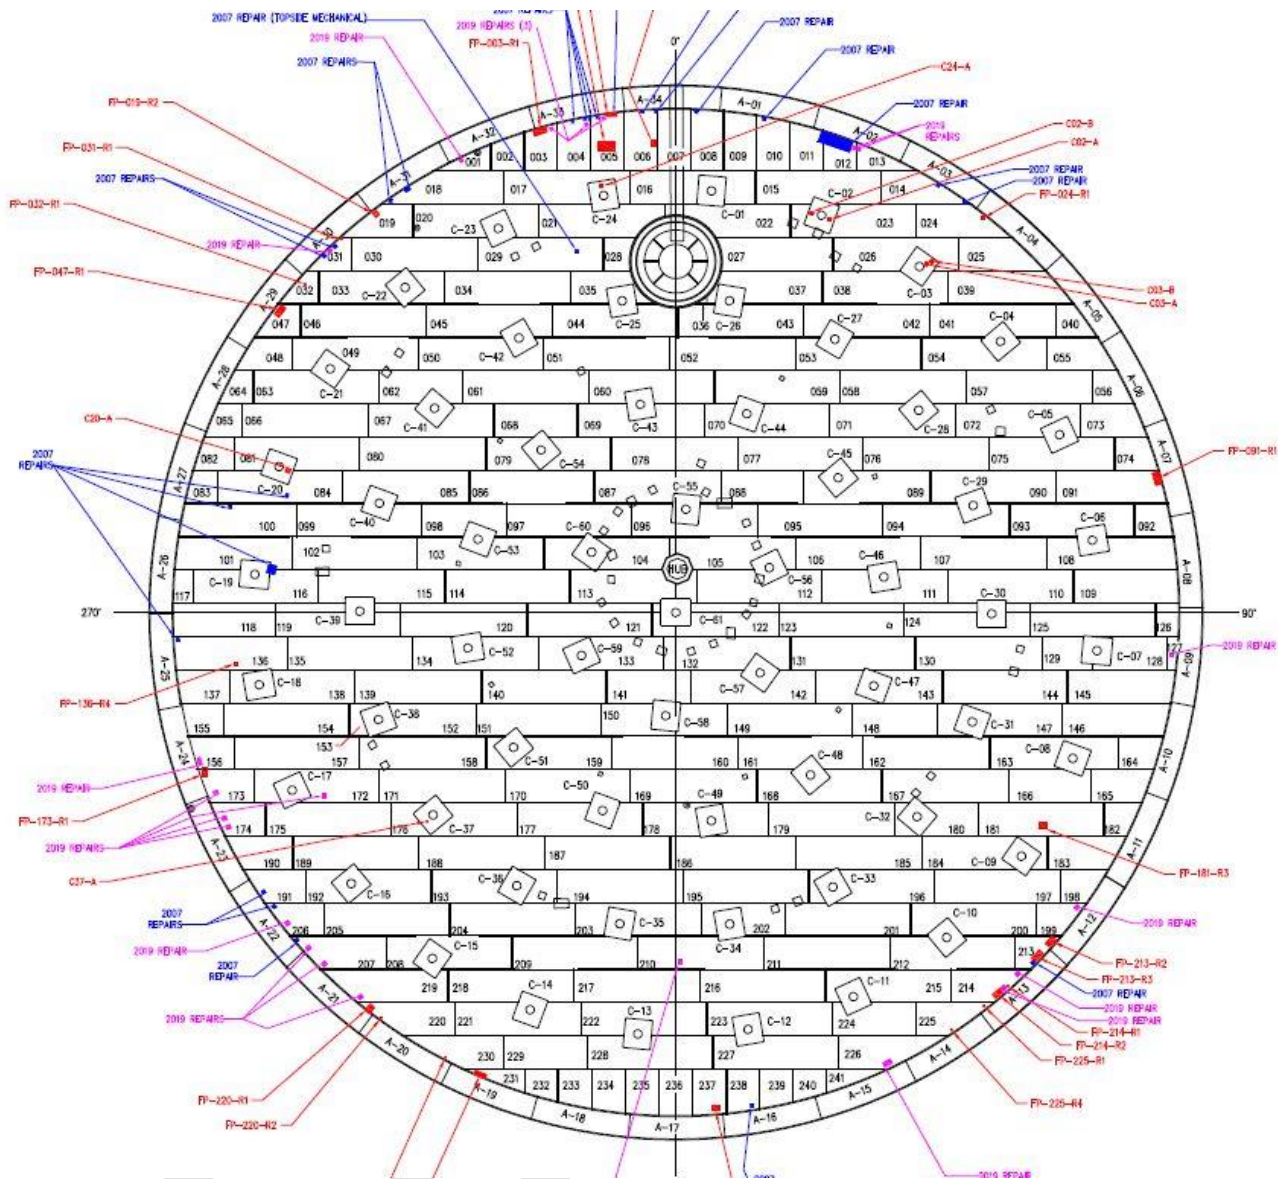
Figure 21- Tank 8 Repair Patch Locations

This may be in part why the majority of the floorplate repairs completed in 2007 and 2019 were located on the perimeter plates of Tank 8 (Figure 21).
