Final report.

Corrosion Survey of Valdez Marine Terminal

Contract Number 559.12.01

December 20, 2012

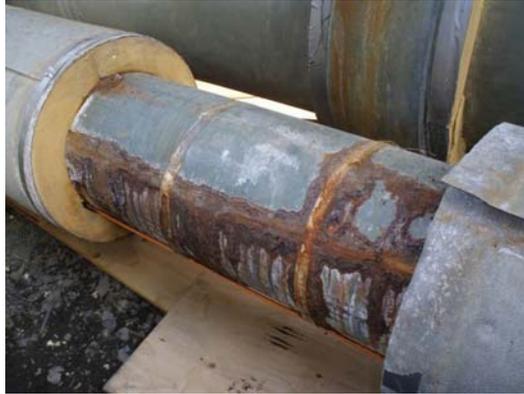
A similar problem, the lack of protective coatings at welds, was found by APSC in May 2008. This is shown in Figure 1, a photo supplied to DRI by T. Kuckertz, PWSRCAC, who took the picture.

Figure 1: Corrosion near unpainted welds on insulated piping.
Photograph by T. Kuckertz, PWSRCAC, May 29, 2008 at the
VMT Ballast Water Treatment Facility

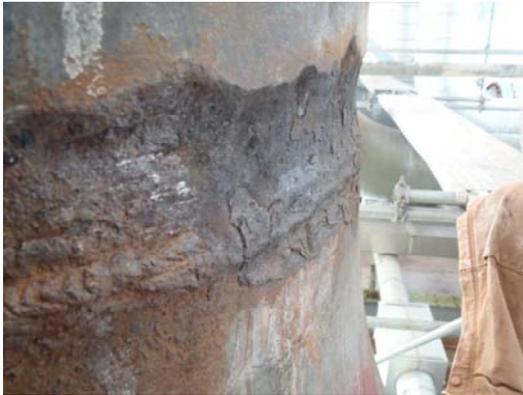
Figures 2-7 below show corrosion found after thermal insulation was removed from vertical piping on Berth 4 at the VMT. These pictures were supplied by APSC. The repairs are in accordance with standard industry practice for repair of corroded piping.

Figure 2: CUI on vertical piping

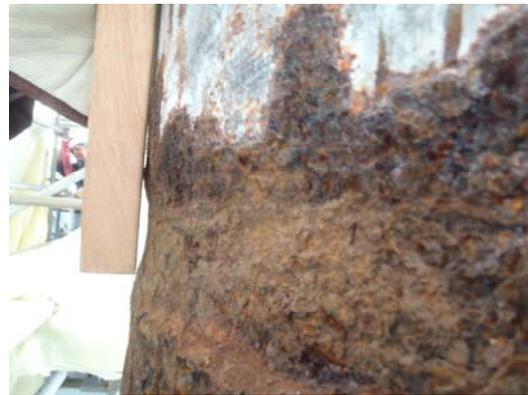
Figure 3: Corrosion showing
depth of pitting

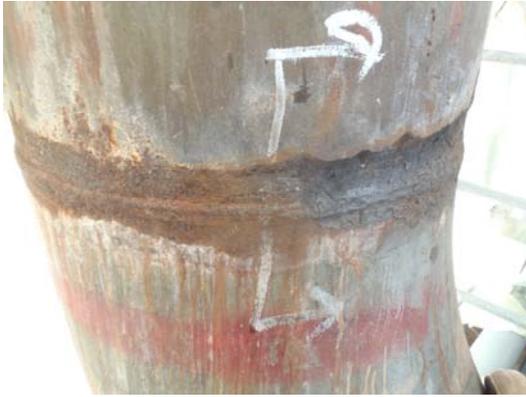
Figure 4: Vertical piping showing that corrosion is associated with unpainted steel at welded joints

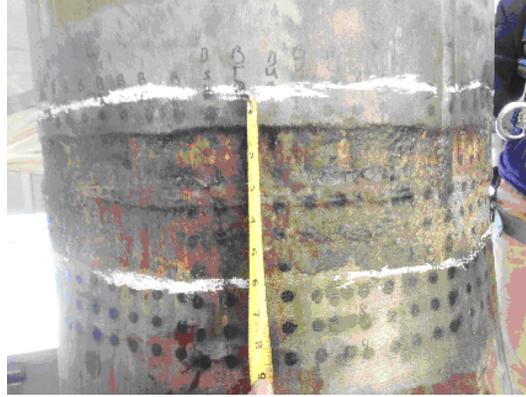
Figure 5: Ultrasonic (UT) test grid for determining maximum wall loss at corroded location

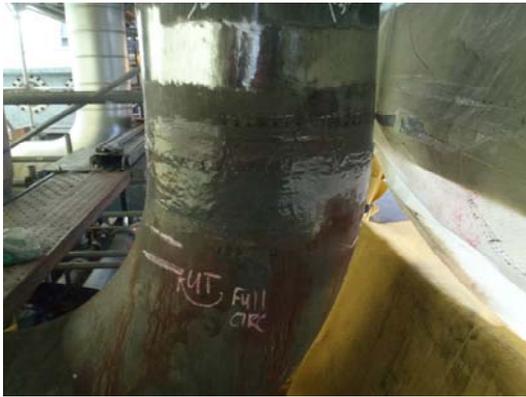
Figure 6: Epoxy repairs to corroded vertical piping

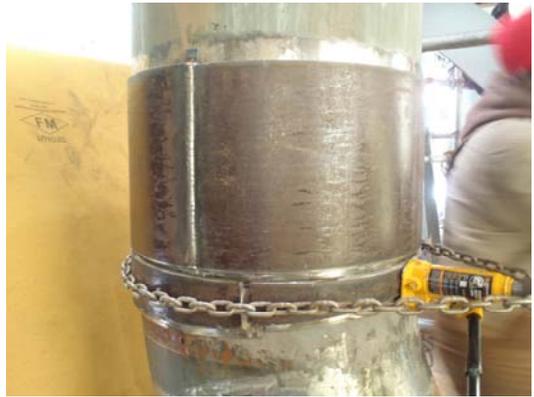
Figure 7: Steel sleeve installed over repaired metal

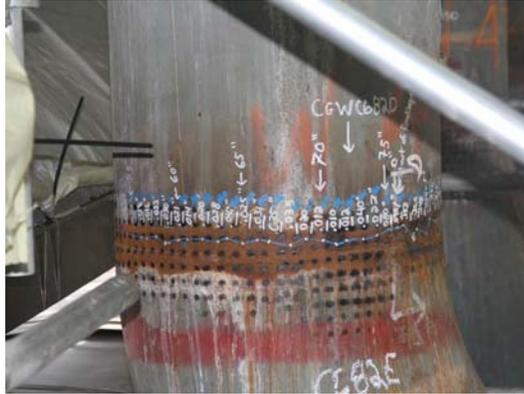
Figure 8 below, taken on Berth 5, shows a similar pattern of corrosion underneath insulation on vertical piping. The same lack of protective coating at welds shown in Figure 1 (2008 ballast water treatment facility) and Figures 2-7 (Berth 4) is apparent.

Figure 8: Corrosion under insulation (CUI) at unpainted welds on Berth 5
Note the ultrasonic (UT) inspection grid markings similar to those shown in Figure 5.

Finding F1: Figures 1-8 show that a pattern of corrosion at unpainted welds has been noted on piping under insulation since at least 2008. The corrosion discovered in 2012 was deep enough to warrant repair sleeves, and, equally important, it was on piping over the water. If the corrosion had not been discovered in time, it could have led to crude oil releases into Port Valdez. APSC reports that this condition was found as part of their planned CUI inspection project Z683 titled “VMT crude header external condition survey.”

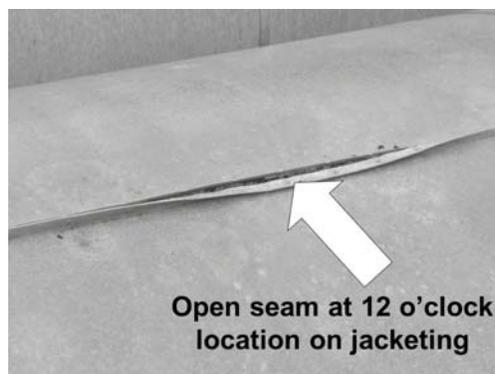
Figure 10 shows a defective seam at the 12 o'clock position on insulated piping along the causeway leading to Berth 5 at the VMT.

Figure 10: Open seam on insulation jacketing on piping leading to Berth 5 at the VMT

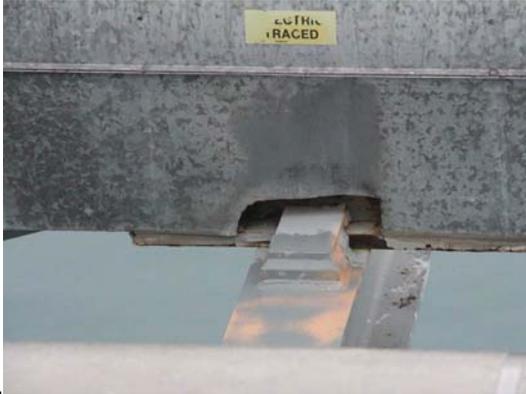
Figure 11: Opening in weather jacketing on piping leading to Berth 5

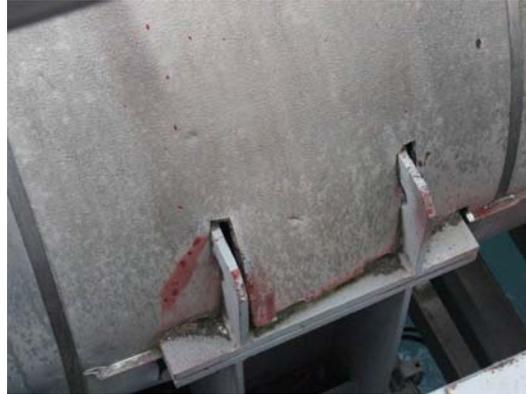
Figure 12: Opening in weather jacketing on piping leading to Berth 5

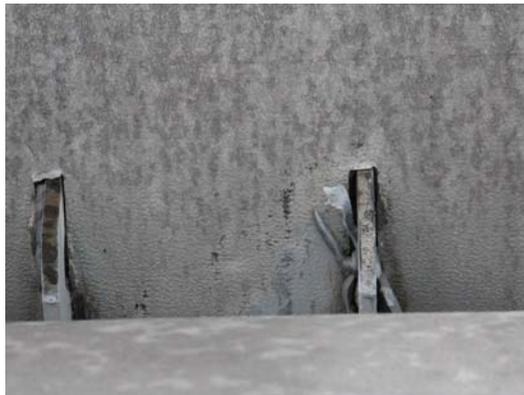
Figure 13: Opening in weather jacketing on piping leading to Berth 5

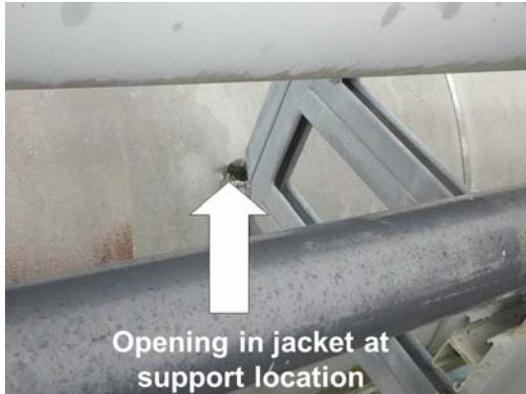
Figures 14 and 15 show similar openings where movement of the piping has caused damage to the sheet metal of the jacketing at the attachment openings.

Figure 14: Opening in jacket at support location

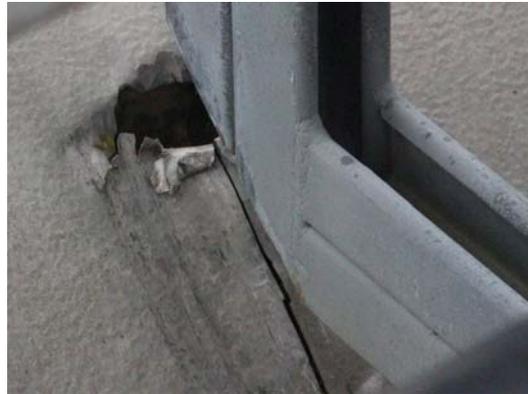
Figure 15: Tearing of jacket at support due to mechanical motion of causeway or piping

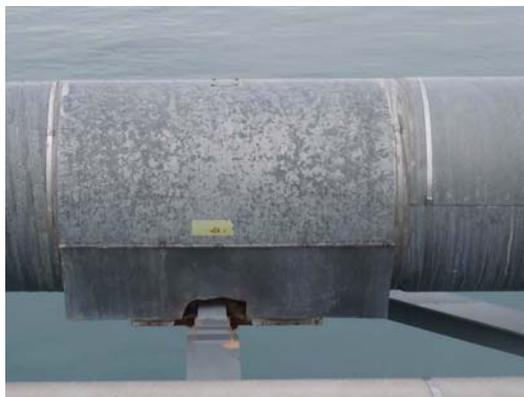
Repairs to the weather-proofing metal jacketing are sometimes protected at vulnerable joints by covering the piping with sheet metal. This is shown in Figure 16.

Figure 16: Cover over repaired jacketing on insulated vapor recovery line

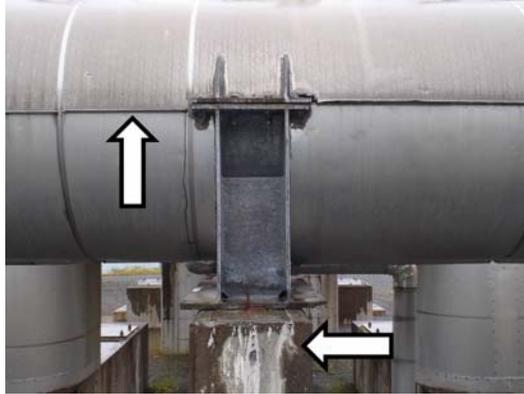
Figure 17 below shows an area where excessive moisture caused efflorescence (mineral "bleeding") from the concrete supports below the piping. Other indications of excessive moisture include moss (Figures 18 and 19) and stains along the bottom of the exterior jackets (Figure 20).

Figure 17: Repaired insulation jacket indicated by top (vertical) arrow. Bottom (horizontal) area shows efflorescence indicating excessive moisture on the concrete support at this location

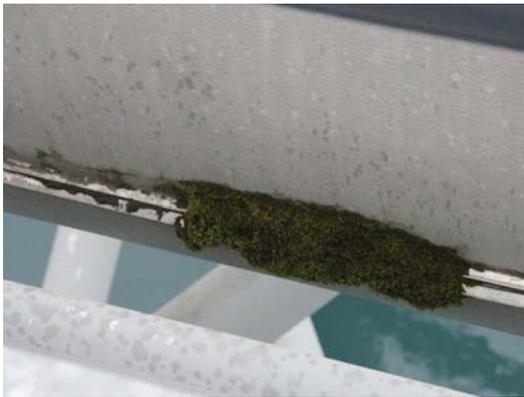
Figure 18: Moss growing at excessive moisture on thermal barrier jacketing on the Berth 5 causeway

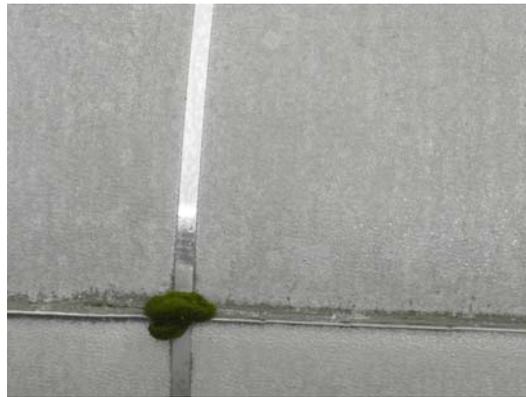
Figure 19: Moss growing at another location on the Berth 5 causeway

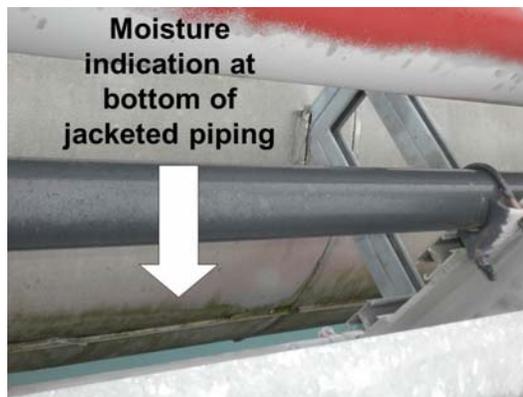
Figure 20: Moisture indications at the bottom of insulated piping

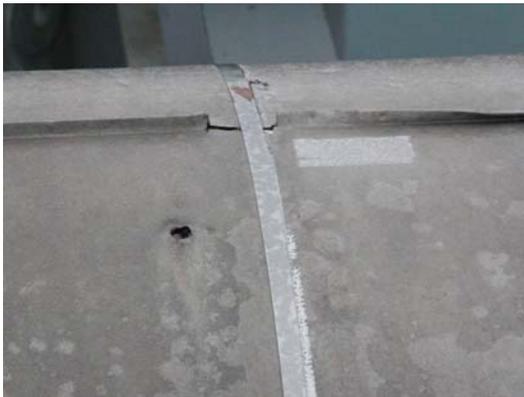
Figure 21: Hole in repaired thermal on Berth 5 causeway

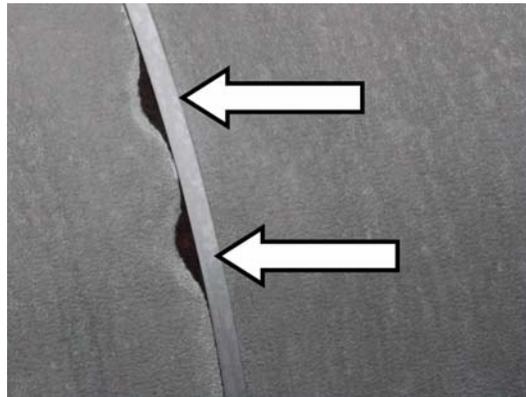
Figure 22: Wrinkled jacketing underneath tightening band

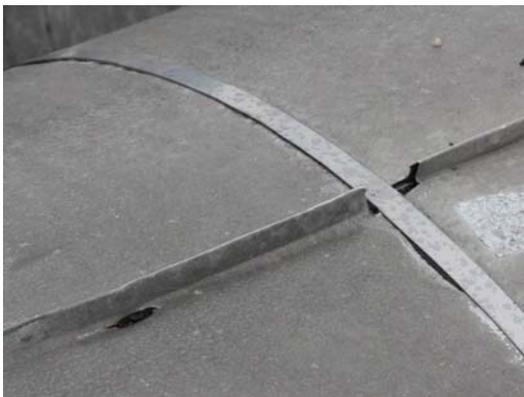
Figure 23: Cut in top seam on weather barrier jacking

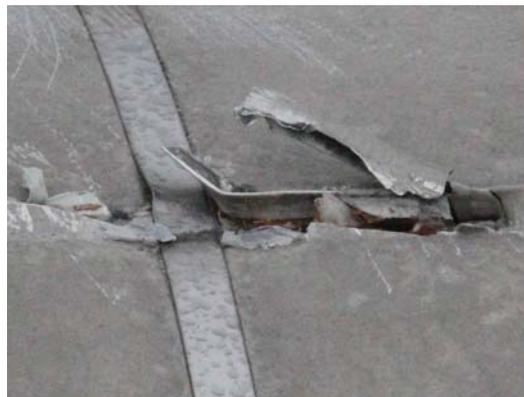
Figure 24: Mechanical damage to top seam on weather barrier jacking

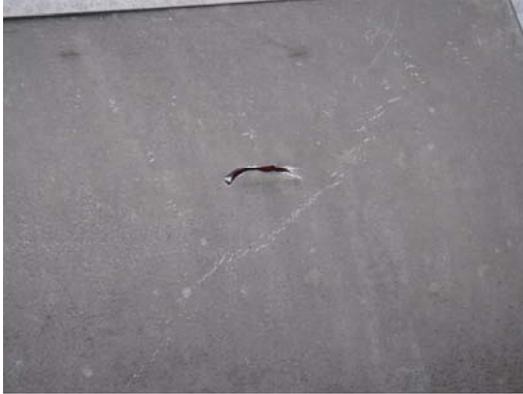
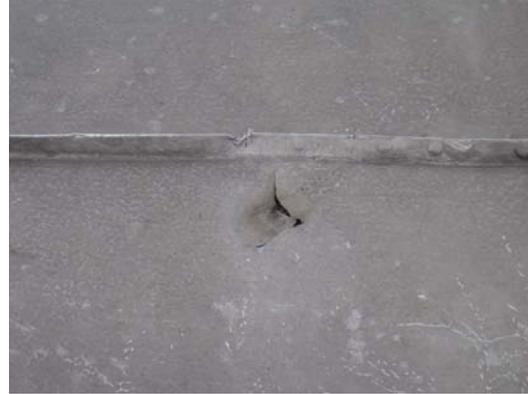
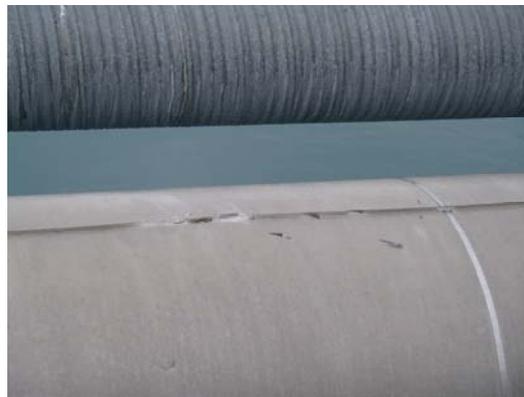
Figure 25: Snow removal damage

Figure 26: Snow removal damage

Figure 27: Snow removal damage

- Repairs to external jacketing on piping systems necessitated by mechanical damage during snow removal in 2012 and other damage from previous years should be implemented as soon as possible.

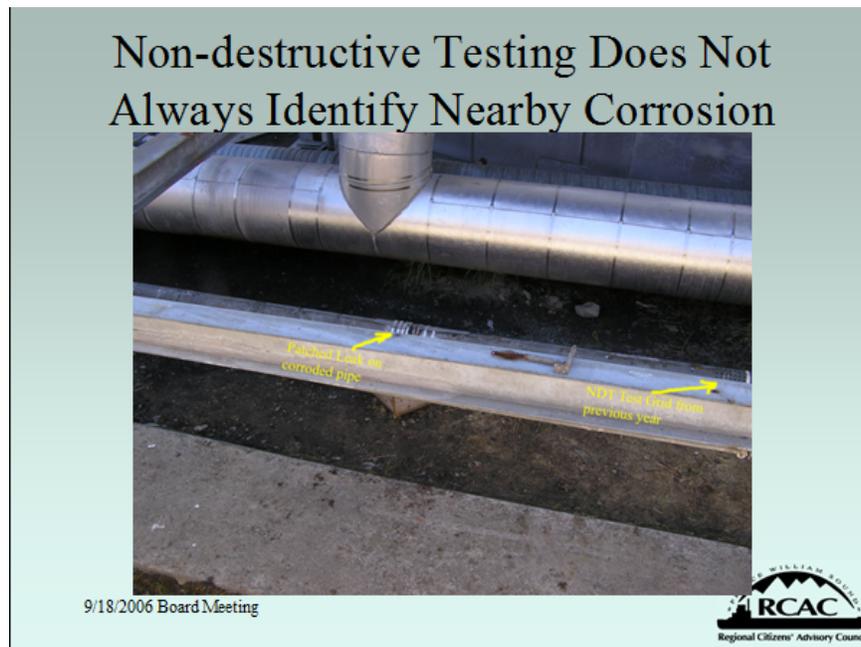
Unfortunately, the most well-planned localized inspection program cannot be expected to identify the precise location where the greatest corrosion damage (most likely pitting corrosion) will occur. Figure 29 shows a pipe at the VMT where corrosion-caused leaks occurred only one year after non-destructive inspection (non-destructive testing) nearby failed to identify where the leak would happen.

Figure 29: Corrosion leaking on a pipe at the VMT Ballast Water Treatment Facility one year after the piping had passed a non-destructive inspection. Figure 29 is from a briefing by T. Kuckertz to the PWSRCAC, 9/18/2006

Recommendation: A possible solution to the problem of inspecting for corrosion (to include CUI) on VMT piping is to alter the existing piping systems so that they can be inspected using "smart" inspection pigs. This would also allow for inspection for internal corrosion. **This modification of the VMT is the most important recommendation in this report** (See Section 4 below for this and other recommendations).

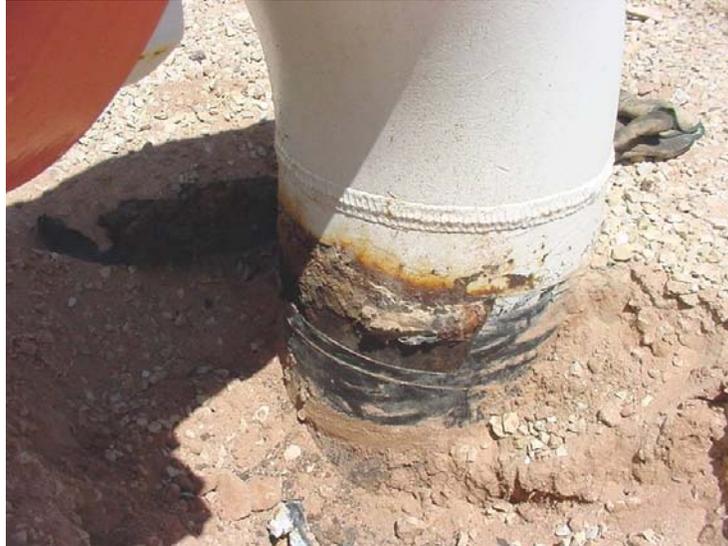
Figure 31 shows the conditions at the air-to-soil interface of a pipeline in another state. Cathodic protection cannot protect the metal at this location due to the poor consolidation of the soil and a combination of environments making this location susceptible to corrosion. This is why APSC, in accordance with Federal [49 CFR 195.583 (b)] and industry guidelines, has devoted time and effort inspecting for corrosion at these locations.^{1, 4, 6}

*Figure 31: Corroded pipeline at the air-to-soil interface
(Note that this photo was not taken at the VMT)*

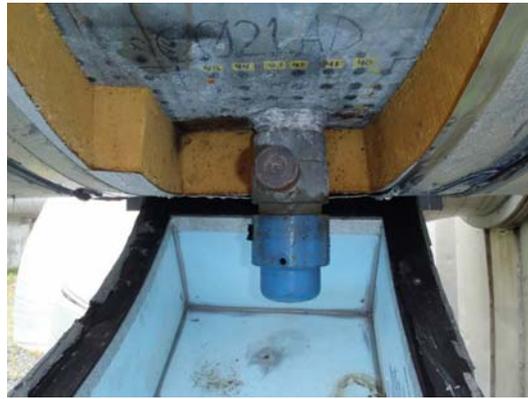
Figure 34: UT inspection grid on carrier at station 54-02A

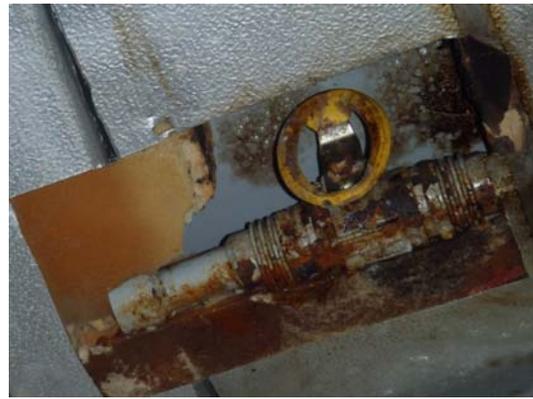
Figure 36: Close-up view of the inhibitor injection device at station 54-01E

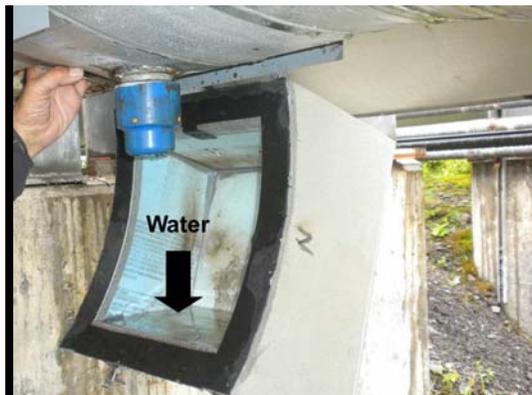
Figure 37: Water in coupon box C011B, which was full of water when opened on both August 7 and August 8, 2012

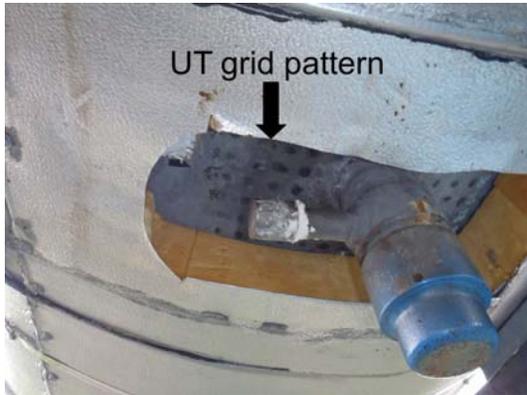
A UT inspection grid pattern shown in Figure 34 is also apparent in Figure 38, indicating that both of these locations have been accessed, not only by the corrosion inhibitor and the corrosion coupon contractors, but also by a non-destructive inspection organization. Employees of any inspection organization should be cognizant of the significance of water under insulation, but, once again, it is not apparent this information was reported to the appropriate APSC and VMT decision makers.

Figure 38: UT grid pattern on carrier pipe at location where water was noted.

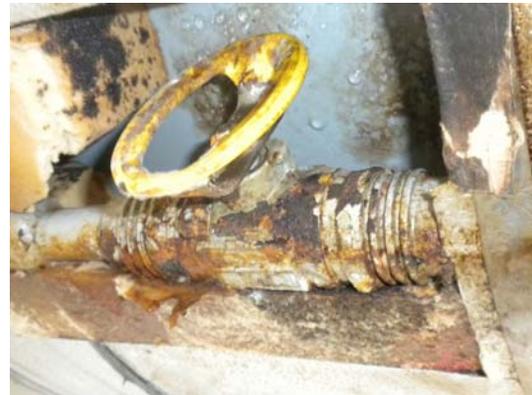
Figure 39: Corroded corrosion inhibitor coupon injection point. The carrier pipe in this picture was wet when touched by DRI and APSC personnel on August 8, 2012.

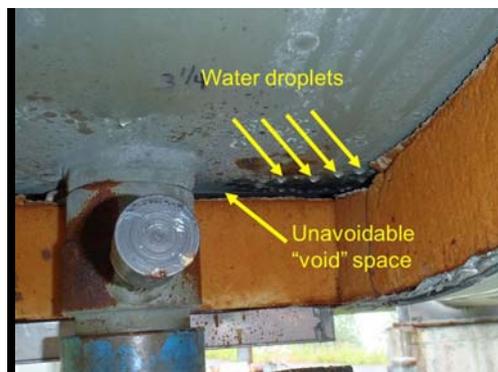
Figure 40 shows water droplets on the carrier pipe and the unavoidable void space between the carrier pipe and the rigid plastic foam insulation. Standing water can accumulate in this void space, and this has happened at this location as shown by the staining on the carrier pipe above the void space.

Figure 40: Water droplets and void spaces above a corrosion inhibitor injection point
