Crude Oil Storage Tank 8 Maintenance Review

PWSRCAC Contract # 5056.20.01

William Mott P.E.

April 2021

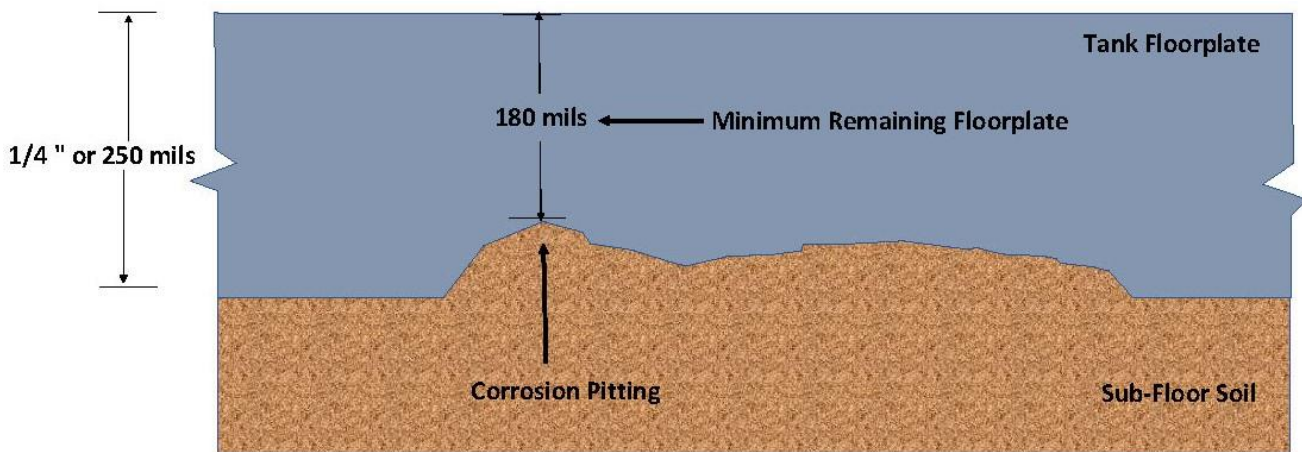
Figure 5 - Minimum Remaining Floorplate After 2019/2020 Repairs

The Tank 8 floorplate is comprised of ¼-inch (250-mil) steel plate. The top surface is coated, and no topside corrosion was reported during the 2019/2020 internal inspection. After the 2020 repairs, the minimum remaining floorplate should be no less than 180-mils thick. Figure 5 shows how a cross section of the thinnest remaining (unrepaired) floor in Tank 8 might appear.

The code requires that the floor still have a minimum of 100-mils of thickness remaining at the end of the planned service interval. That left APSC's engineers an 80-mil corrosion allowance to bridge the 4-year period between the inspection (2019) and removal from service again (2023). APSC used a corrosion rate of 20-mils per year as justification to bridge the 4-year service interval.

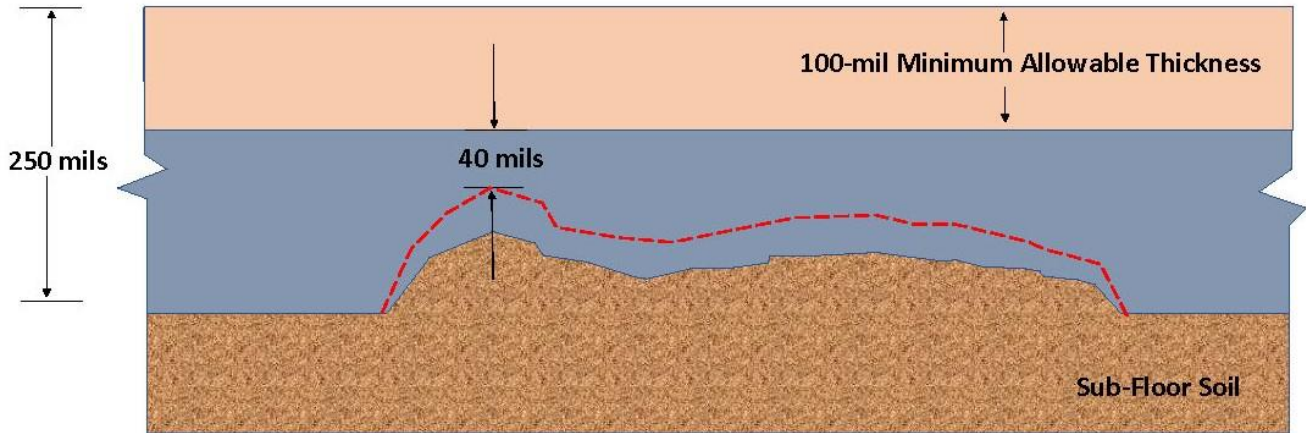
Figure 6 - Predicted Minimum Remaining Floorplate in 2023

The actual corrosion rate experienced on the tank floor is closer to 11 mils-per year. The red dotted line in Figure 6 depicts the probable deepest pitting in the floorplate that will exist in 2023 (approximately 140-mils remaining wall thickness). The beige area represents the 100-mil minimum allowable floorplate thickness after the service interval.

APSC’s approach to the 2020 return-to-service is relatively conservative. The assumed corrosion rate of the service interval calculations is significantly higher than the measured rate. There is very little risk of a corrosion failure from Tank 8 before the tank is removed from service again in 2023.

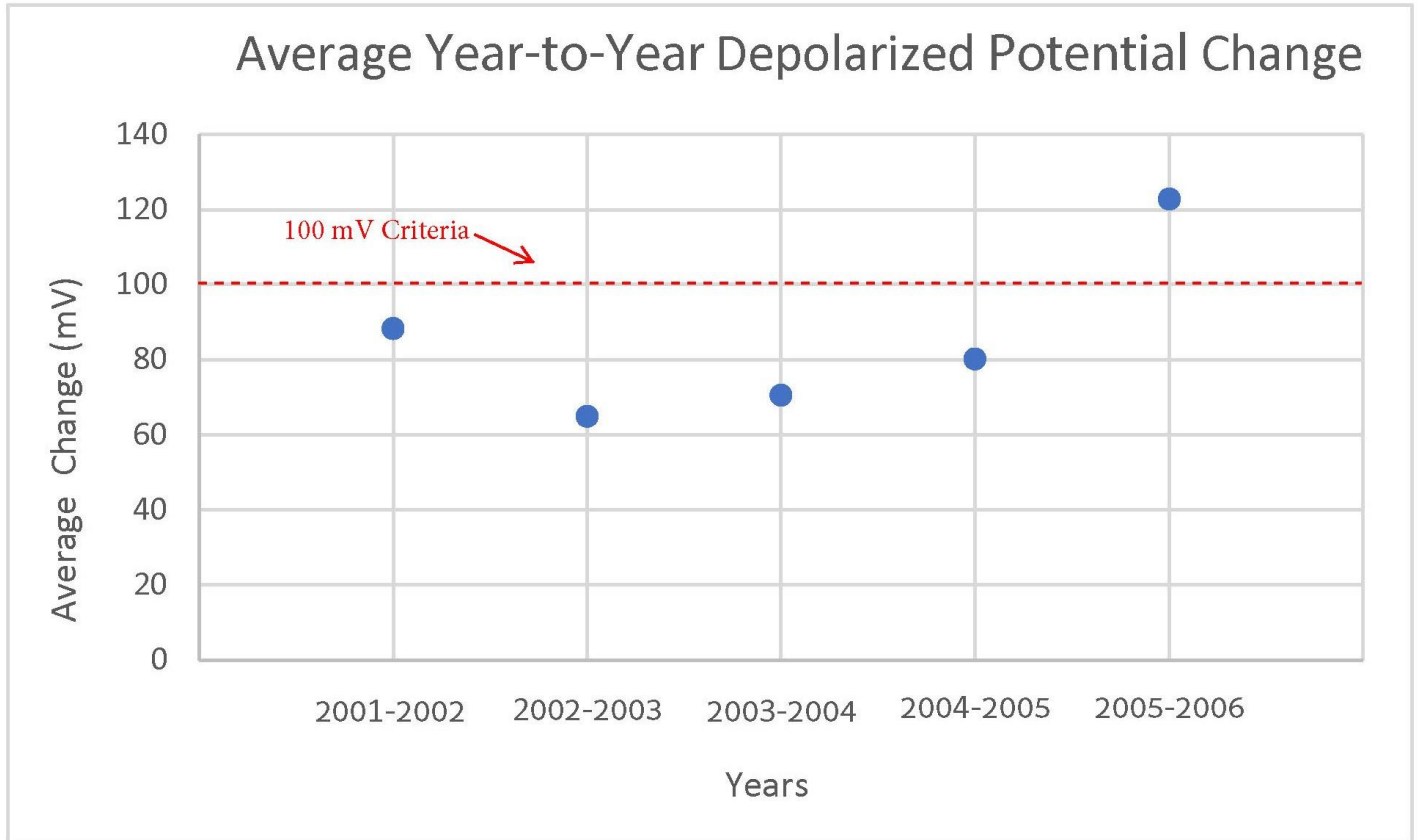
Figure 17 – 2001-2006 Average Change in Tank 8 Depolarized Potential Readings

Figure 17 presents a graph of the 2001-2006 year-to-year average change in depolarized potentials for Tank 8. A line showing the 100 mV criteria was added to the graph for reference. This clearly illustrates that the annual changes in the depolarized potentials on the tank are similar in magnitude to the criteria that is being measured against. In fact, between 2005 and 2006, the average change in depolarization potentials was greater than the 100 mV criteria that is being measured against.

The depolarized potential is used (with the instant off potential) to ascertain if the structure has 100 mV of polarization. These year-to-year changes in the depolarized readings on Tank 8, clearly illustrate why the standard requires that the operator measure the formation or decay or polarization each year. This data provides clear, empirical evidence that the practice of using depolarized data from past years will result in errors and invalid CP data. This supports the NACE SP0169 requirement that the formation or decay of polarization be measured in order to utilize the 100 mV criteria. The depolarized readings should be collected in the same relative timeframe (within weeks) of the collection of instant off or IR-free data.

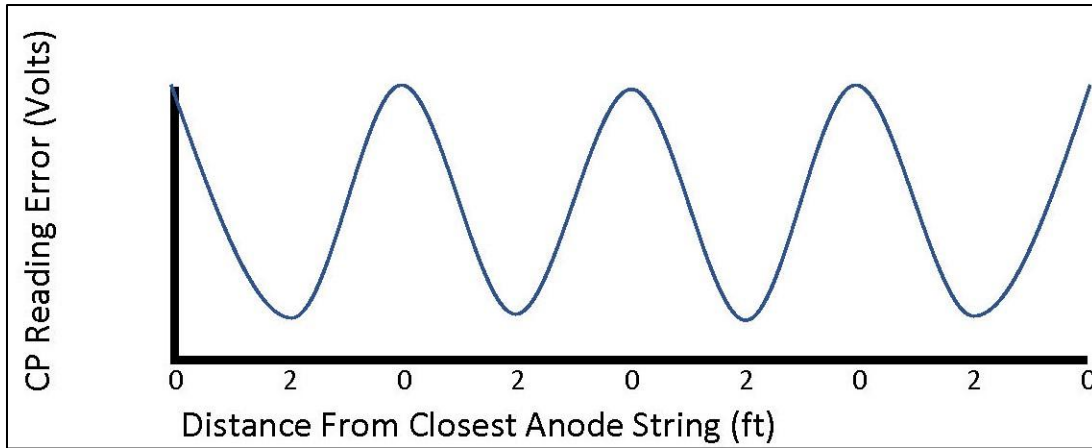
Figure 19 – CP Reading Error/Distance from Anode

If the CP reading errors were caused by proximity to the anodes, then the magnitude of that error would gradually decrease as the distance from the anode increases. This decrease would continue until the reading was taken at the midpoint between two anode wires (as depicted in Figure 19), at which point the error would begin to increase again. If APSC's statement regarding proximity to the anode is accurate, this means that all CP readings collected beneath the tank are likely to be impacted by the same causal error, although the magnitude of that error may vary relative to the distance from the anode.

In our professional opinion, the reasoning for the error that is cited may not be entirely correct. If all impacting CP systems are properly interrupted, then the field around the anode should collapse and the potential readings should not be impacted by the relative proximity to the anode.

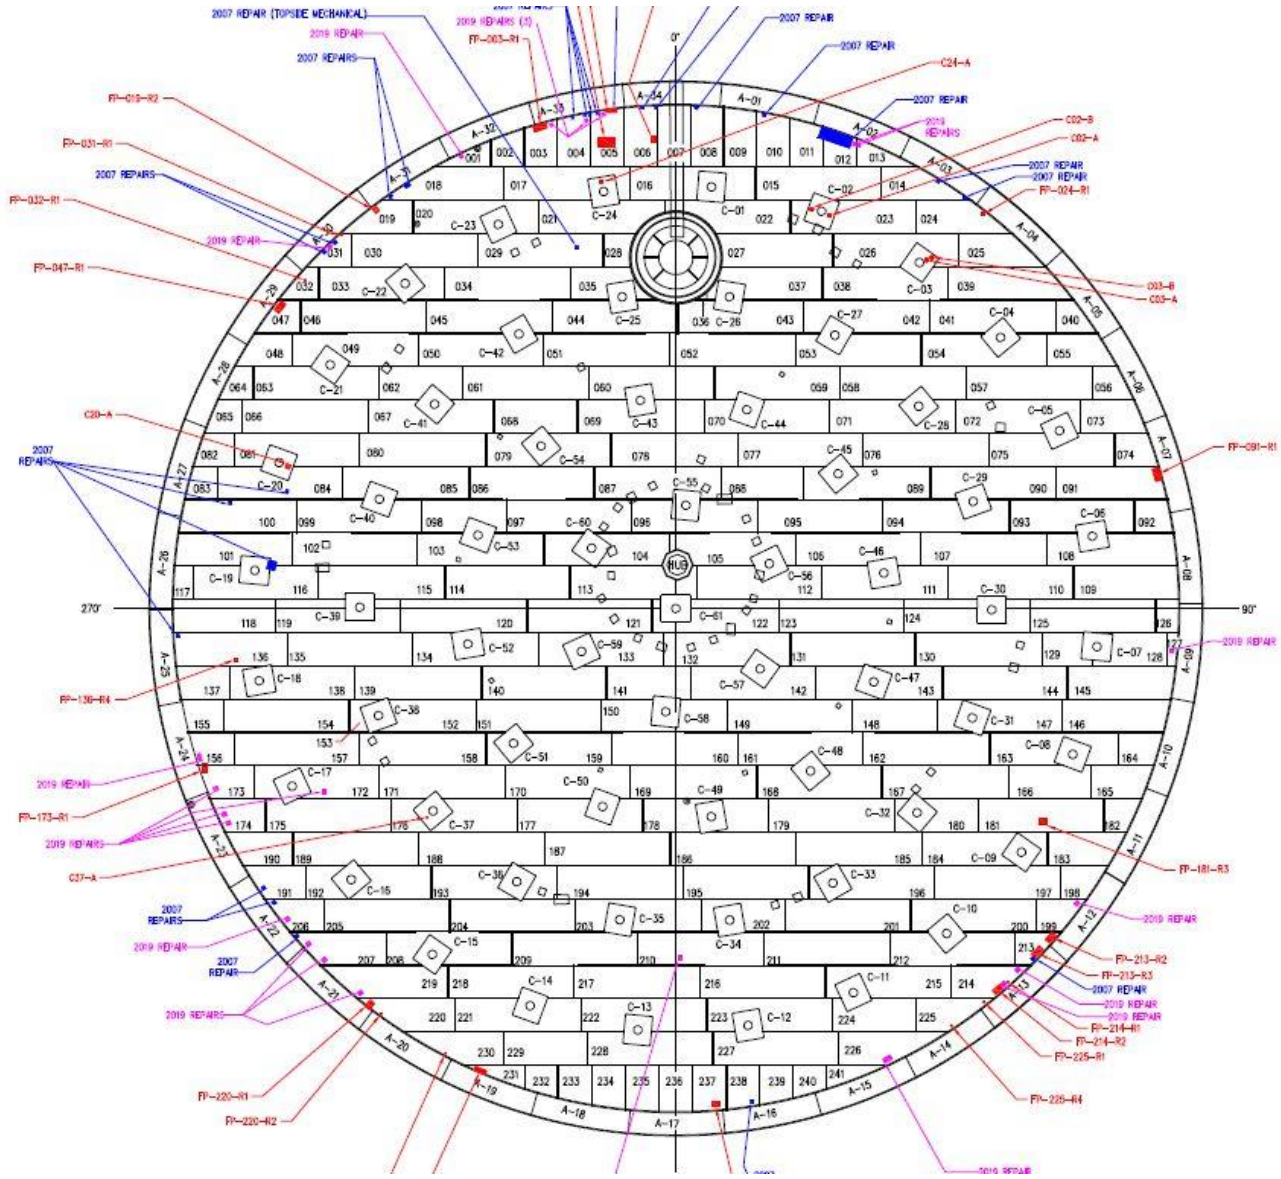
Figure 21- Tank 8 Repair Patch Locations

This may be in part why the majority of the floorplate repairs completed in 2007 and 2019 were located on the perimeter plates of Tank 8 (Figure 21).
