## Prince William Sound Regional Citizens Advisory Council

### Valdez Marine Terminal Storage Storage Tank Mechanical Integrity Investigation (Contract No. 505.2007.02)

The Hendrix Group, Inc. Report No. H27053

September 14, 2007

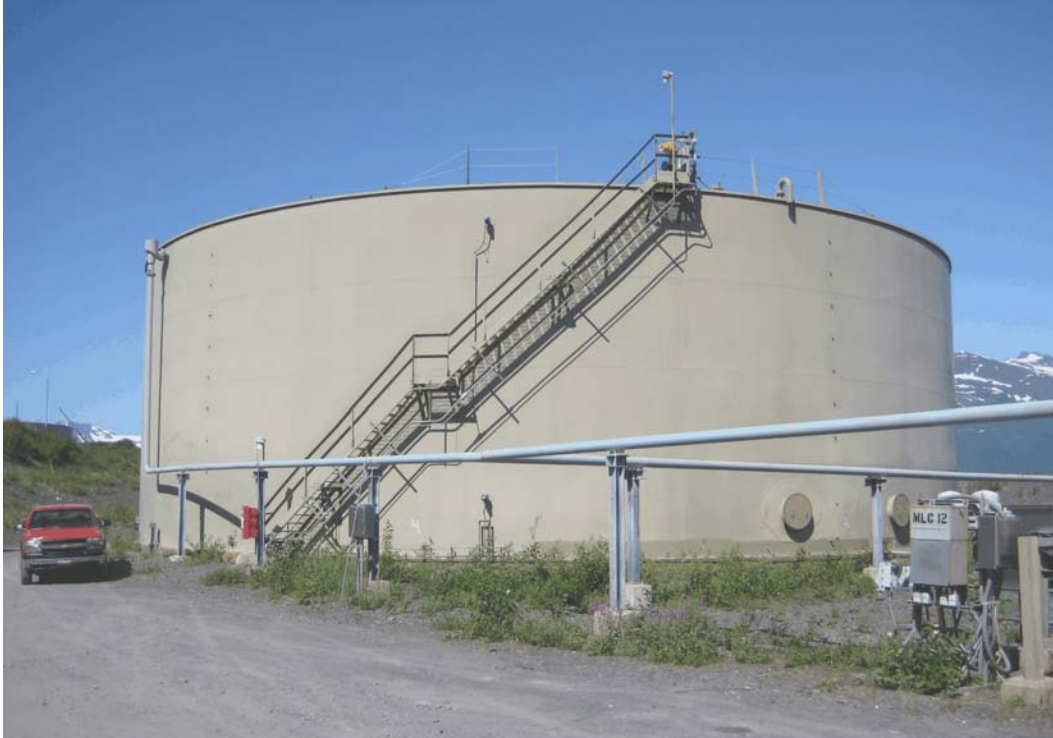
**figure 1** - Tank 58-TK-55 at the APSC facility in Valdez, AK

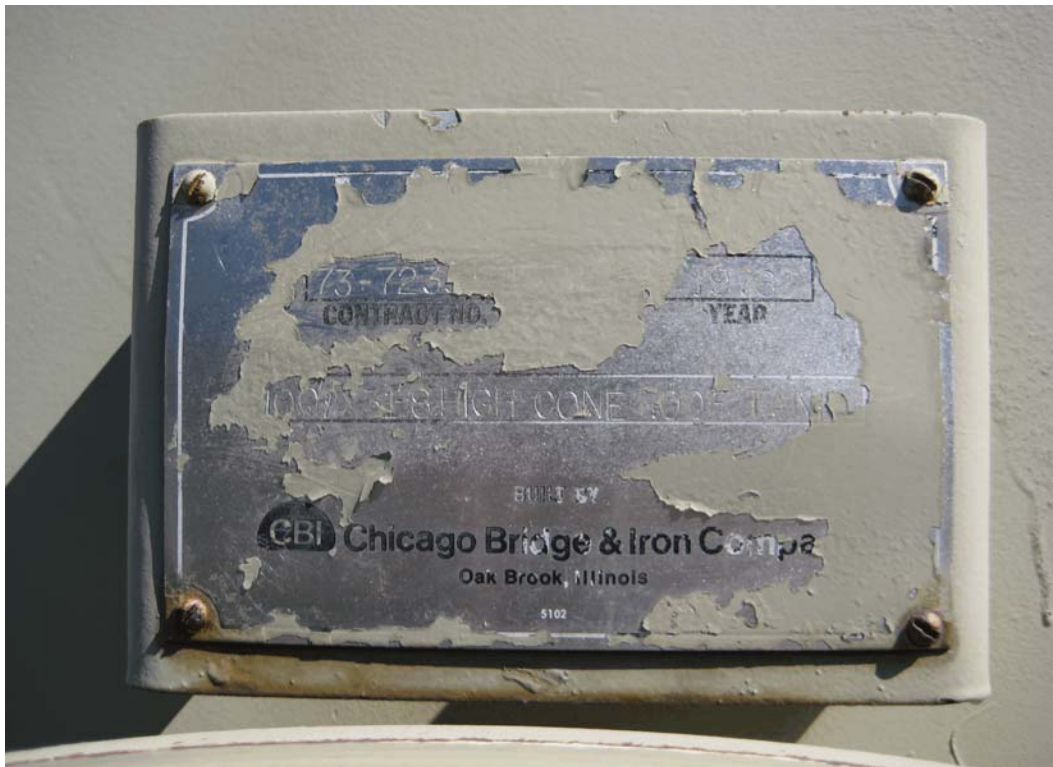
**figure 2** - 58-TK-55 tank nameplate. The contract number (73-7235) and build year (1976) are legible.

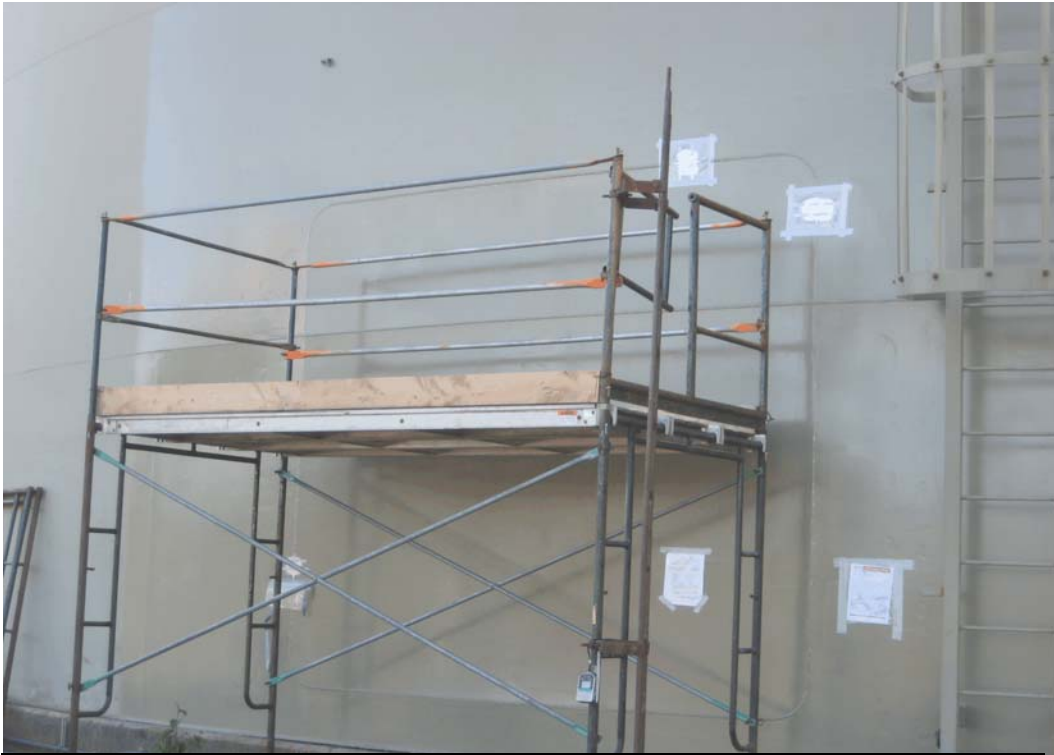
**figure 3** - The taped areas represent where hardness measurements were taken on the door sheet.

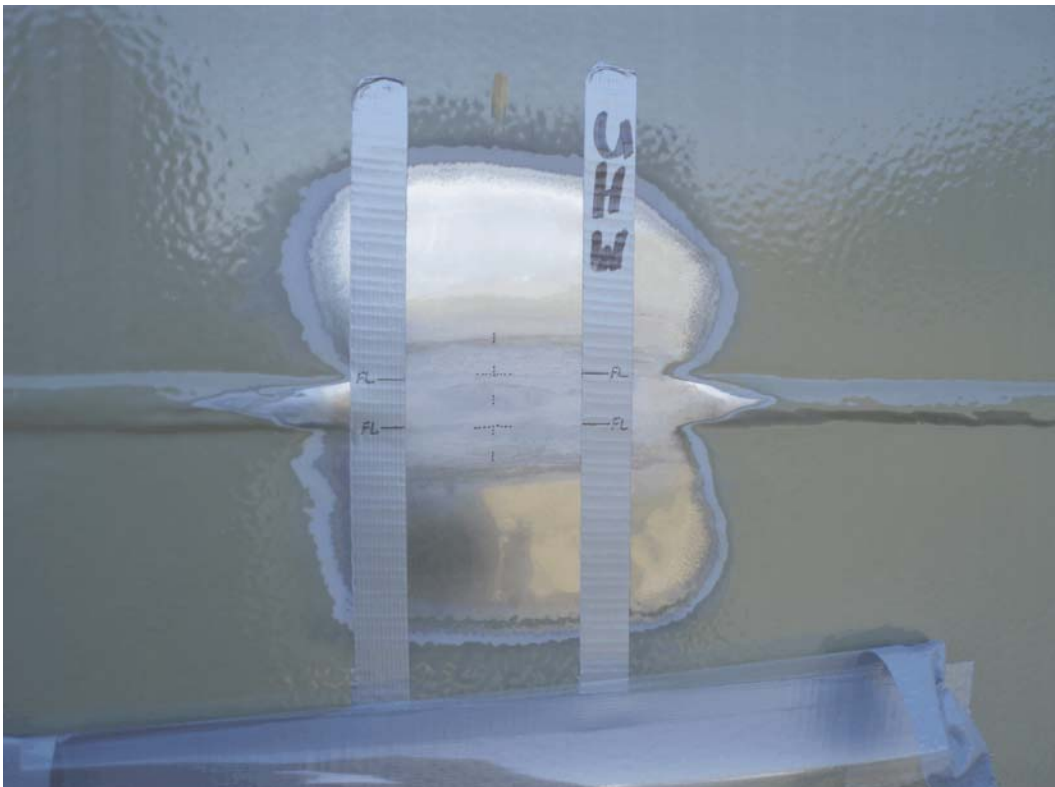
**figure 4** - An example of a door sheet weld prepared for hardness testing.

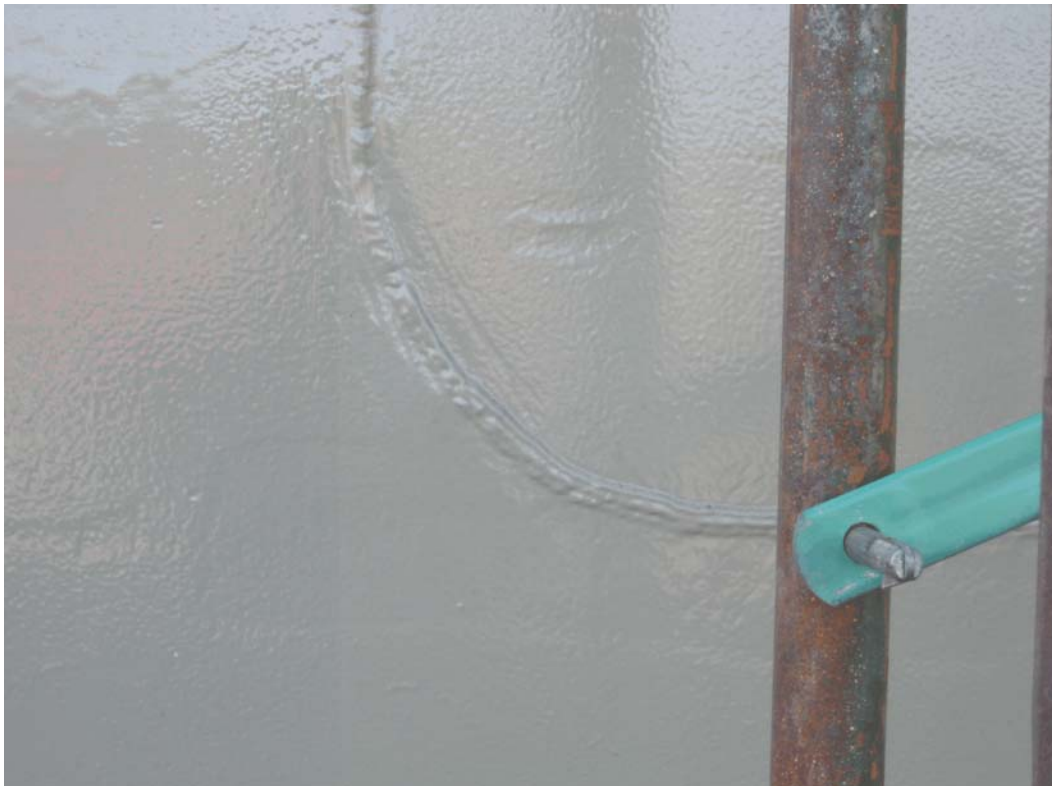
**figure 6** - Close-up of a doorsheet corner weld.

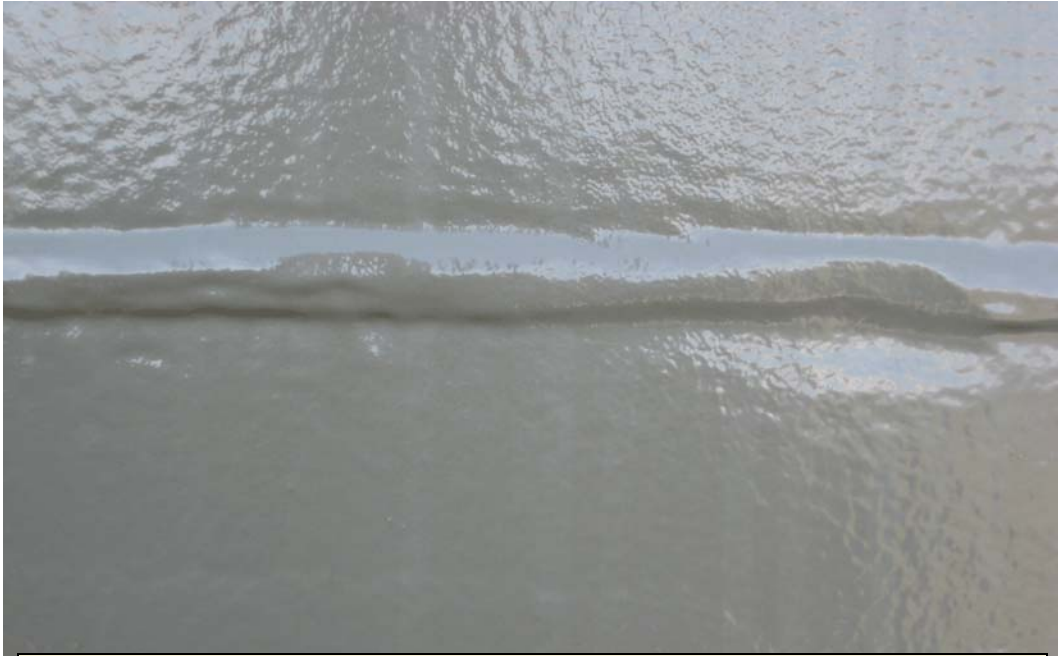
**figure 7** - Close-up of a doorsheet horizontal weld.

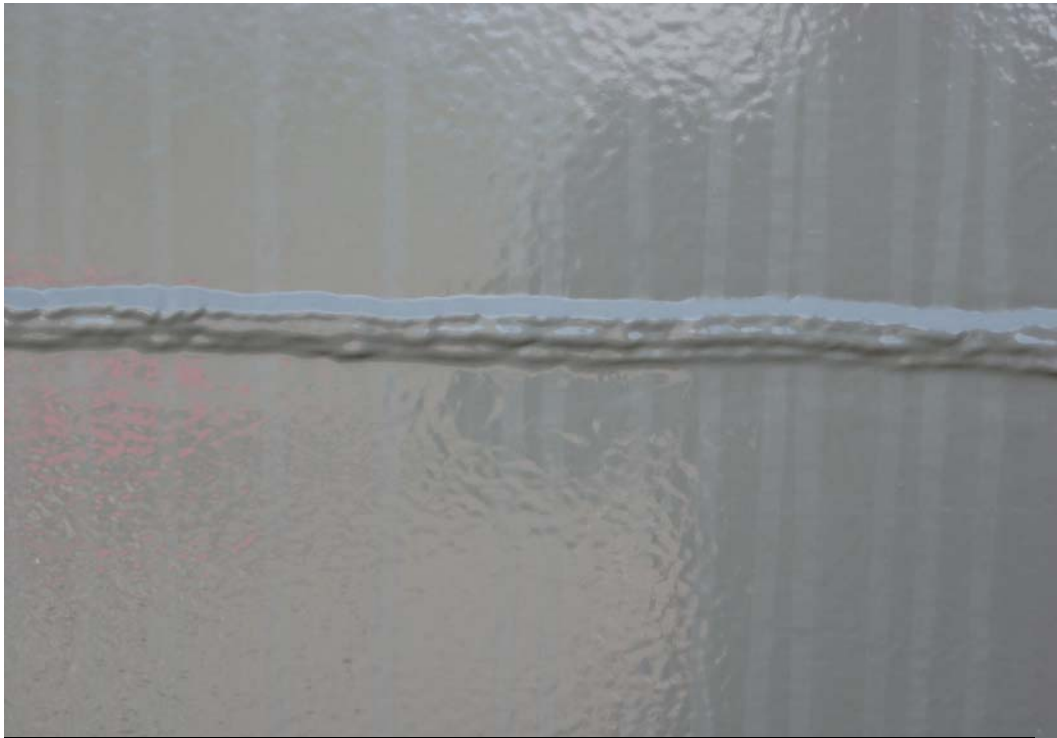
**figure 8** - Close-up of a doorsheet weld, possibly representing a repair weld.
