**Regional Citizens' Advisory Council** / "Citizens promoting environmentally safe operation of the Alyeska terminal and associated tankers."

- (b) "Valdez Marine Terminal Tank 55 Alleged Integrity Concerns Preliminary Investigation" Revision 2 dated March 15, 2007.
- (c) "Valdez Marine Terminal Tank 5 Alleged Integrity Concerns Preliminary Investigation" Revision 3 dated March 13, 2007.

## **Harvey Consulting LLC, Summary of Findings of Facts, Allegations, and Recommendations**

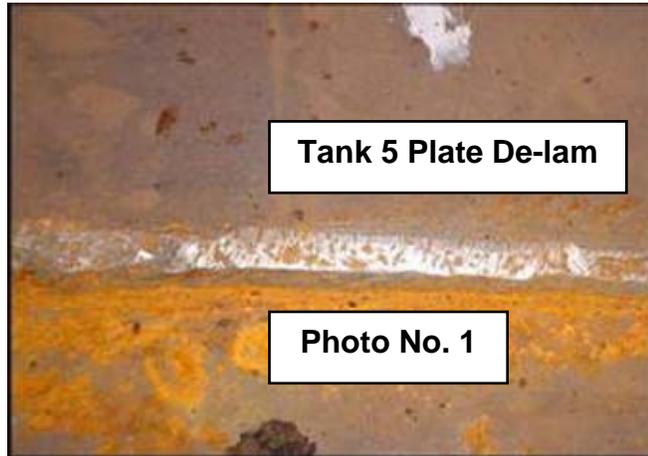
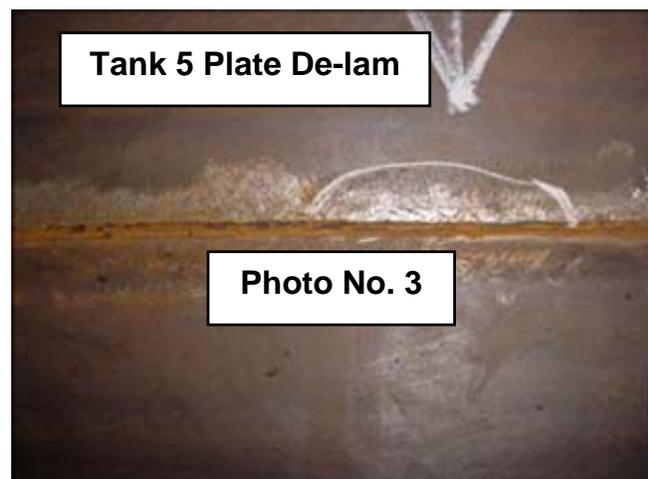
**Interview with JPO:** Mr. Harrison (JPO) explained that JPO and ADEC received a complaint about laminations in the metal used to repair the tank floors. The complaint alleged the laminations were shaved out of the metal surface and nondestructive testing was not completed to ensure adequate metal thickness before using the material to repair/replace the tank floors. Mr. Harrison said laminations were found in the metal that was used to repair the Tank 5 and 93's floors. He explained that when the metal is rolled out at the factory, sometimes marks and irregularities are left in the top of the sheet. He said the metal used to repair the tank floors must be a certain thickness. When a lamination is removed by grinding and sanding, after the floor is laid down, this reduces the thickness of the floor and there is no way of ensuring the final remaining thickness is adequate without completing UT. By the time Mr. Harrison went into Tank 5, the laminations were ground out. Mr. Harrison said ADEC had their engineer, Saengsudham, review the allegation. Mr. Saengsudham concluded nondestructive testing was not required for the tank floor laminations. Mr. Harrison was concerned about this conclusion because significant lamination repair can result in a thinner metal.

Photos shown were brought to ADEC by a concerned employee. The employee took the photos, labeled them and provided them to ADEC to document the laminations. Labels were not altered for this report; except to enlarge them slightly for better readability. The photos are shown as part of the historical record. This report does not affirm that these photos actually depict plate delamination.

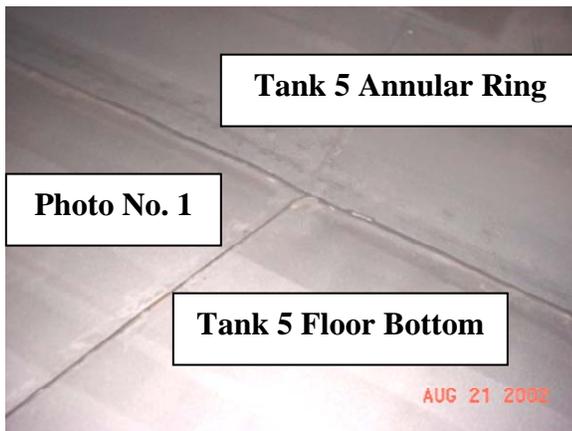
*TK-5, 3 Plate overlap 12" rule –bottom to annular- refer to API-650 Section 3.1.5.4.*

Another KAM Inspector also concluded that APSC's interpretation of the 3-plate rule was incorrect. An August 24, 2006 API 653 tank inspection report prepared by API 653 inspector, Mr. Lane, concluded that welds made in the floor plates do not conform to the API 650, Section 3.1.5.4, 3 plate rule.

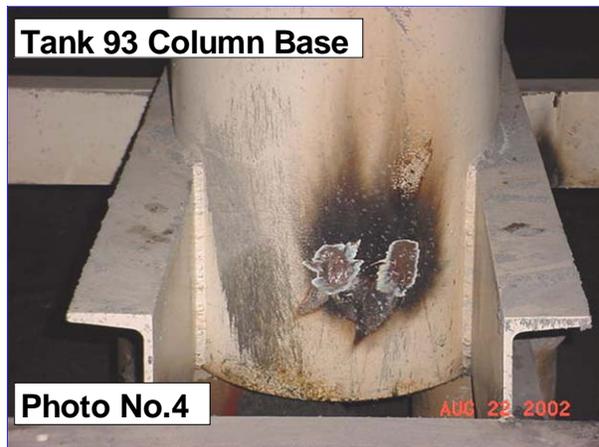
**Concern:** “Temporary clips were welded to the columns (for tank jacking). No NDE was done on the columns once they were removed.”

**ADEC Finding:** “API 653, Subsection 10.1.4.1 has provision for temporary attachments. But it only applies for attachments to the shell course. The source referred to Section 9.10.2.3 of API

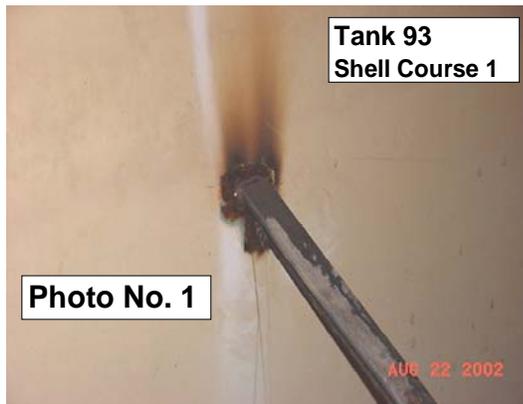
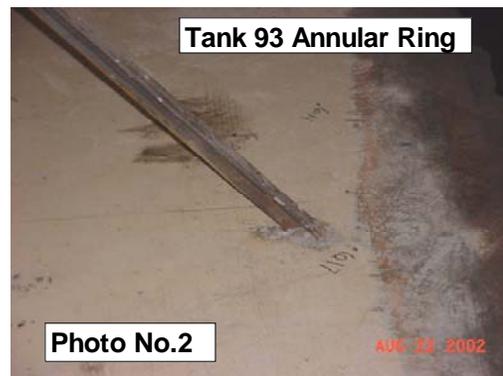
## Allegation No. 2 – Annular Plate Bracing

**Concern:** “Knee braces and plates at the annular plate.”

**Analysis:** A November 19, 2002, letter from APSC to JPO lists this concern as Unsatisfactory Inspection Finding No. 7 (UNSAT #7).<sup>13</sup> UNSAT#7 was logged on July 12, 2002, by KAM Inspector Mr. Kale, he wrote:

**Findings:** The requirements of APSC Project Specification T-411 would have to be reviewed to verify the welding requirement established for this tank. API 650 does not specifically address the use of base plates under angle iron; however, this may be common “good welding” practice. It is recommended that the welding expert review these photos and provide PWSRCAC with advice on this concern.

**Refer to  
weld expert**
