# FINAL REPORT Crude Oil Storage Tank Vent Snow Damage

PWSRCAC Contract # 5056.20.01

William Mott P.E.

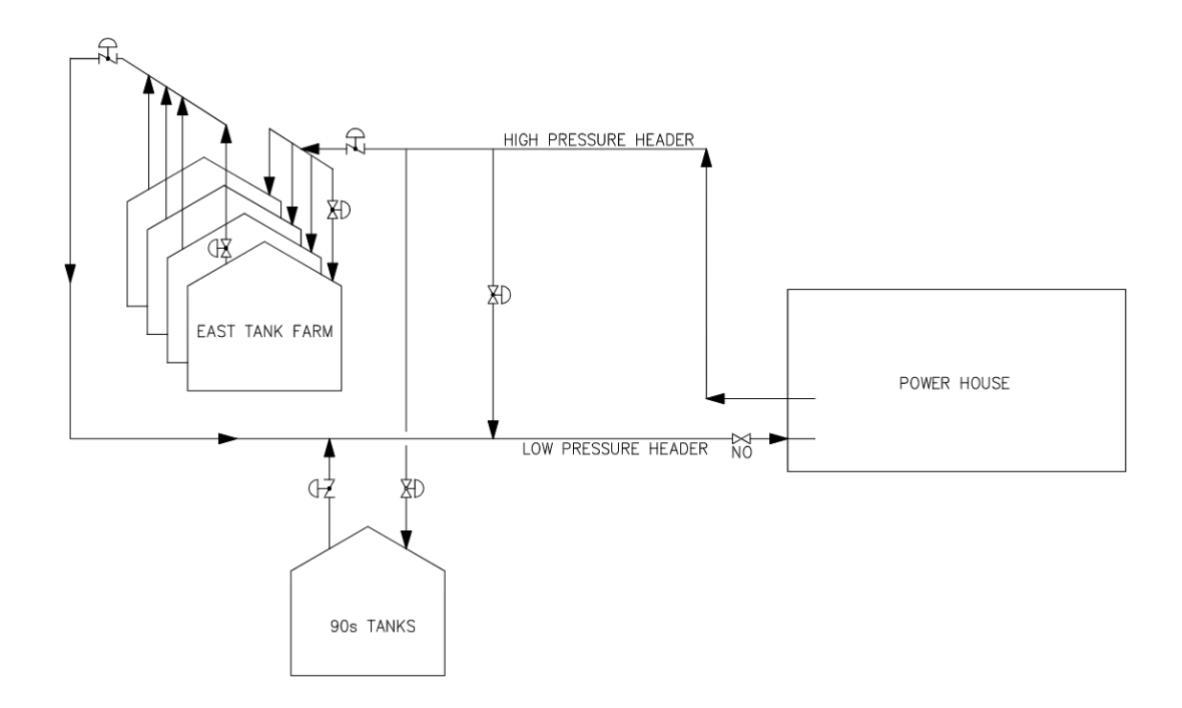
Figure 1 – Tank Vapor Recovery System Simplified Process Flow Diagram

The low-pressure vapor header piping moves vapors from the 14 crude storage tanks and the two Ballast Water Treatment "90's Tanks" to the Power Vapor Facility. The  $O_2$  content of that header is continually monitored downstream of all the storage tanks (Figure 1). The high-pressure header carries inert gases from the Power Plant to the crude and ballast water tanks. During the 3/31/2022 meeting, the group was informed that the continuous  $O_2$  sensors in the vapor system alarm at 6.0%, alarm with actions to eliminate ignition sources at 8.0%, and the system is shut down if  $O_2$  levels are measured at 10%.

The existing vapor system for the VMT includes only a single fixed  $O_2$  monitoring point for the entire East Tank Farm (ETF). That point provides the average bulk  $O_2$  concentration for all the vapor from the ETF tanks. A significant  $O_2$  excursion in a single tank would be non-detectable with the existing fixed monitoring equipment.

APSC should consider the installation of fixed FLIR vapor detectors around the tank farm to allow them to remotely and rapidly identify tank vapor releases without putting personnel at risk. Additionally, APSC should consider the installation of additional O<sub>2</sub> monitoring points so that headspace gas concentration excursions can be readily identified.

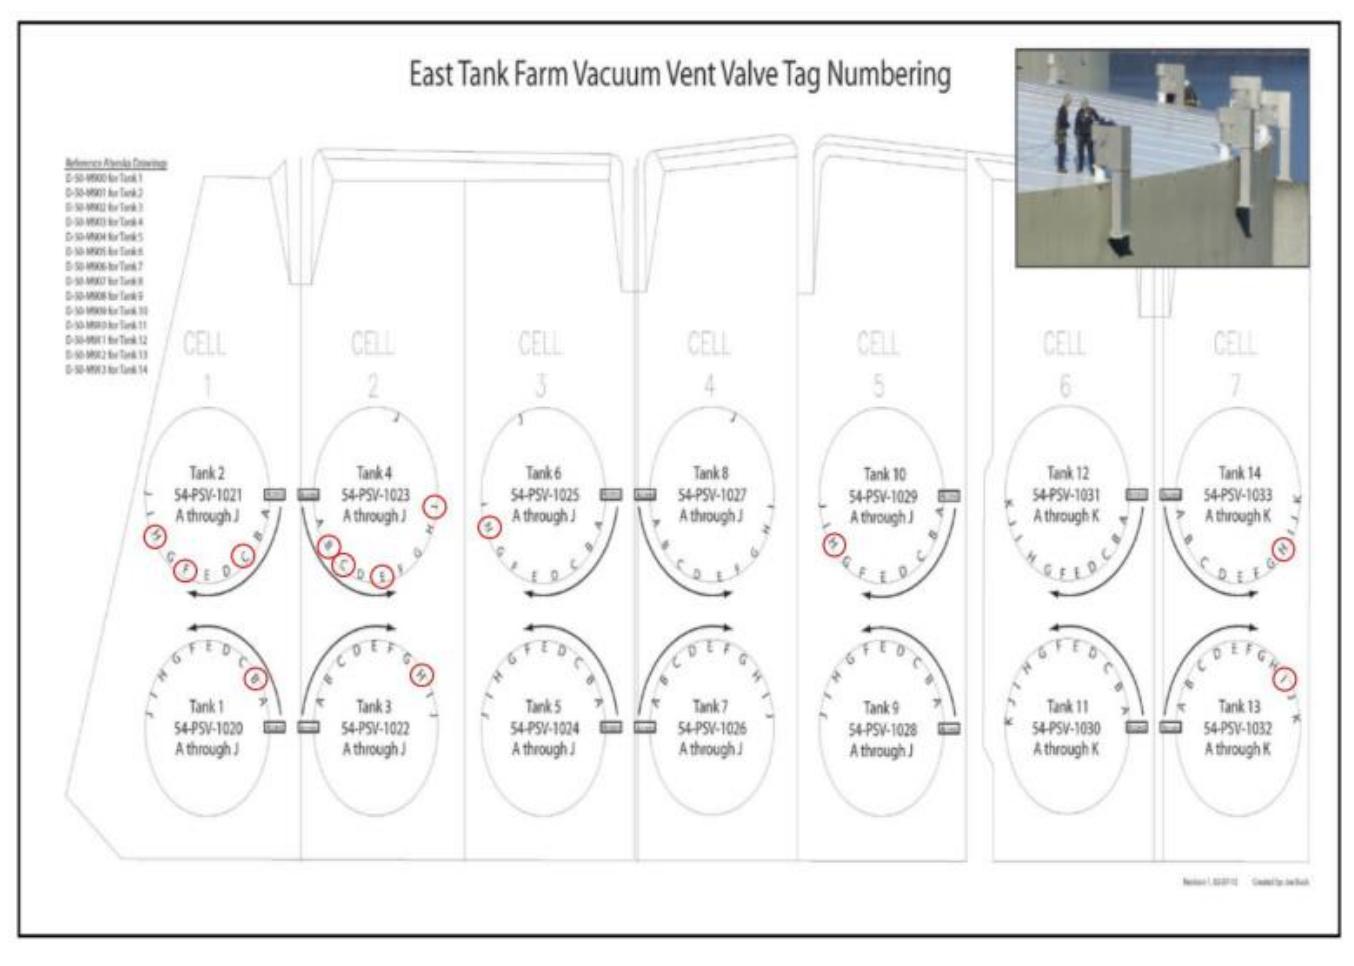
Figure 2 – Significantly Damaged Vents (not comprehensive - does not include lesser damage).

At the time of the 5.59%  $O_2$  excursion in the low-pressure header (12:13 pm on 3/17/2022), seven of the 14 ETF tanks were operating under a vacuum. Based on Alyeska's comment that tanks were shifted to a slight vacuum when vent damage was discovered, seven of the 14 tanks can be assumed to have had known damaged PV pallets on March 17<sup>th</sup>, 2022.

Elevated levels of  $O_2$  in the low-pressure header were caused by air entering tanks with damaged PV pallets. Alyeska reported that tanks with noted damage to the vents were operated at a slight vacuum (versus a slight pressure) to reduce vapor emissions. However, operating the tanks at a slight vacuum increases the ingress of  $O_2$  into the tank headspace. This becomes a cause for concern if the ingress of  $O_2$  increases the concentration of  $O_2$  above the lower-explosive-limit (LEL), which is the lowest concentration of gas capable of resulting in a fire when exposed to an ignition source.

Eight of the tanks had "significantly" damaged vents (circled in red in Figure 2). A significantly damaged vent allows much higher ingress of  $O_2$  than a bent or cracked nozzle. Tanks 2 and 4 had three and four significantly damaged vents, respectively. This suggests that a significant fraction or the errant  $O_2$  in the low-pressure-header entered the closed system through the damaged vents on Tanks 2 and 4. A simple mass balance executed on the  $O_2$  in the vapor recovery system at the time of peak  $O_2$  concentrations in the low-pressure header, indicates that the estimated concentration of  $O_2$  in the headspaces of Tanks 2 and 4 was above the lowerexplosive-limit (LEL)<sup>1</sup>, meaning that the presence of an ignition source could have resulted in a tank fire or explosion at the VMT.

APSC should develop a model of the tank vapor system that calculates the O<sub>2</sub> concentrations in each tank headspace based on the O<sub>2</sub> concentrations measured elsewhere in the system, vapor valve settings, tank pressure (or vacuum) and the areas of known nozzle or vent damage. This would allow them to better define the headspace gas quality and more accurately define the risk associated with tank-related work.

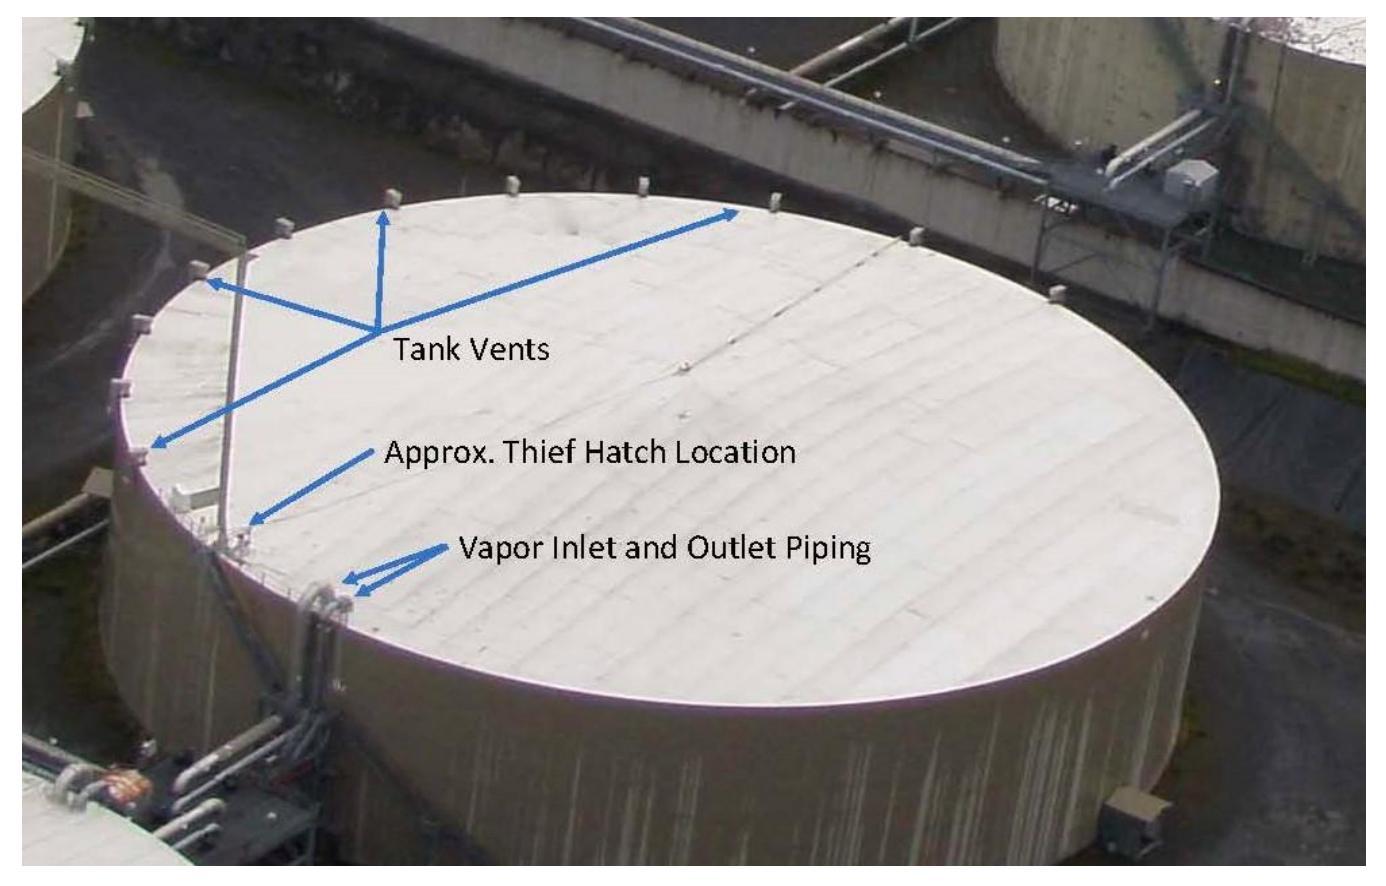
Figure 4 – Tank Roof Appurtenance Locations

During the March 2022 meeting between PWSRCAC and Alyeska, Alyeska noted that they had defined the  $O_2$  concentrations of the tank headspaces through measurements at the tank thief hatches. There are a couple of issues with that practice. First, as shown in Figure 4, the tank vapor inlet and outlet are adjacent to each other. This has historically caused poor headspace mixing and a non-homogeneous mix of gases in the headspace. Alyeska installed flow diverters in some of the tanks which may offer limited mixing, but the headspace is still non-homogeneous, and no single point should be considered as representative of the entire headspace.

Secondly, as shown in Figure 4, the thief hatch is located very close to the inlet and outlet nozzles and a considerable distance from most of the tank vents. Gas testing at the thief hatch will not have the same makeup as gases nearer to a significantly damaged vent.

Alyeska should develop procedures and equipment to better measure and define the headspace gas quality before putting workers on top of the tanks. Workers have the right to know the risks and conditions to which they are being exposed. In this case, workers may not have been provided accurate information upon which to base their decisions. For instance, it is not apparent that Alyeska understood that the headspaces within some of their tanks were likely above the LEL. Had that been fully understood, those conditions should have been better defined and communicated to the tank-top workers and the use of potential spark producing equipment should have been curtailed to prevent a fire or explosion at the VMT.
