PVV Repair Plan Status

9/22/22

Alyeska pipeline

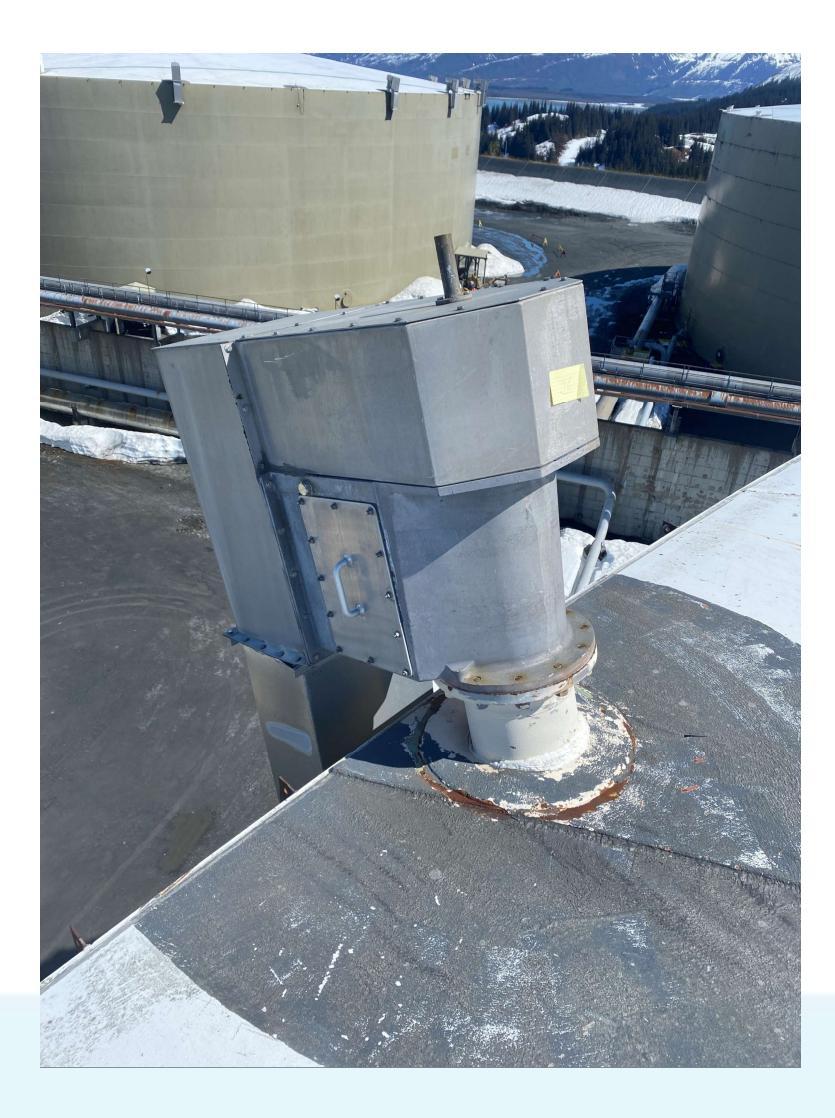
Bent nozzle/vent

This nozzle / PVV is tilted roughly 8 deg. A tilt in excess of 3 deg requires repair.

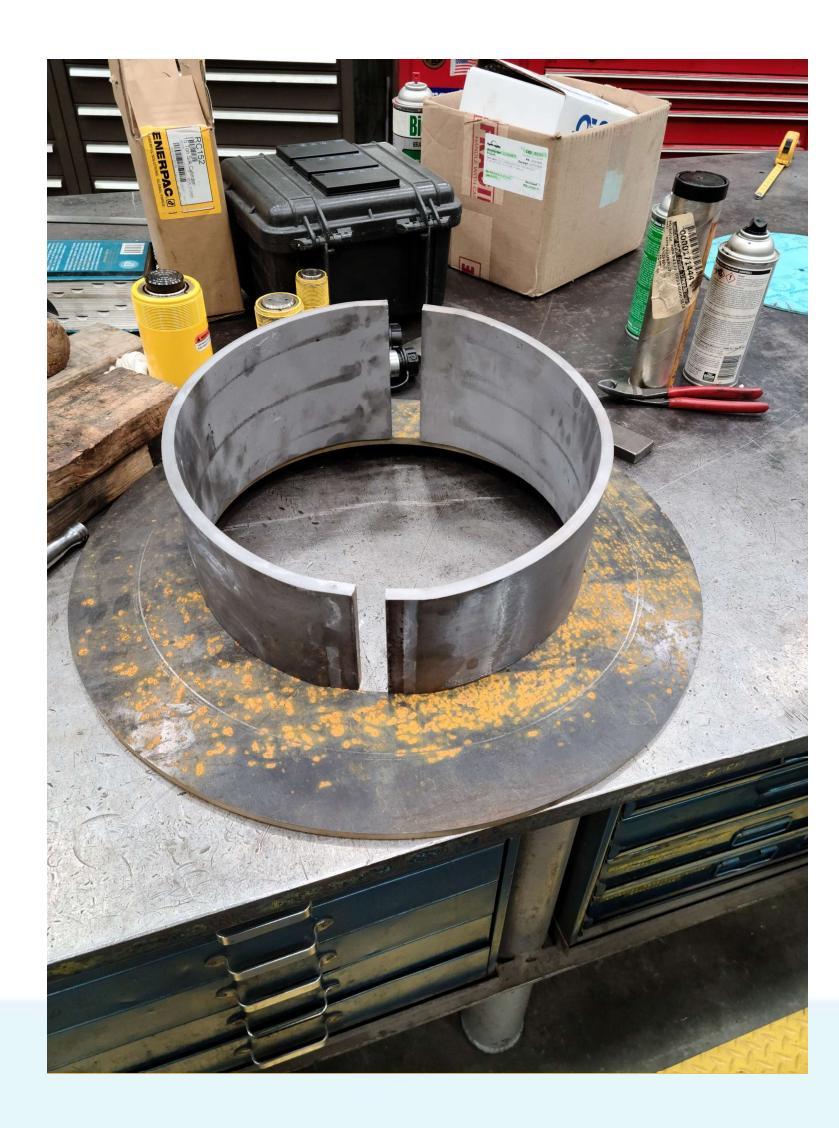
Collar components after forming

- Started with original design when considering repair solutions
- Proposed bracket/collar design reviewed and input provided
- Input incorporated into final design
- Final design of collar provides a 3x strength increase relative to original design

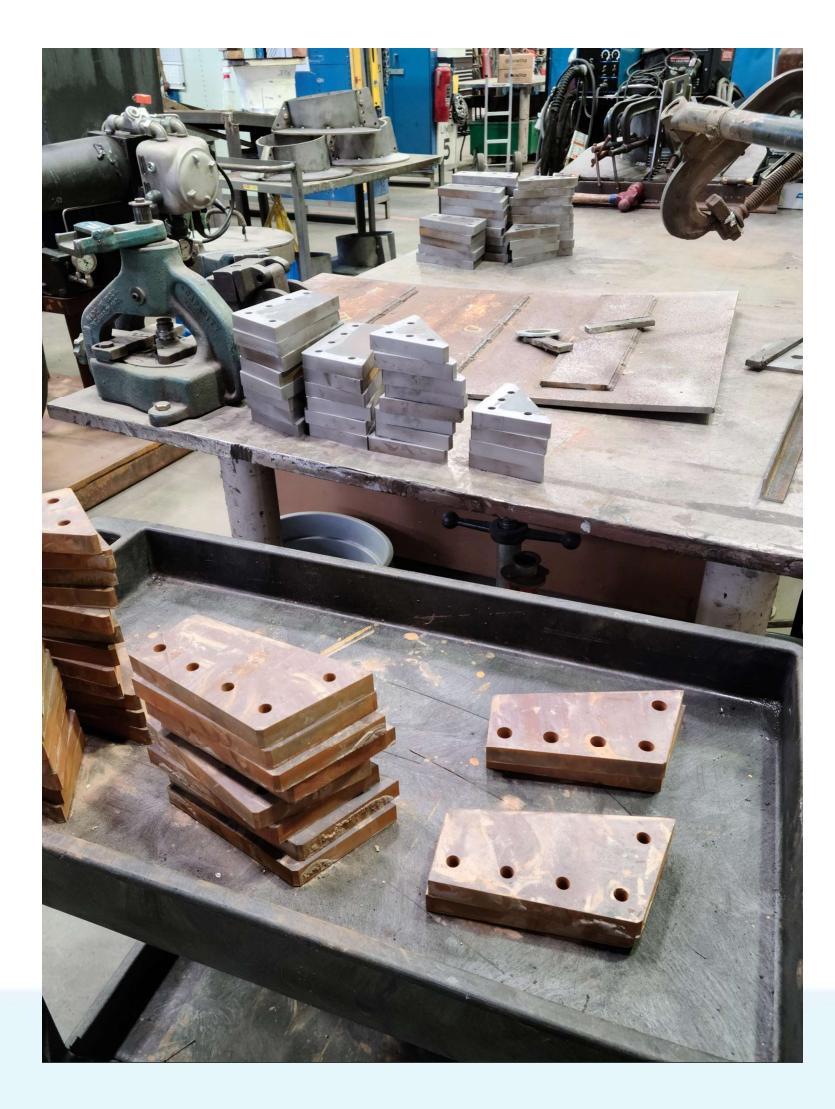
Collar flange brackets for securing to nozzles.

Holes are punched on the water jet, then tapped for a threaded fastener.

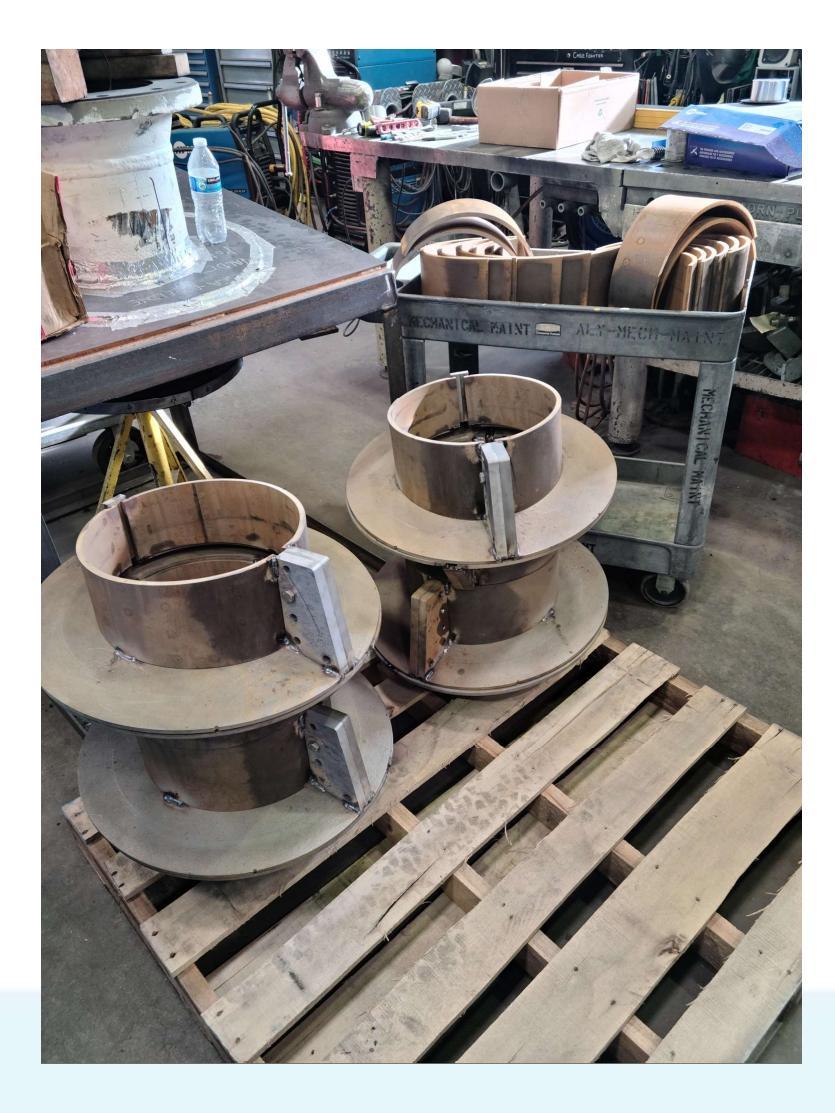
Final weld and coating completed by HCC after pieces tacked together.

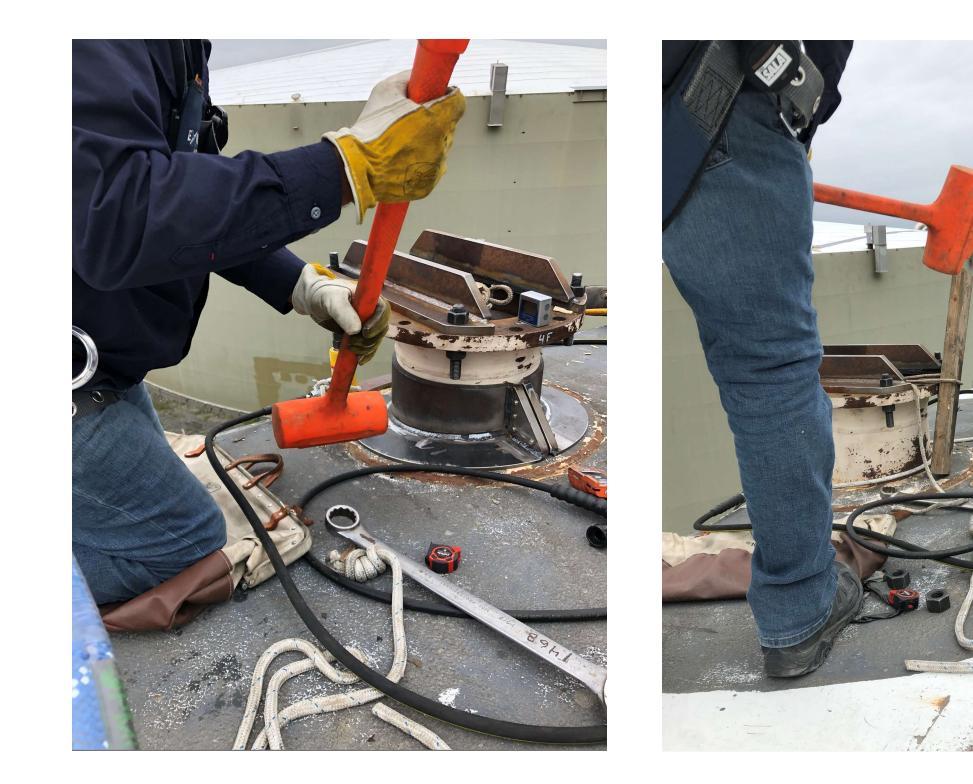
Successful Straightening Test - Nozzle 4F

- Nozzle straighten test was within manufacturers' acceptable tolerances of the current PVVs (3 deg)
- No observed flange face damage
- No observed additional weld damage
- No detected vapor leaks

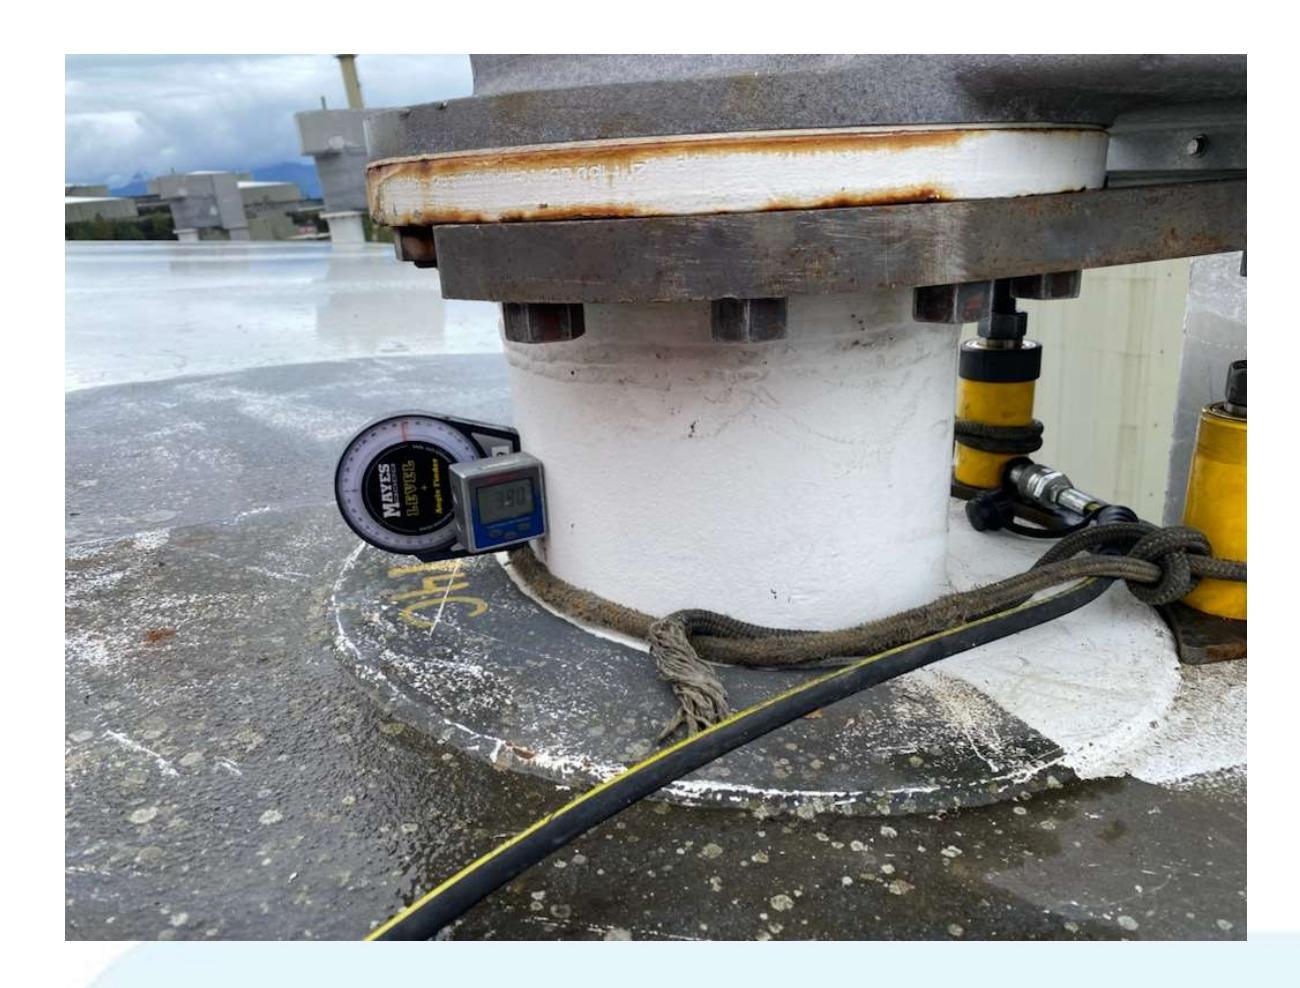
Nozzle Straightening

The target is 0 deg, +/- 3 deg tilt
