SUBJECT: Prince William Sound Regional Citizens' Advisory Council Report:
"A Review of the Proposed New Escort and Support Tugs for
Tanker Operations in Prince William Sound"

ROBERT ALLAN LTD.

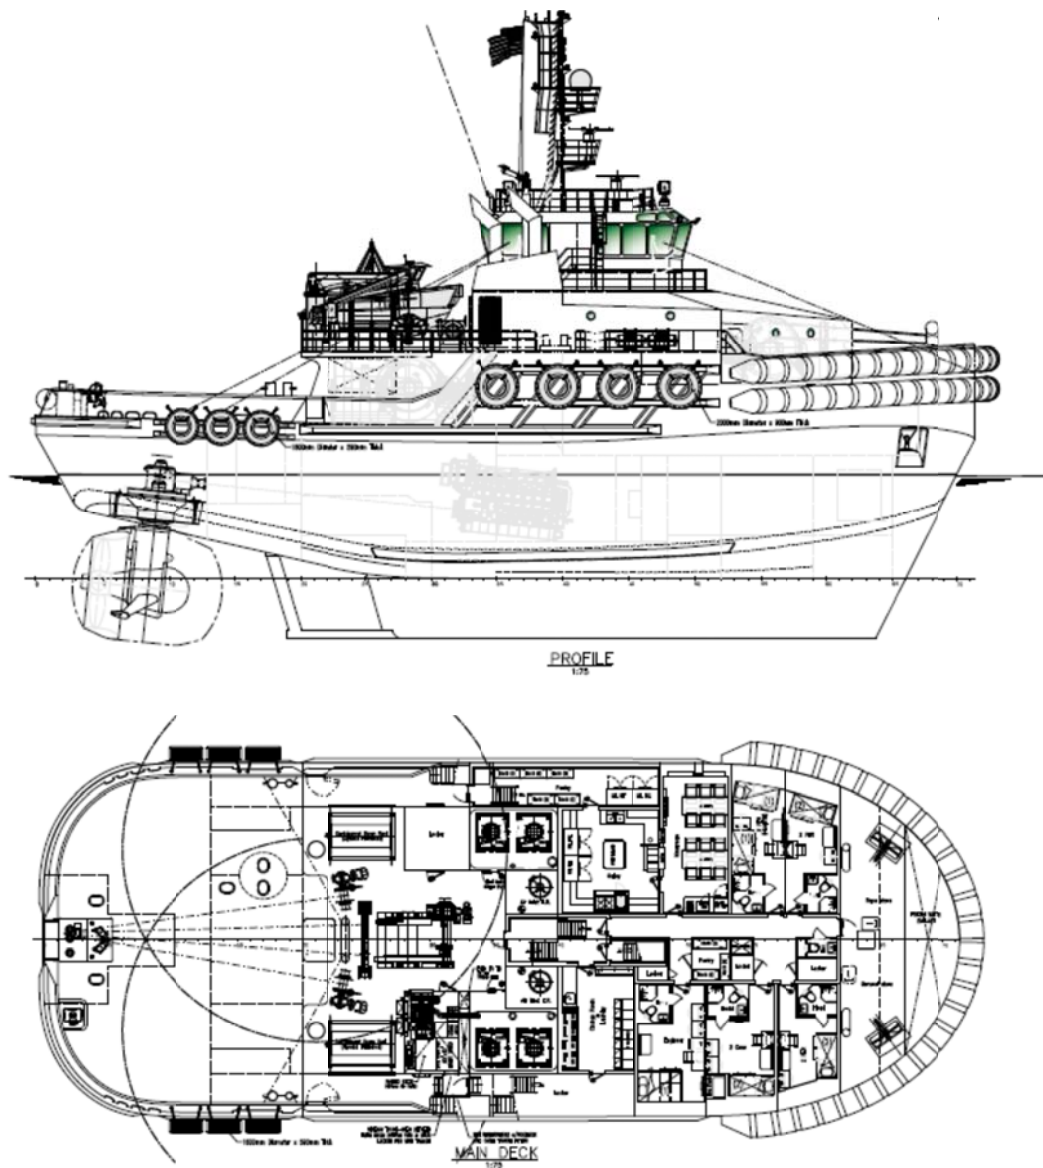
Figure 1 General Arrangement of Damen 4517 Tugboat

- a. The 5.45 metre draft noted on the General Arrangement is presumably the moulded draft to the moulded keel line (USK) and NOT to the underside of the skeg. ECO to advise the total maximum navigational draft as this is the value most critical to the safe navigation of the tug. (Note: Based on other dimensions given, the max. draft is calculated as 8.15 metres (26.75 ft.))

- b. The skeg is inordinately large for this type of tug, and accordingly moves the centre of lateral pressure further aft than desirable for efficient escort operations. ECO should be asked to present calculations defining why such a large skeg is necessary and how "fail-safe" operations are assured in the event of any tug propulsion or towline failure during indirect escort operations.

- k. Fendering: Experienced Masters familiar with the PWS tug operations advise [Annexes A and B] that the fendering arrangement shown on the GA drawings will be insufficient for the PWS operations. Their recommendations include:

- 1. increase the fendering by adding 2,000 mm x 900 mm tires forward of frame 52 (on top of the cylindrical fenders), and
 - 2. replace the 1,600 mm x 590 mm tires aft with 2,000 mm x 900 mm tires

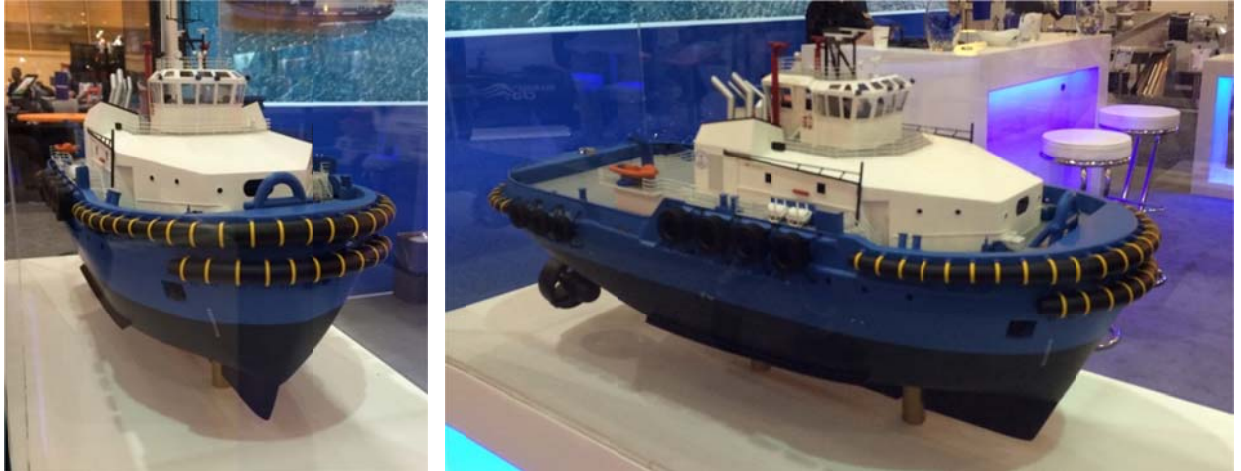
- g. The bow form is extremely bluff as illustrated in Figure 2 below showing a model of this boat:

Figure 2 Model of Damen 4517 Tug, Indicating Bluff Forward Shape and Low Effective Bow Height to Bottom of Fenders (see also O/B Profile Drawing)

The combination of the bluff shape and low knuckle height will result in high speed loss in waves and a generally wet boat. Model testing should be performed in order to define speed loss in waves, particularly for any Sentinel tug mission.

There are many concerns that would be potentially eliminated (bow wetness, performance, seakeeping, etc.) by model testing of this vessel. It is strongly recommended that model testing be conducted at the soonest opportunity to identify any potential issues that could be rectified at this early stage. At a bare minimum, a class-approved CFD analysis should be conducted.

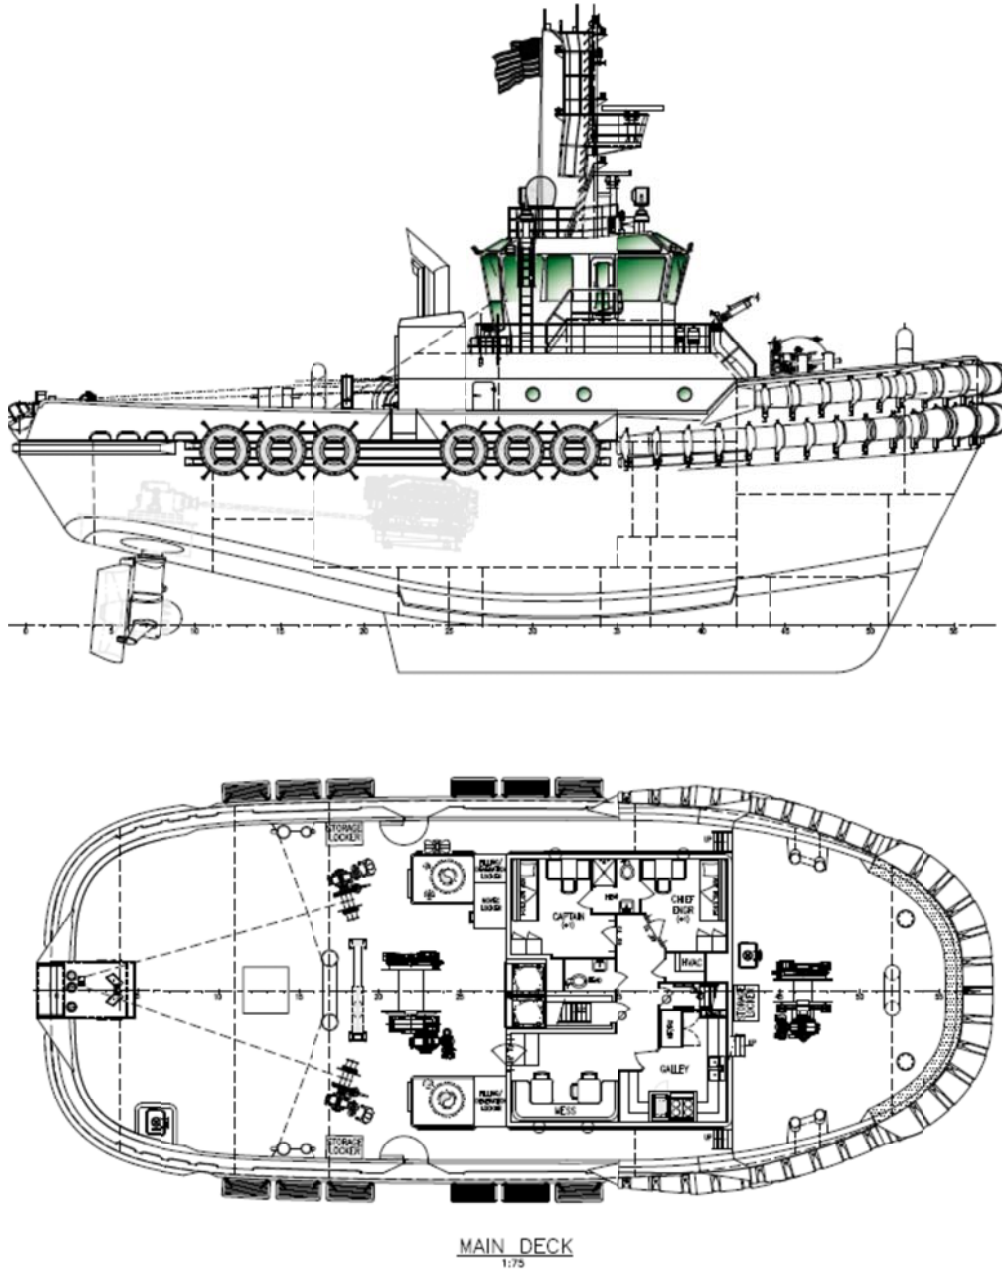
Figure 3 General Arrangement of *Damen 3212* Tugboat

- e. The arrangement of the stern tow-pin/roller system as shown is problematic: it will snag towing gear in the right angle space created between the pin "table" and the bulwarks. The top surface needs to extend diagonally outward to intercept the bulwarks at about a 45° angle and have no corners or overhangs to catch SWR sockets, shackles or similar towing fittings. Also, the position of the roller portion of these two-pin set is extremely vulnerable to contact damage when barge-handling. These rollers are normally set well forward of the contact area and are protected by fendering. Detailed drawings should be provided for approval

- f. The main deck accommodation layout is inappropriate for the Alaskan climate:
 - i. There is no wet room or even wet gear lockers at the entry. The main entry leads directly into the tiny mess area with no place to put wet boots, coats, etc. Maintaining this area in a semi-clean condition will be impossible. The mess space is tiny and abuts the main access corridor

- g. Ladder from fore deck to boat deck is very steep ... potentially dangerous, especially in snow or icy conditions. It is also strongly advised that any exterior ladders and gratings be constructed of GRP to minimize potential for snow and ice accumulation. ECO to define what is presently specified for ladders and gratings and if necessary change for best crew safety

- h. Fendering on the stern looks inadequate. Details of fendering and towing arrangement to be provided and reviewed/approved by Masters familiar with local towing operations and conditions

- j. Deck locker space is totally inadequate for towing gear etc. in the cold climate. Provide details to demonstrate suitable drainage, ventilation and heating in ALL gear lockers to ensure lines are all readily usable in all weather conditions

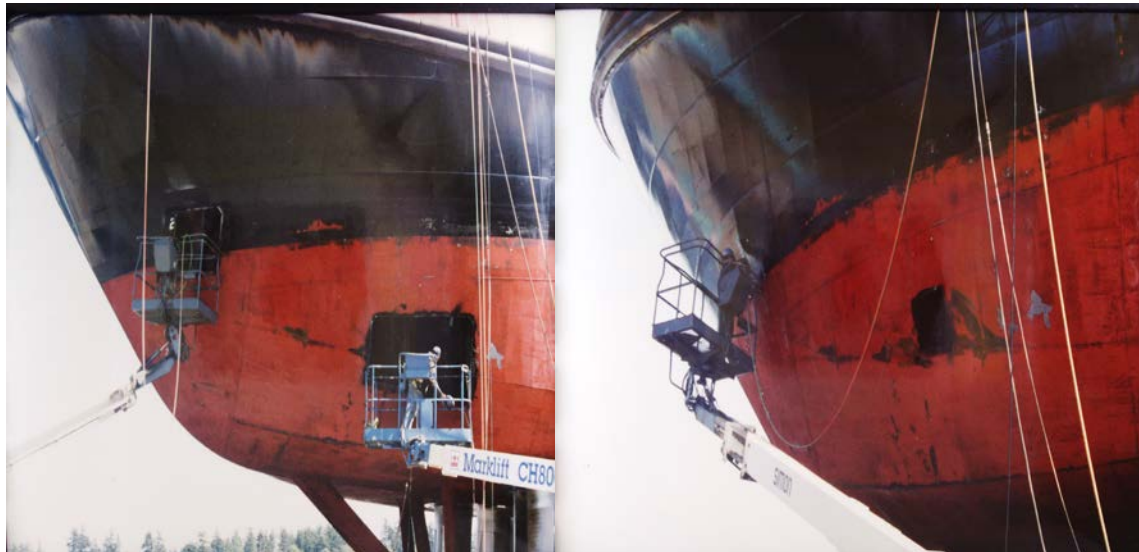
Hull repairs underway at regular yard period to replace set-in plating from contact with glacier ice, which made initial contact near waterline and rolled down to strike vessel again below the water line. After close inspection of vessel in the water it was determined there was no breach of hull plating but very close.

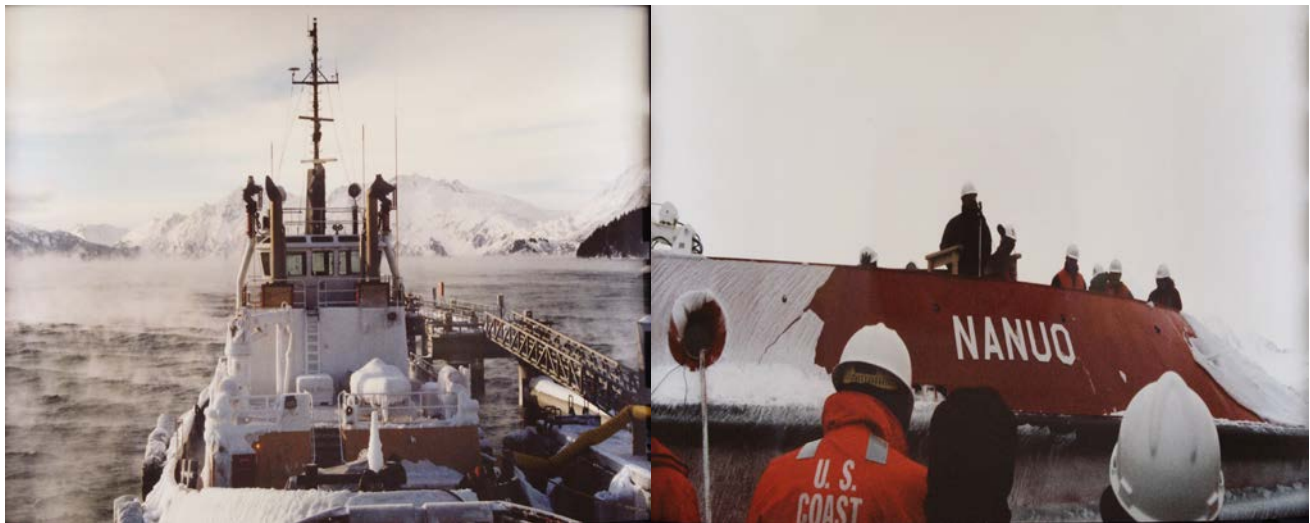
**Vessel icing does happen in Valdez
Tugs at SERVS Dock**

Tug *Protector* de-icing at SERVS Dock.

Tug *Nanuq* christening at SERVS Dock.
Crew used ball bats to uncover name.

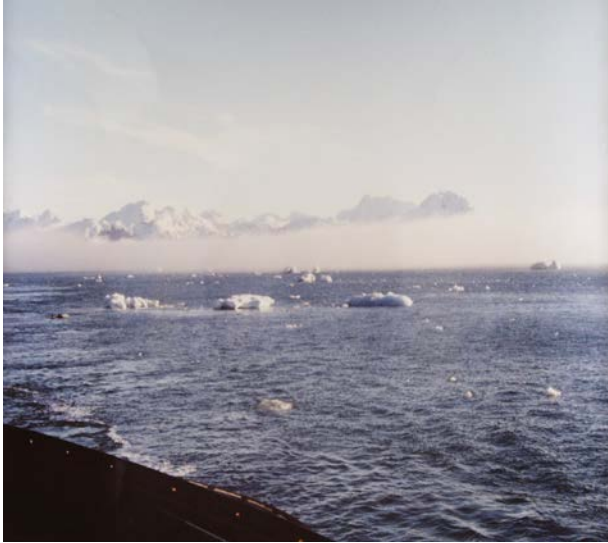
Mid-Sound ice from Columbia Glacier

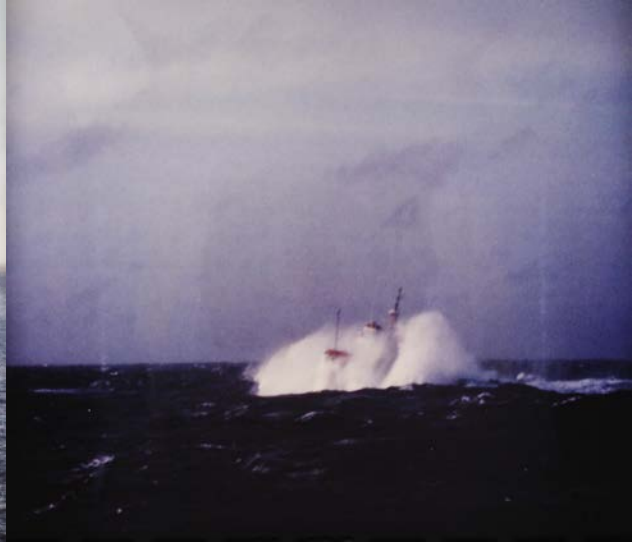
Near closure weather at Hinchinbrook
ERV Gulf Service
