**Observers' Report**  
**MMS Cold Water Dispersant Tests**  
**Ohmsett Testing Facility**  
**28 February – 3 March 2006**

**Report to**  
**PRINCE WILLIAM SOUND**  
**REGIONAL CITIZENS' ADVISORY COUNCIL**

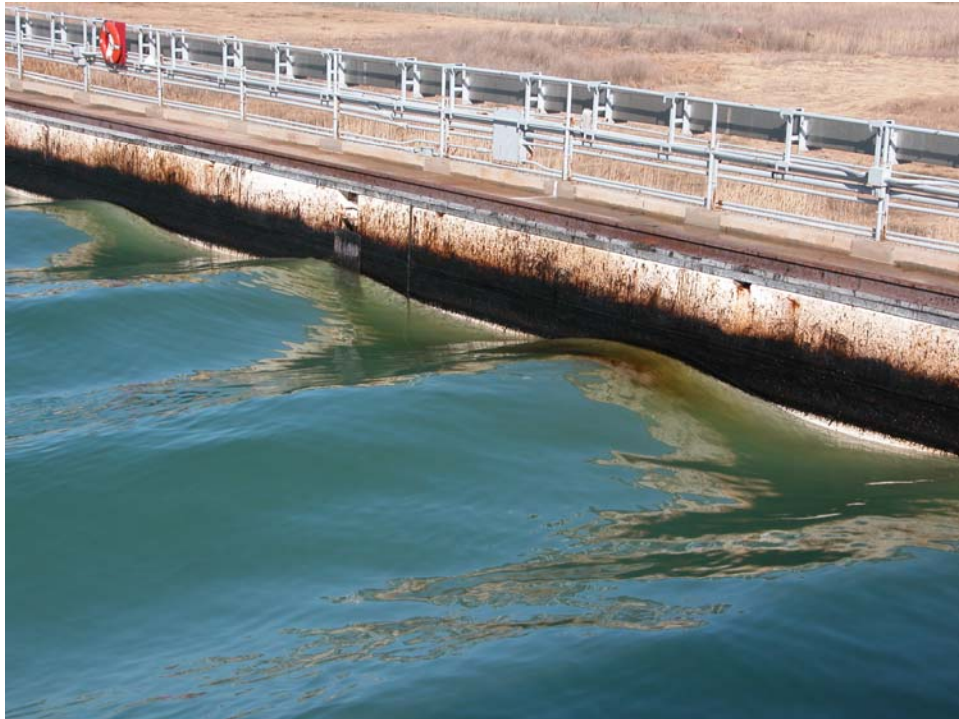
**Figure 2: Oil stains on tank wall**

Significant tank contamination was observed. Even before the tests began, a thick, dark oil stain was visible as a "bathtub ring" around the tank (Figure 2). This bathtub ring emitted a visible sheen throughout the test period. Contamination was also present in the area beyond the booms at the north and south ends of the tank. An appreciable slick of oil, at varying degrees of weathering, was present at either end of the tank. The size of these slicks increased as the test period progressed (Figure 9).

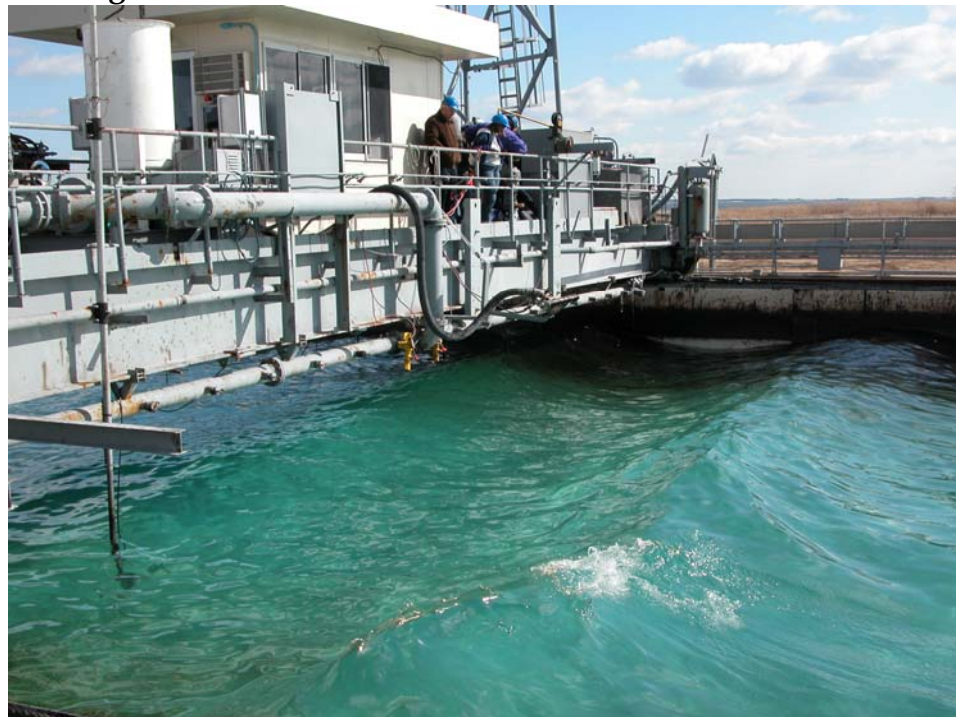
**Figure 3: Bridge**

The tank is equipped with a traveling bridge that extends across the width of the tank and is propelled along the length of the tank by steel cables on the sides of the tank. This bridge includes an enclosed, heated cab where the technicians work to conduct the tests. They record data using hand-written data logs, data exports from various types of equipment, and photographs. A video camera under the bridge records each test from beginning to end.

The bridge is also the platform where equipment is installed to conduct the tests (Figure 3). In the case of the dispersant tests, the main equipment installed on the bridge was as follows:

- A sprayer on the leading edge of the bridge to lay down the crude oils used in the tests;
- A sprayer on the trailing edge to lay down dispersant (oil sprayer and dispersant sprayer are separated by approximately 10 feet);
- Containers of crude oil and dispersant; and
- Two large fire-hose type nozzles used to spray water for herding oil into the corner of the boom enclosure for recovery.

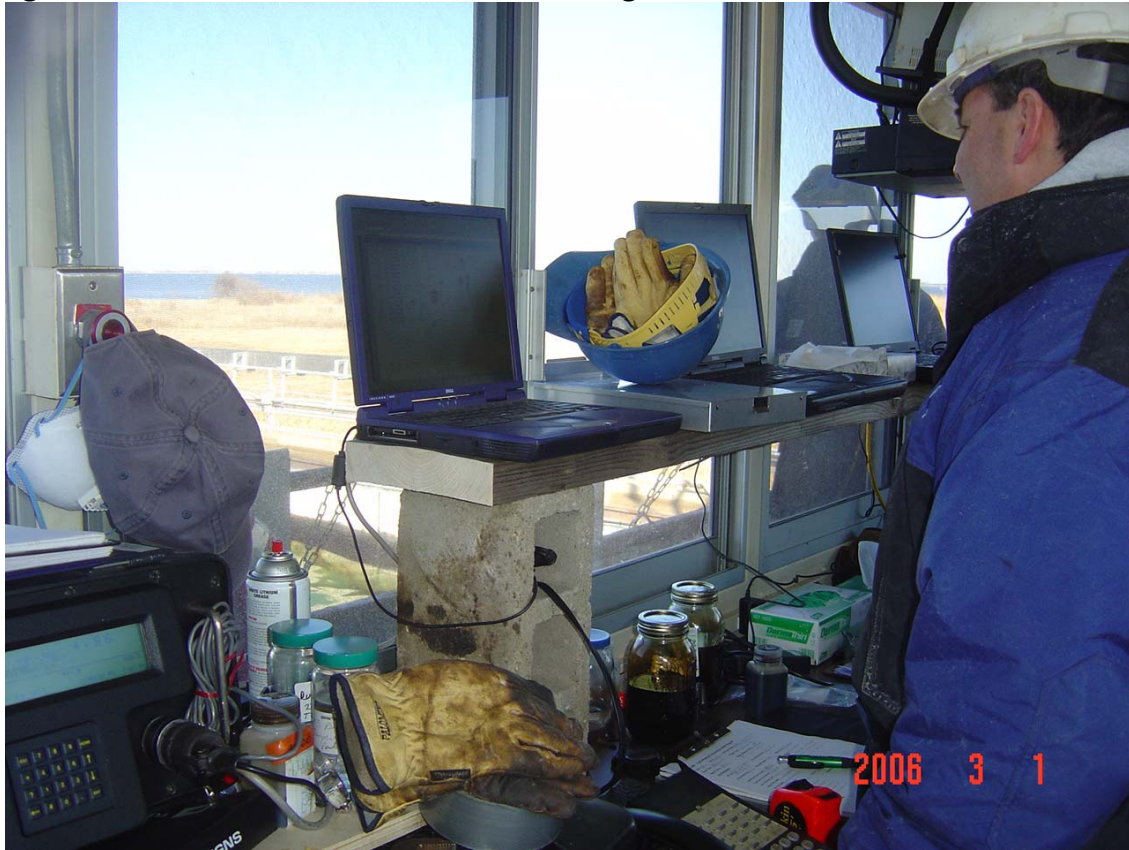
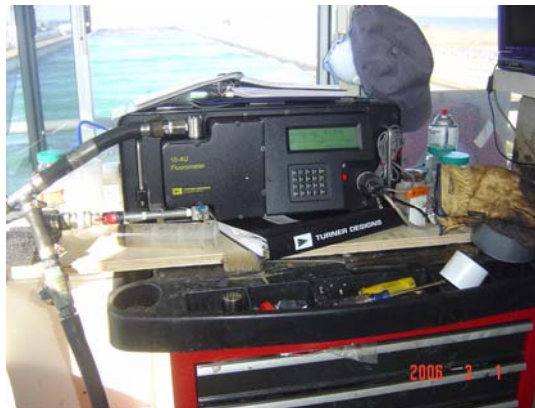
**Figure 4: Instrumentation monitors on bridge**

Several instruments were suspended approximately 1.5 m below the bridge to take readings during the tests. The instrumentation monitored on the bridge during these tests (Figure 4) included:

- Live video feed from video camera (mounted directly under bridge, above water line)
- LISST Particle size monitor

- OSRL Fluorometer (second type of fluorometer monitored by OSRL employee)
- Turner fluorometer – outputted to excel spreadsheet with data points every 5 seconds
- Sontek Velocimeter – constant data feed which was recorded in “bursts” every 30 seconds when the bridge was stopped at either end of the test area.

Velocimeter

Turner Fluorometer

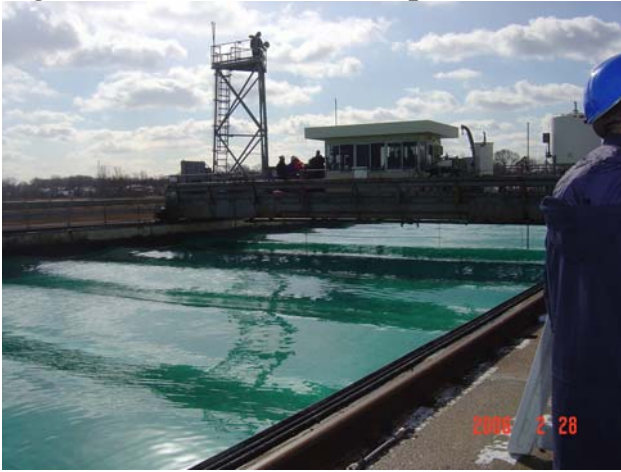
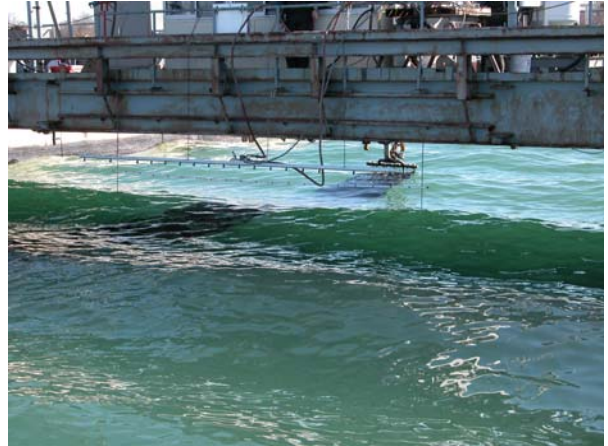
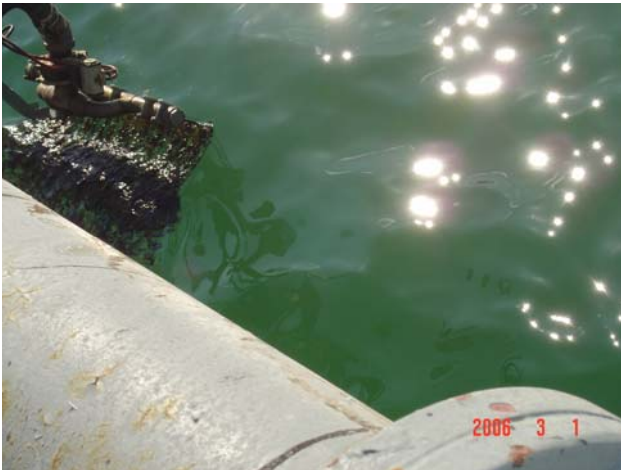
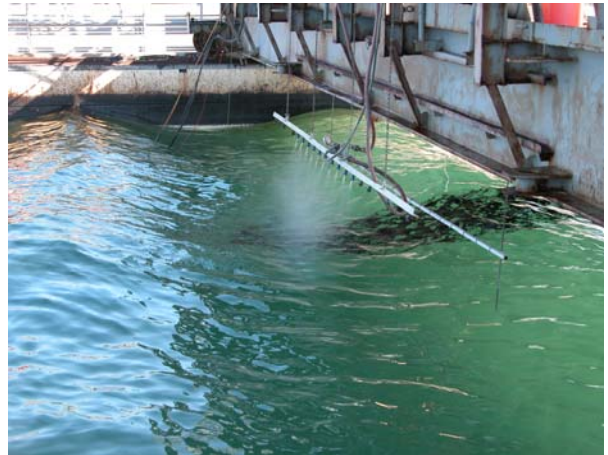
**Figure 5: Procedures for Dispersant Tests**

Each test was conducted the same way. The bridge was positioned at the beginning of the track run. Waves were started and once up to a steady state (just prior to the onset of breaking waves), the experiment was started. After the bridge began to move (at a speed of approximately 1 knot), oil and dispersant began to be sprayed into the tank (during control tests oil only was sprayed). Oil was sprayed from a nozzle at the leading edge of the bridge and dispersant from a boom at the trailing edge. Oil (and dispersant, in some tests) was laid from north to south over an approximately 100-foot swath of the tank, near the south (wave-generating) end of the tank. The dispersant spray boom was appreciably wider than the oil spray nozzle (Figure 5).

*Wave generation*

*Oil nozzle and dispersant boom mounted on bridge*

*Nozzle laying down oil*

*Boom spraying dispersant*

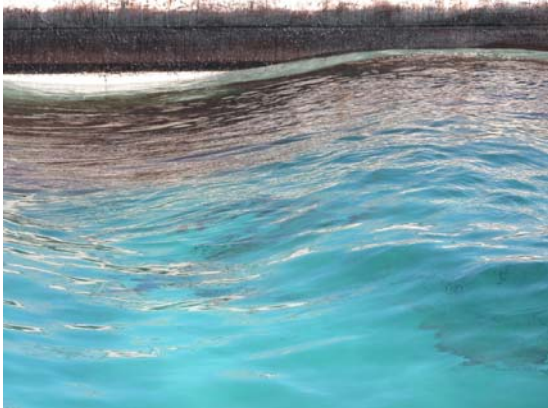
*Test 3*

Test 3, a fresh ANS dispersant test using Corexit 9527 was conducted on February 28 as the second demonstration for the Ohmsett visitors. The oil slick was again driven toward the east wall, however after about 10 minutes, some plumes were noted. After about 20 minutes there was more dispersion. Our visual estimates were that 20 to 40% of the oil was dispersed, although one of the operators said that about 67% was. The particle size instrument measured the droplet sizes at 35-50 microns.

About 45 minutes after the slick was laid, the oil was flushed to a collection center while the observers returned to the training room for a debriefing. Approximately 2 hours after the test, we went back up to the tank and noted that the tank was entirely covered with sheen and small patches of oil, despite the fact that it was supposed to have been cleared about  $\frac{3}{4}$  of an hour earlier. It appeared that a very large portion (up to 90%) of the original volume of oil had resurfaced within this time.

**Figure 8: Oil dispersion observed during Dispersant Tests**

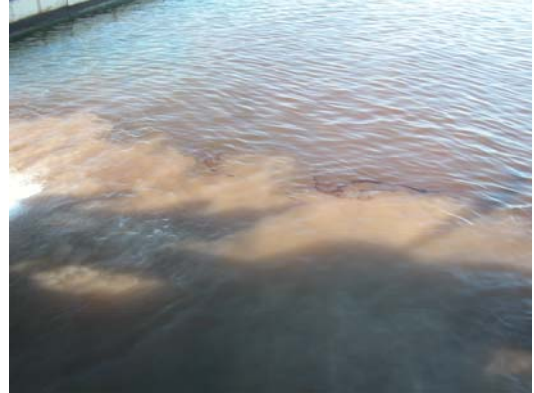
*Test 6*

Test 6 took place March 1. ANS which had been 16% weathered by air sparging was applied with Corexit 9527. The oil slick was more cohesive than others (stayed together and relatively central in the tank, at least initially) and thus the dispersant application seemed to hit the slick dead on.

The oil and dispersed oil was driven to the side wall by a wind of about 15 mph. A small localized dispersed plume formed beside the wall and the fluorometric readings through this small plume of about 20 feet long by about 10 feet wide ranged up to 180 relative fluorometric units. Our visual estimates were that about 50% was dispersed. The oil was flushed away 30 minutes after the experiment. We noted that rather than flushing oil down the tank, the spray re-dispersed oil and spread it more over the tank. We performed a walk around the tank and found significant re-surfacing within 45 minutes of “sweeping” the tank clean. We again did a walk around the tank after one and a quarter hours and found that even more oil was resurfaced. There was about a 3 foot band of re-surfaced oil all along the downwind side of the tank for about 400 feet. In the morning, we again re-surveyed the tank and found a heavy layer of oil on the downwind side of the tank. Based on the size and thickness of the slick, we estimated that the amount of oil in this slick to have been in the range of 6 to 13 gallons, or between 35% and 70% of the oil put out in the last test.

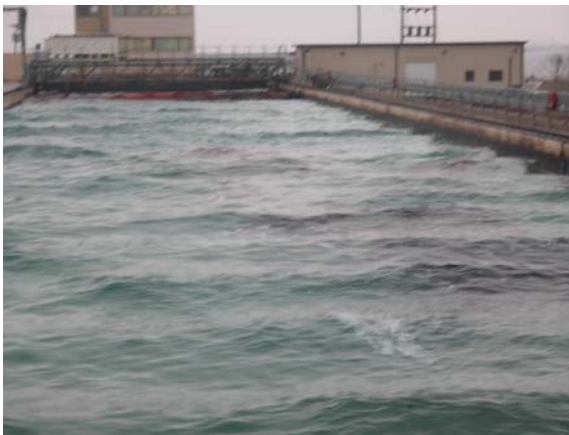
*Test 9*

Test 9 was the final test on March 2, and was initially delayed due to rain. The oil (ANS crude weathered 15% on tank with high energy) was laid to the North central part of the tank as the wind was from the North. The oil dispersed visually to about 50%. After the experiment, (30 minutes) the crew swept the tank with fire hoses and recovered about 5 gallons of oil with water, estimating that 4 of it was pure oil. We observed that the entire tank was covered with a sheen of darker gray colour. We estimated that about 10 gallons or more of the oil was in this sheen. The next morning, we found that there was about 5 gallons of oil in a heavy slick near the south end of the tank as would be expected from the wind direction. There was other oil on the tank. Because oil behind the booms was not cleaned out, it is not known from which experiment the oil in the tank or behind the booms was derived.

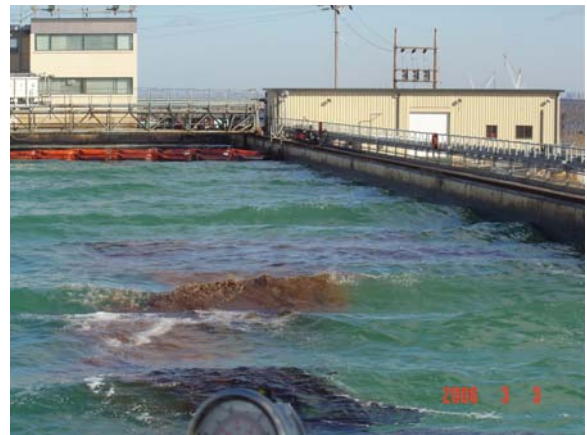
*Test 10*

Test 9 was the first of two tests on March 3. ANS which had been 15% weathered on the tank with low energy was laid to the North central part of the tank as the wind was from the North west. The oil dispersed visually to about 50%. After the experiment, (30 minutes) the crew swept the tank with fire hoses and just before the second time this was done, we observed that the East side of the tank had a column of oil all along it with some concentrations. This oil was estimated to be 10 gallons, in volume. This did not count the oil removed on the first sweep which was estimated to be 5 gallons. Another sweep was carried out later and this yielded still another 5 gallons. The origin of all this oil was not known as there was oil left behind booms from previous experiments (Figure 9).

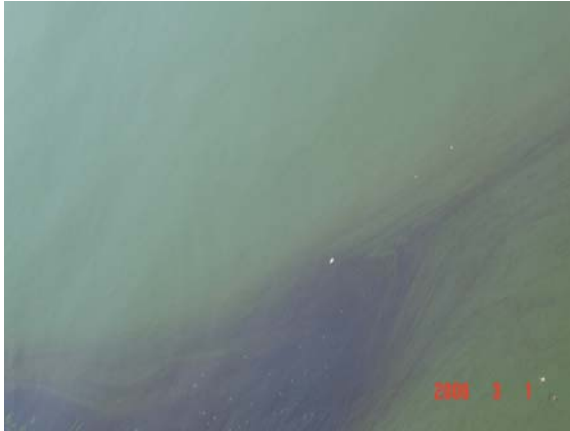
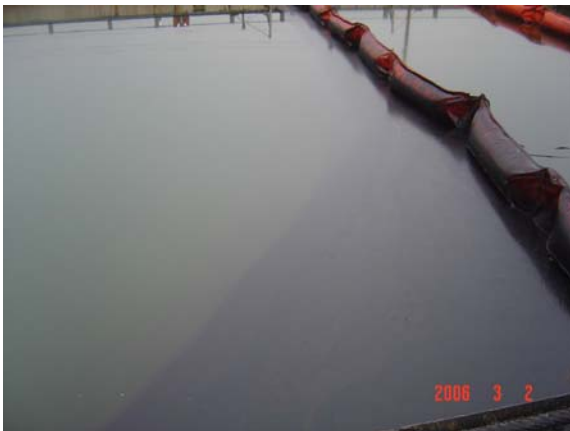
**Figure 10: Observations of Resurfaced Oil**

Resurfaced oil was observed upon completion of each dispersant test, after the wave generator had been turned off. This effect was most obvious during the time period between the end of one day's testing and the beginning of the next. Every morning prior to initiating the days' testing, the tank was re-cleaned using the fire hose method, and the oil was herded under the boom at either end of the tank. This oil was never accounted for, as no mass balance was calculated.

*Resurfaced oil visible in tank 1 hour after Test 6*

*Resurfaced oil and surfactant (1 hour after Test 6)*

*Resurfaced oil the morning after Test 6*

The pending Technical Analysis Report prepared by the PWS RCAC observer team discusses the resurfacing phenomenon in detail, and recommends measures to address this by increasing the length of time between dispersant application and data collection.
