FINAL REPORT

Crude Oil Storage Tank 8 Floor and Cathodic Protection System Design Review

PWSRCAC Contract # 5056.22.01

June 2022

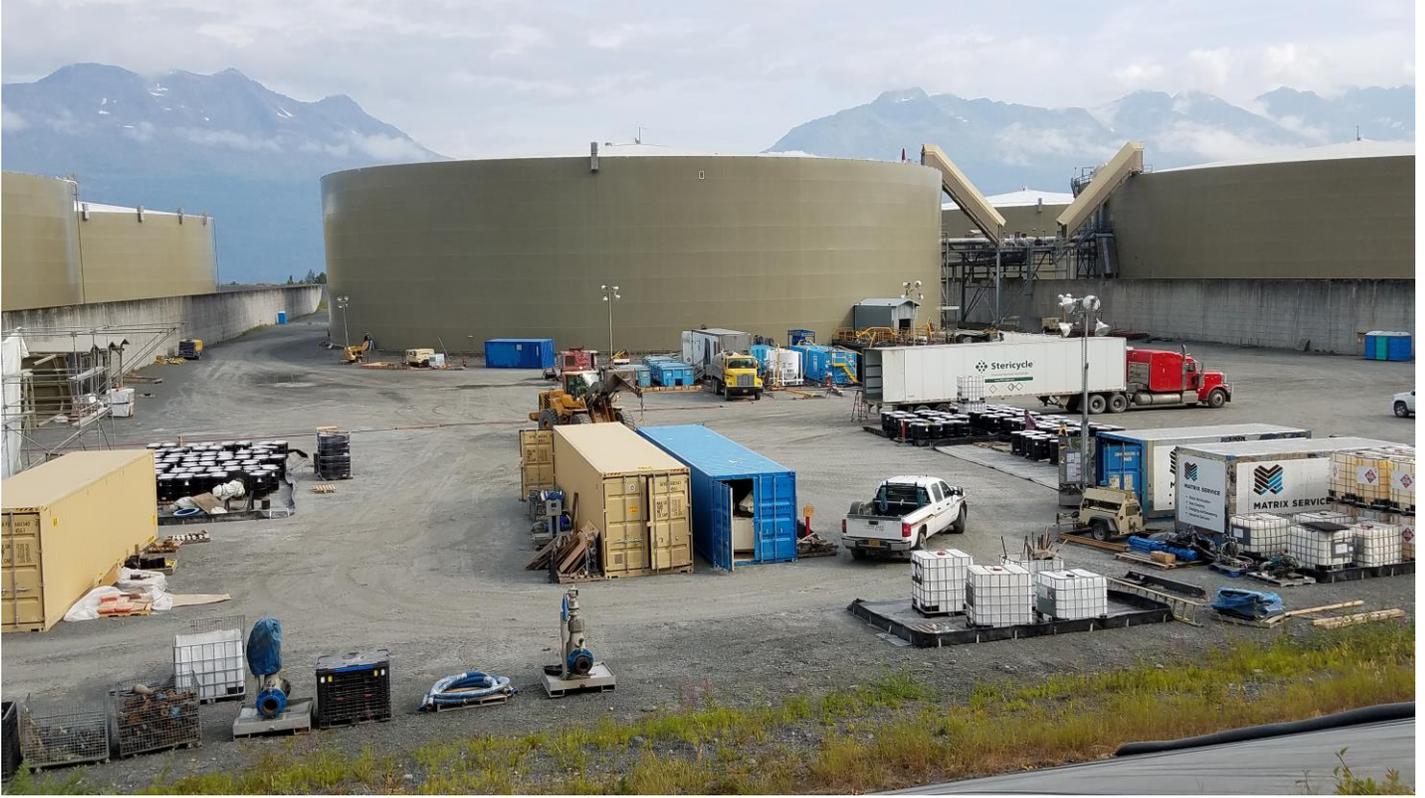
Figure 3 - Tank 8 During 2019 Out-of-Service Inspection (photo courtesy of Austin Love/PWSRCAC)

Tank 8 was removed from service for internal inspection in 2007 and 2019. After the 2019 out-of-service inspection, minor repairs were completed on the tank floor and the tank was prepared to be coated and returned to service (Figure 3). A follow-up inspection, prompted by one of APSC's engineers, resulted in the discovery of more than 160 additional locations of corrosion that had been missed during the first inspection. At that point, the decision was made to replace the tank floor and CP system. Due to issues arising from the COVID-19 pandemic in 2020, the decision was made to complete minor repairs on Tank 8 and return it to short-term service until 2023. At that time, APSC plans to remove the tank from service and replace the tank floor and CP system.

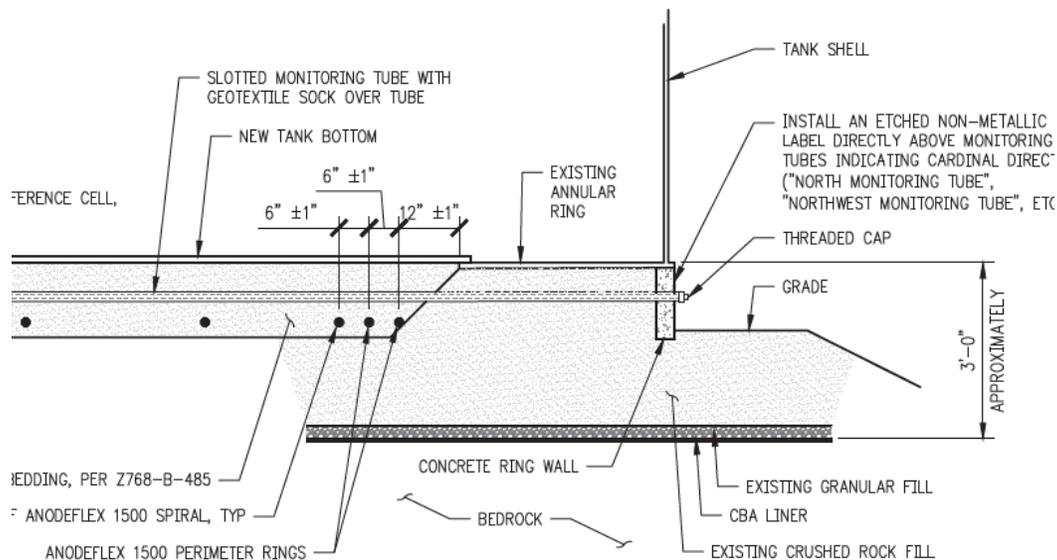
Figure 4 – Annular Ring CP Groundbed

The ground bed design for the new Tank 8 floor CP system, consists of Anodefex rings distributed throughout the area beneath the tank floorplate. The CP design includes two separate anode flex loops intended to protect the tank's annular plates. However, in that design, the annular ring Anodefex loops are located beneath the floorplate, not beneath the annular plate. They are located roughly 1-foot from the inside diameter of the annular plate (see Figure 4, excerpted from drawing D-54-Z768-CP101).

This configuration is unlikely to protect the annular plates for the following reasons:

First, the annular plate and floorplate are welded together and therefore electrically continuous. The Anodefex loops intended to protect the annular plates will distribute current primarily via the lowest resistance pathways. In this case, assuming similar backfill resistivity, the current will go to the closest steel, which is the regular floorplate steel, not the annular plate.

The CP designer appears to recognize this shortcoming in the design. Within the document "Cathodic Protection Calculations Annular Ring Circuit," Section 3.0, "Assumptions," the designer included the following statement: "Anodeflex will not be installed directly under the annular ring due to construction restraints; therefore, reduced CP current density is expected near the shell."

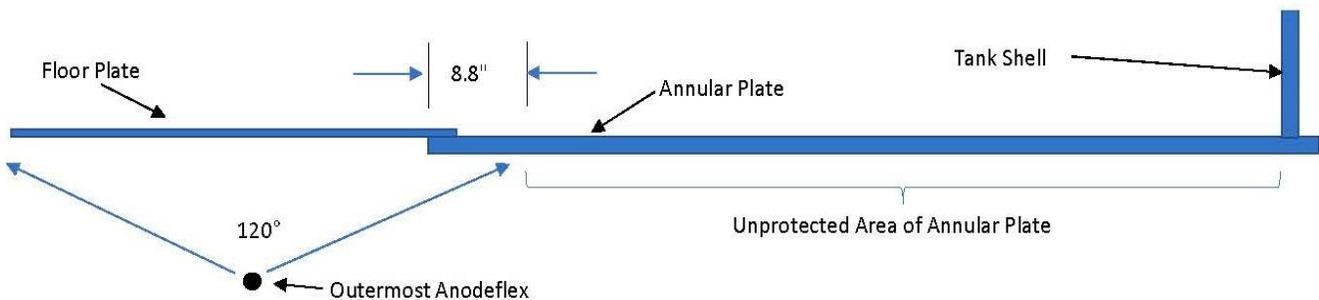
Figure 5 – Annular Plate CP Groundbed Current Distribution in Proposed Design

A general rule of thumb, used for designing uniform distribution of CP current for close coupled anodes, is to assume that the anode will distribute current to the steel surface in a (roughly) 120-degree arc of influence.¹ This is depicted below in Figure 5. As shown in the figure, the Anodeflex loops intended to protect the annular plate, will only impact a small section of the annular plate that is located closest to the Anodeflex (also depicted in Figure 5).

Based on this geometry, over 85% of the soil-side surface area of the annular plate is likely to remain unprotected from corrosion with the proposed cathodic protection design.

The two Anodeflex loops that are dedicated for the annular plate are tied to a separate circuit that can be adjusted independently of the floorplate system. It appears that APSC will attempt to protect the annular plate by using a higher driving voltage on the dedicated Anodeflex loops. This approach is very unlikely to be effective. As discussed above, the Anodeflex loops dedicated to protecting the annular plate are much closer to the floorplate than they are to the annular plate. Even with the ability to independently power the annular plate Anodeflex loops, the resulting CP current will go predominantly to the perimeter floorplate and will not measurably increase the annular plate area impacted by cathodic protection.

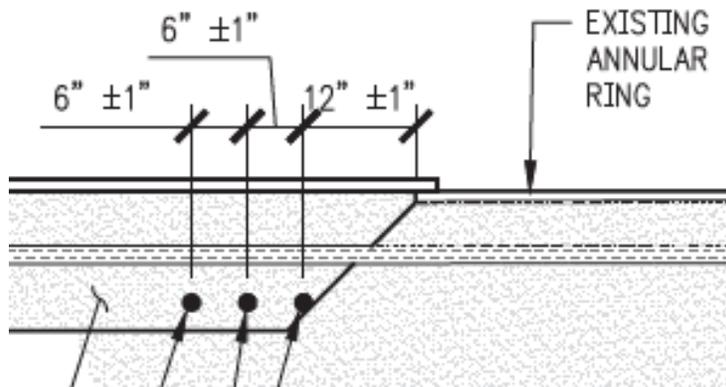
Figure 6 – Annular Ring CP Groundbed Spacing

However, the preliminary annular plate CP system design includes placing the outermost three anode loops very closely spaced together (6 inches apart) as shown in Figure 6 (excerpted from drawing D-54-Z768-CP101). The two outermost rings are dedicated to protecting the annular plate. The innermost of the three rings is intended to protect the floorplate.

The designer should have utilized a modified Sunde Equation to calculate the added resistance that will occur due to mutual interference between closely spaced anodes.

We have run these calculations using soil resistivities that are typical of what would be expected for clean graded fill. Based on the results of those calculations, the rectifier included in the design will not have sufficient voltage to overcome the resistance caused by the anode crowding.

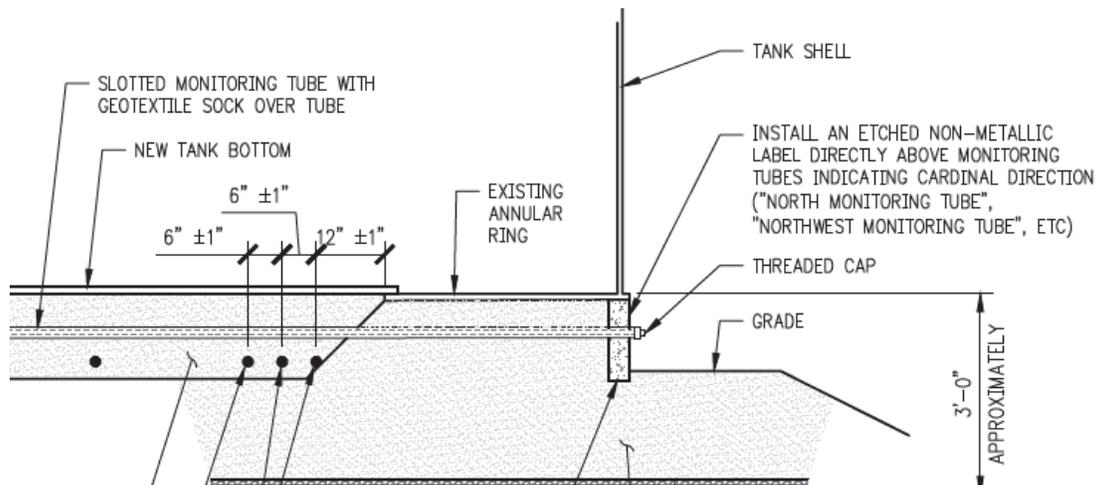
Figure 9 – CP Monitoring Tube Detail

The new CP system design appears to correct this shortcoming. Figure 9 is an excerpt of preliminary design drawing D-54-768-CP101, showing the proposed monitoring tube. It appears that APSC intends to install slotted tubes beneath the annular plate as well as the floorplate. That will enable APSC to monitor the levels of cathodic protection on the annular plate as well as the floorplate. This represents a design improvement over the existing systems.

The existing CP system design utilized CP monitoring tubes that are slotted to allow the collection of CP readings beneath the floor. However, for some reason, the old monitoring tube design did not extend the slots to beneath the annular plate. That basically left APSC blind to the level of CP being afforded the annular plates on their crude tanks.

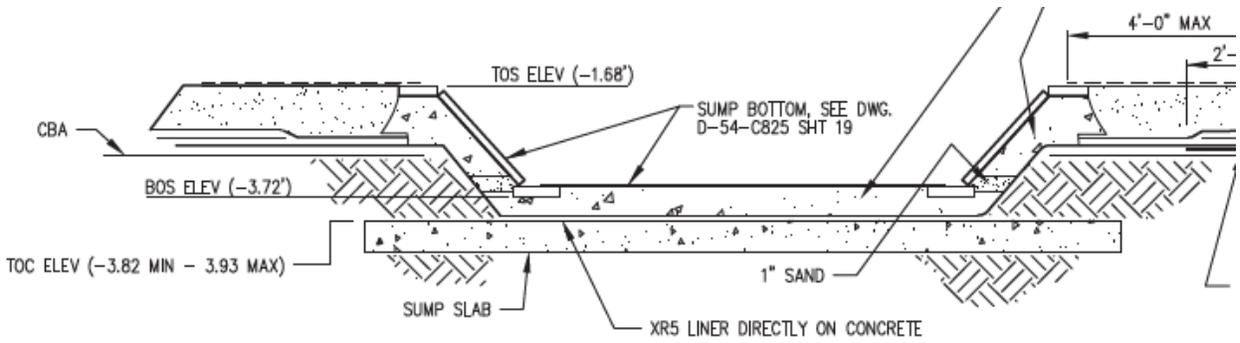
Figure 10 – Sump/Secondary Containment Liner Details

Both the existing and new CP systems are not configured to protect the steel associated with the bottom of the tank sump. The sump rests within a few inches of the secondary containment liner. That close proximity precludes the installation of anodes beneath the sump. Figure 10 is an excerpt from APSC design drawing D-54-C285 Sheet 20, showing the sump location relative to the secondary containment liner (shown as "XR5 Liner" on the drawing excerpt).

The design details provided by Alyeska and depicted in Figure 10, confirm that there is not sufficient clearance to accommodate anodes between the sump bottom and secondary containment liner. Figure 11 (an excerpt from design drawing D-54-Z768-CP102 Sheet 1) shows the routing of anode material around the sump to accommodate the lack of clearance. No anodes will be installed directly beneath the sump. Based on this configuration, the soil-side surfaces of the sump bottom will not see any benefit from the new cathodic protection system.

Further, the secondary containment liner elevation follows the contour of the slope forming a low point beneath the sump. This means that the sump bottom will spend more time in contact with water than any other soil-side surface.

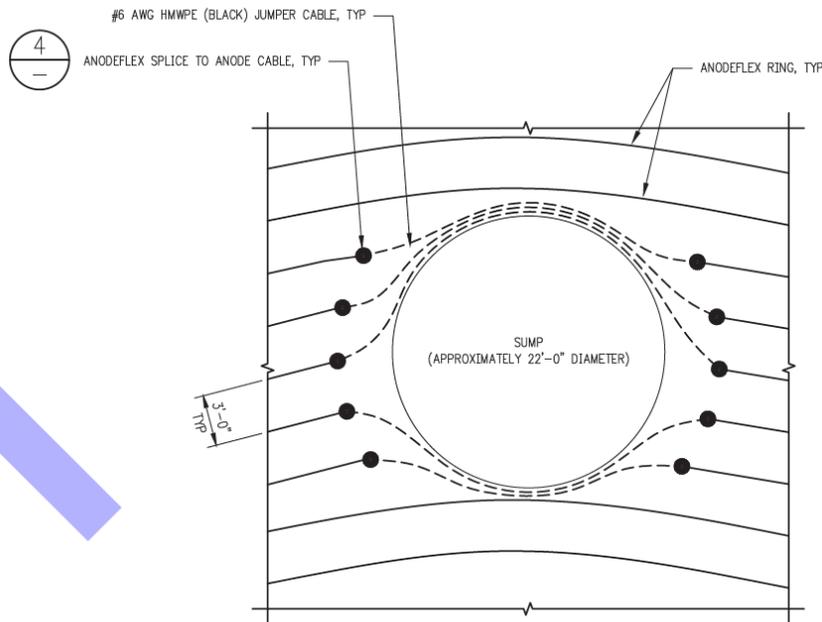
Figure 11 – Anode Distribution Around the Tank 8 Sump

The output of the anode placed as shown in Figure 11 will also be impacted by the crowding effect of placing three or four Anodeflex rings in such close proximity (similar to the situation discussed in Section 3.3 of this report). The result will be that significantly less current will be distributed to this area.

The CP designer appears to recognize this shortcoming in the design. Within the document "Cathodic Protection Calculations Tank Bottom Circuit," Section 3.0, "Assumptions," the designer included the following statement: "Anodeflex will not be installed under the columns, sump or annular ring due to construction restraints; therefore, reduced CP current density is expected at these locations."

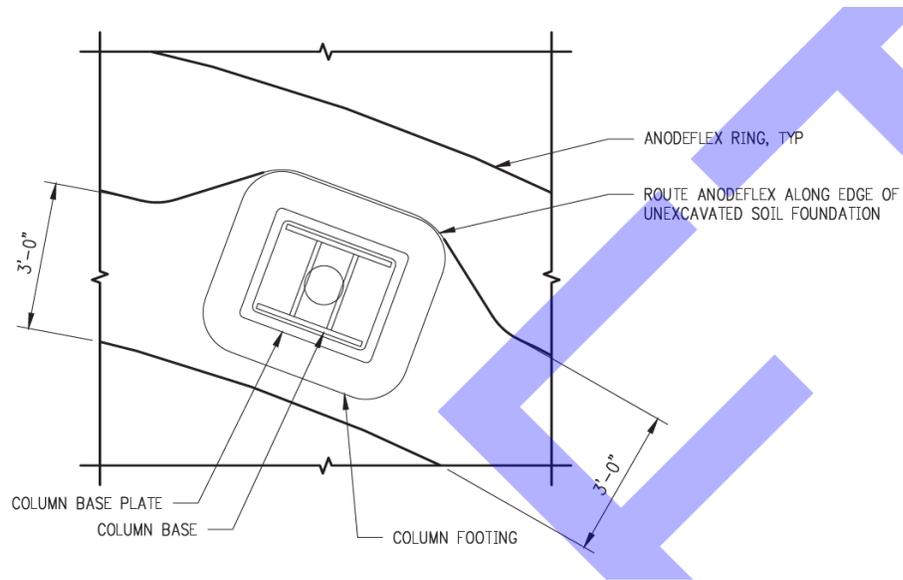
Figure 12 - Column Base Anode Routing

Neither the existing nor new CP system designs are configured to afford full protection of the steel beneath the tank columns. The new CP system design includes routing the Anodeflex material around the soil pads beneath the columns (see Figure 12).

Figure 12, excerpted from drawing D-54-Z768-CP104, presents the best-case scenario for how far the Anodeflex rings will need to deviate to avoid column base pads. In Figure 12, the column base is aligned in parallel to the Anodeflex rings. However, as shown in Figure 13, the column bases are not all oriented the same. In some cases, the column bases may be oriented perpendicular or diagonal to the Anodeflex rings as depicted in Figure 14.

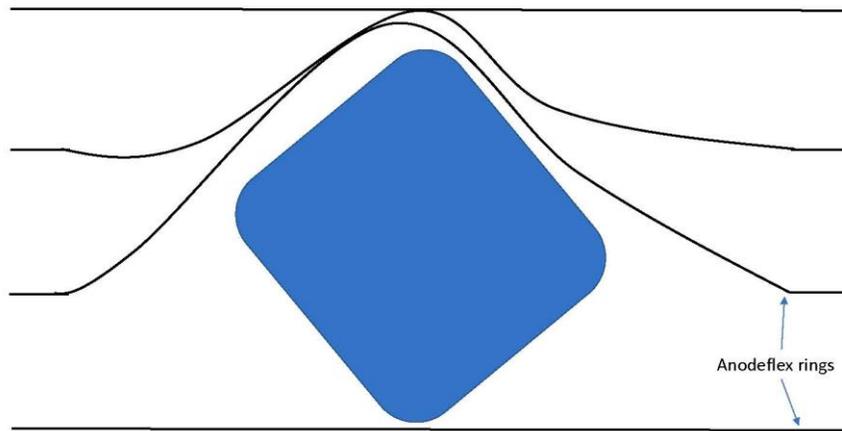
Figure 14 - Diagonal Column Base

The design doesn't include dimensions of the existing column pad remnants that will be left in place or the dimensions of the column feet. Without those dimensions, we can't define the exact impact to anode spacing. However, the presence of a column base that is diagonal to the Anodeflex rings could shift the location of two or more anode rings.

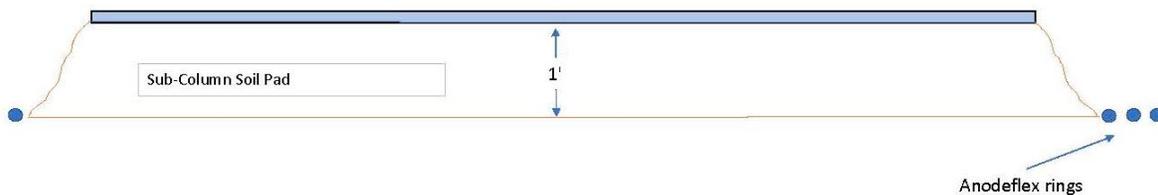
Figure 15 - Cutaway View of Column Pad

The soil pad beneath the column base will slope down and the Anodeflex will be placed at the toe of that slope as shown in Figure 15.

- Current from the Anodeflex rings located at the toe of the column pads will go to the area immediately above the anodes and not reach the floorplate directly beneath the columns (similar to the situation described in Section 3.2 of this report).
- Placing two or more anode rings in close proximity at the toe of the pad will create a "crowding" issue. The sections of Anodeflex rings that are too closely co-located will not provide current to that area (similar to the situation described in Section 3.3 of this report).
