# **SECONDARY CONTAINMENT LINER INTEGRITY EVALUATION**

**Valdez Marine Terminal  
Valdez, Alaska**

Project Number: WG2487

October 2018

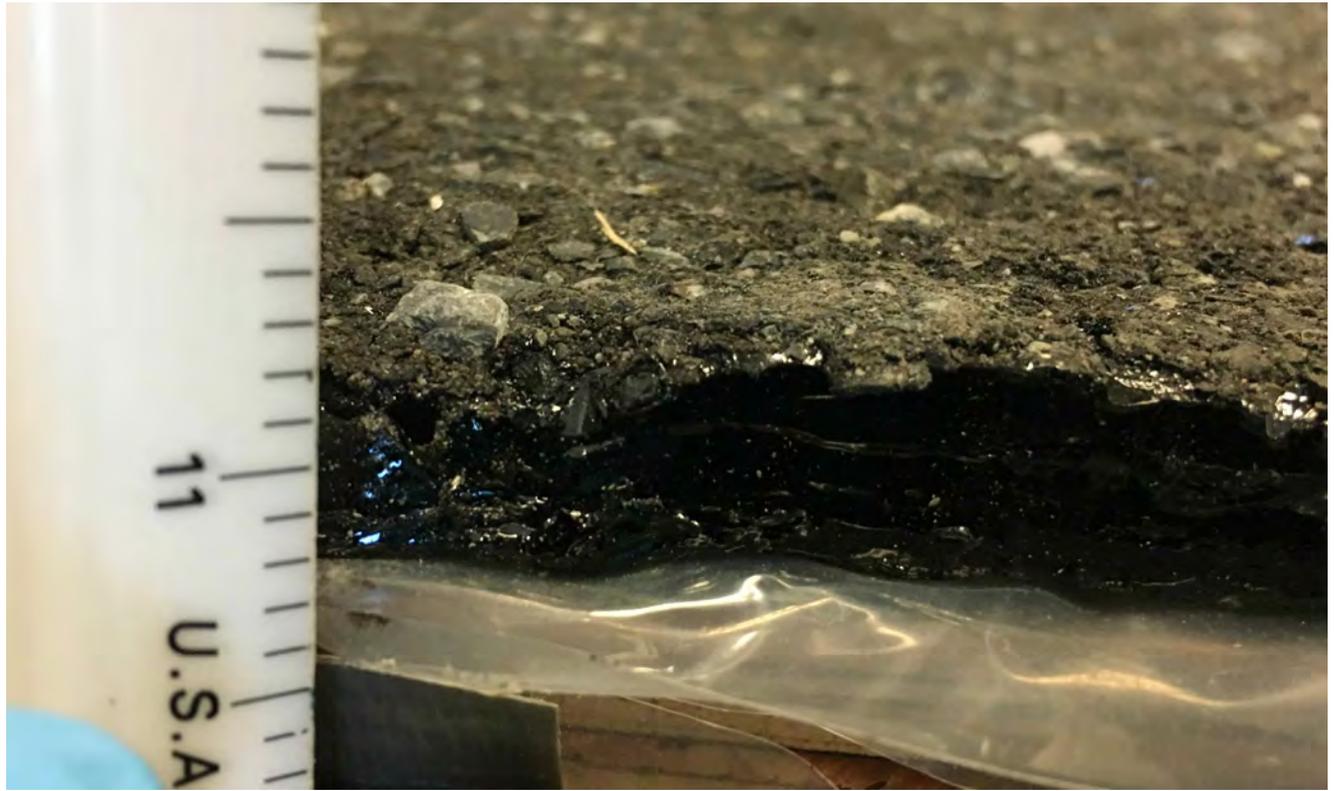
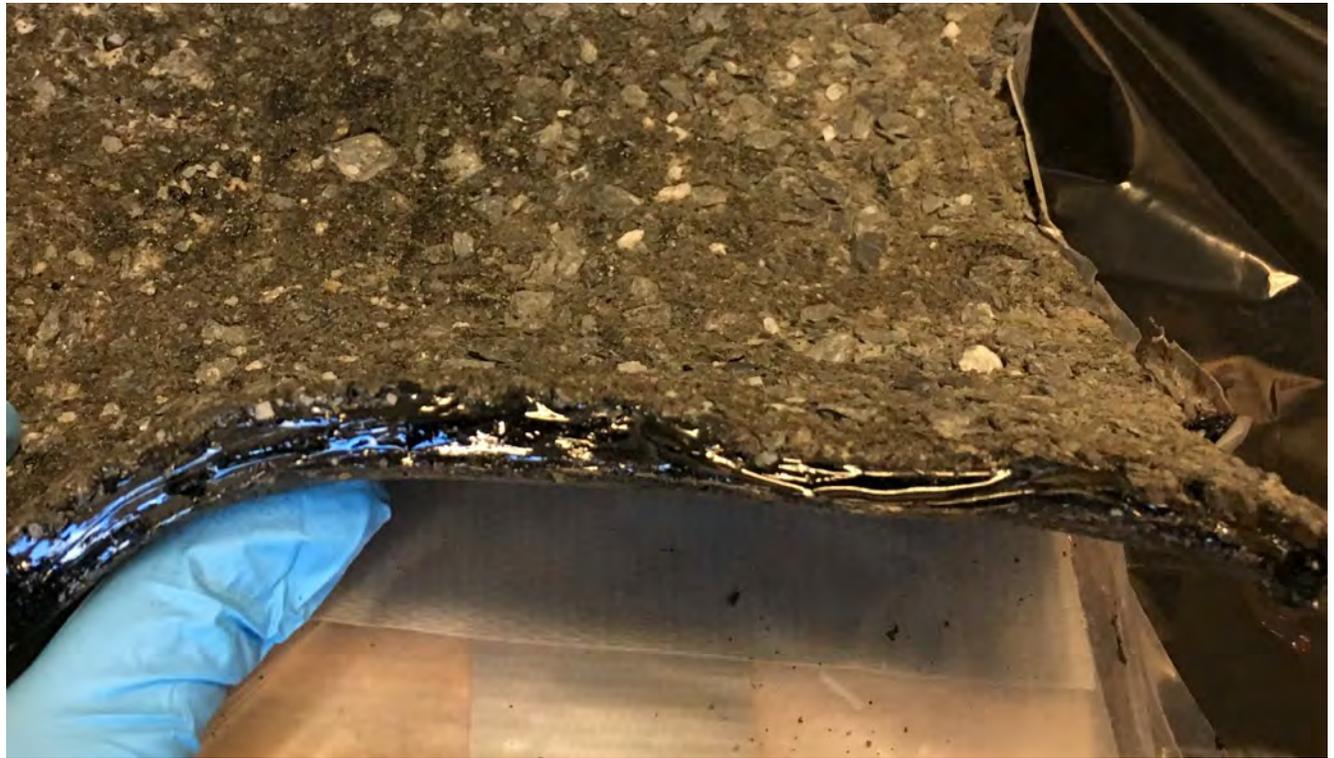
FIGURE  
 2

CBA LINER PHOTOGRAPHS  
 LINER INTEGRITY EVALUATION  
 VALDEZ MARINE TERMINAL  
 VALDEZ, ALASKA

NOTE: SCALE IN UPPER PICTURE MARKS 0.1 INCHES

During the construction of the tank farms in the late 1970s, the CBA liner was installed on the floors of the secondary containment cells. The minimum specified thickness of the CBA liner was 5/16 of an inch and it was spray-applied directly onto subgrade (not applied to a carrier geotextile) [Golder, 2013]. PWSRCAC provided Geosyntec with a sample of the CBA liner obtained from a previous APSC investigation; the CBA material resembled roofing tar and did not appear to contain aggregates or air voids (as would be expected for hot mix asphalt for paving), which is consistent with the description of the material in Golder [2015]. Photographs of the CBA sample are included in Figure 2.

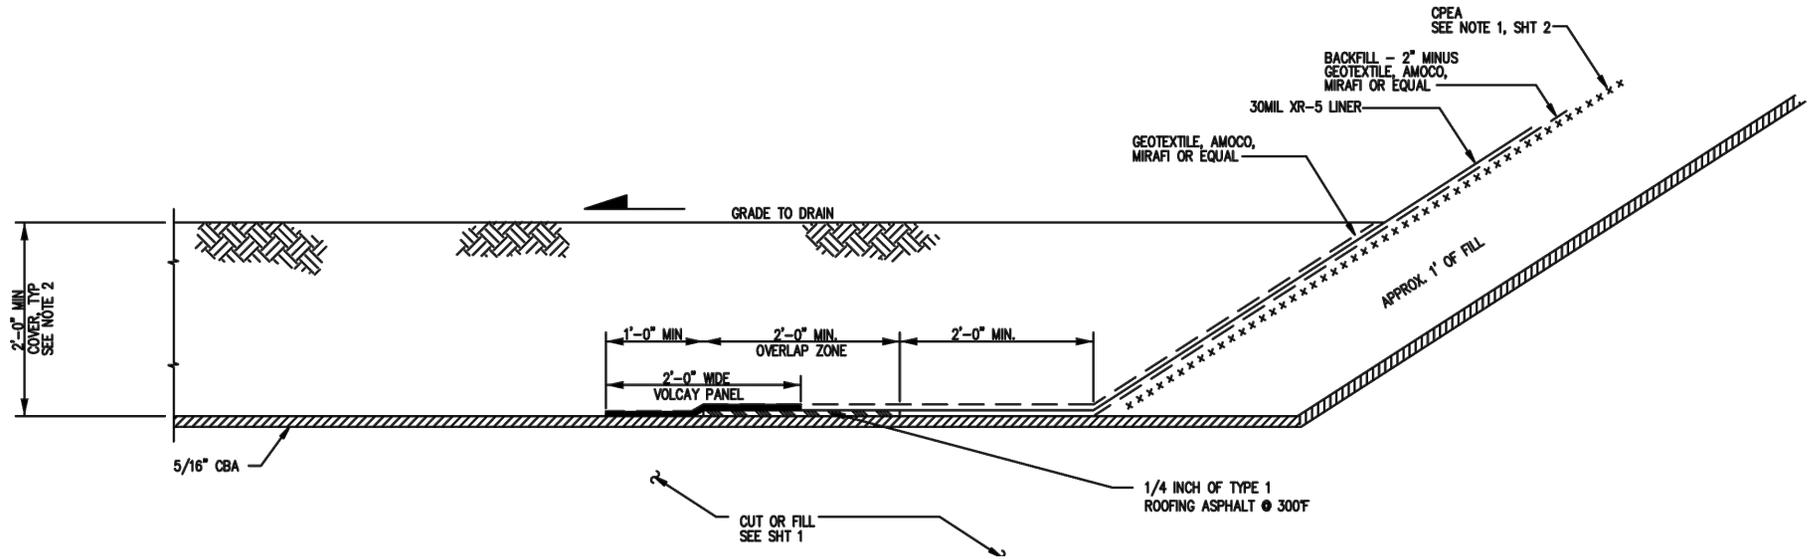
FIGURE  
3

GENERIC CBA CONNECTION DETAIL  
 LINER INTEGRITY EVALUATION  
 VALDEZ MARINE TERMINAL  
 VALDEZ, ALASKA

SOURCE: ALYESKA PIPELINE SERVICE CO., 1990. "EAST TANK FARM, DIKE LINER, GENERAL DETAILS," DRAWING NO. D-54-C21, 23 APRIL 1990.

excavations. Figure 3 provides a generic cross-section of the floor of the secondary containment cells.

In 1992, XR-5 was placed over the exposed Hypalon geomembrane on the earthen dike portions of the secondary containment cells. Generally, a nonwoven geotextile was placed over the Hypalon geomembrane prior to installation of the XR-5 material. The XR-5 geomembrane was overlapped from the dike slopes onto the existing CBA liner and “seamed” with a 2-foot wide Volclay® panel (bentonite clay) and ¼-inch of hot roofing asphalt, as shown in Figure 3.

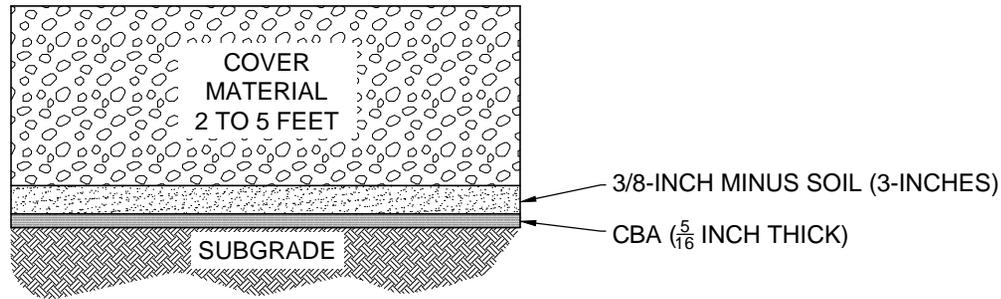
PROJECT NO: WG2487	OCTOBER 2018
FIGURE 4

GENERIC CBA LINER SECTION  
NOT TO SCALE

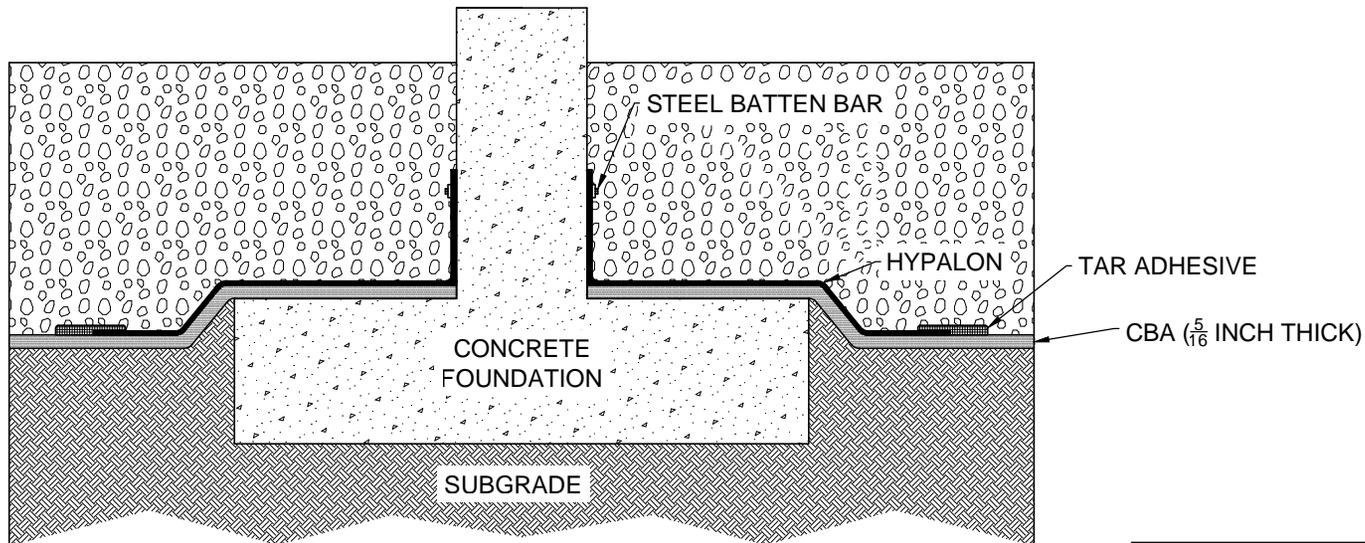
GENERIC CBA-FOUNDATION CONNECTION  
NOT TO SCALE

Based on discussions with APSC personnel, Geosyntec understands that concrete foundations were generally constructed prior to application of the CBA liner and the CBA liner was continued onto the top of the concrete foundations. Hypalon geomembrane was secured to the foundations with a batten bar, overlapped with the CBA liner, and sealed with a tar adhesive. Geosyntec's understanding of the generic foundation connection is presented in Figure 4. In general, the batten bar and Hypalon geomembrane connections have not been replaced since the original construction.

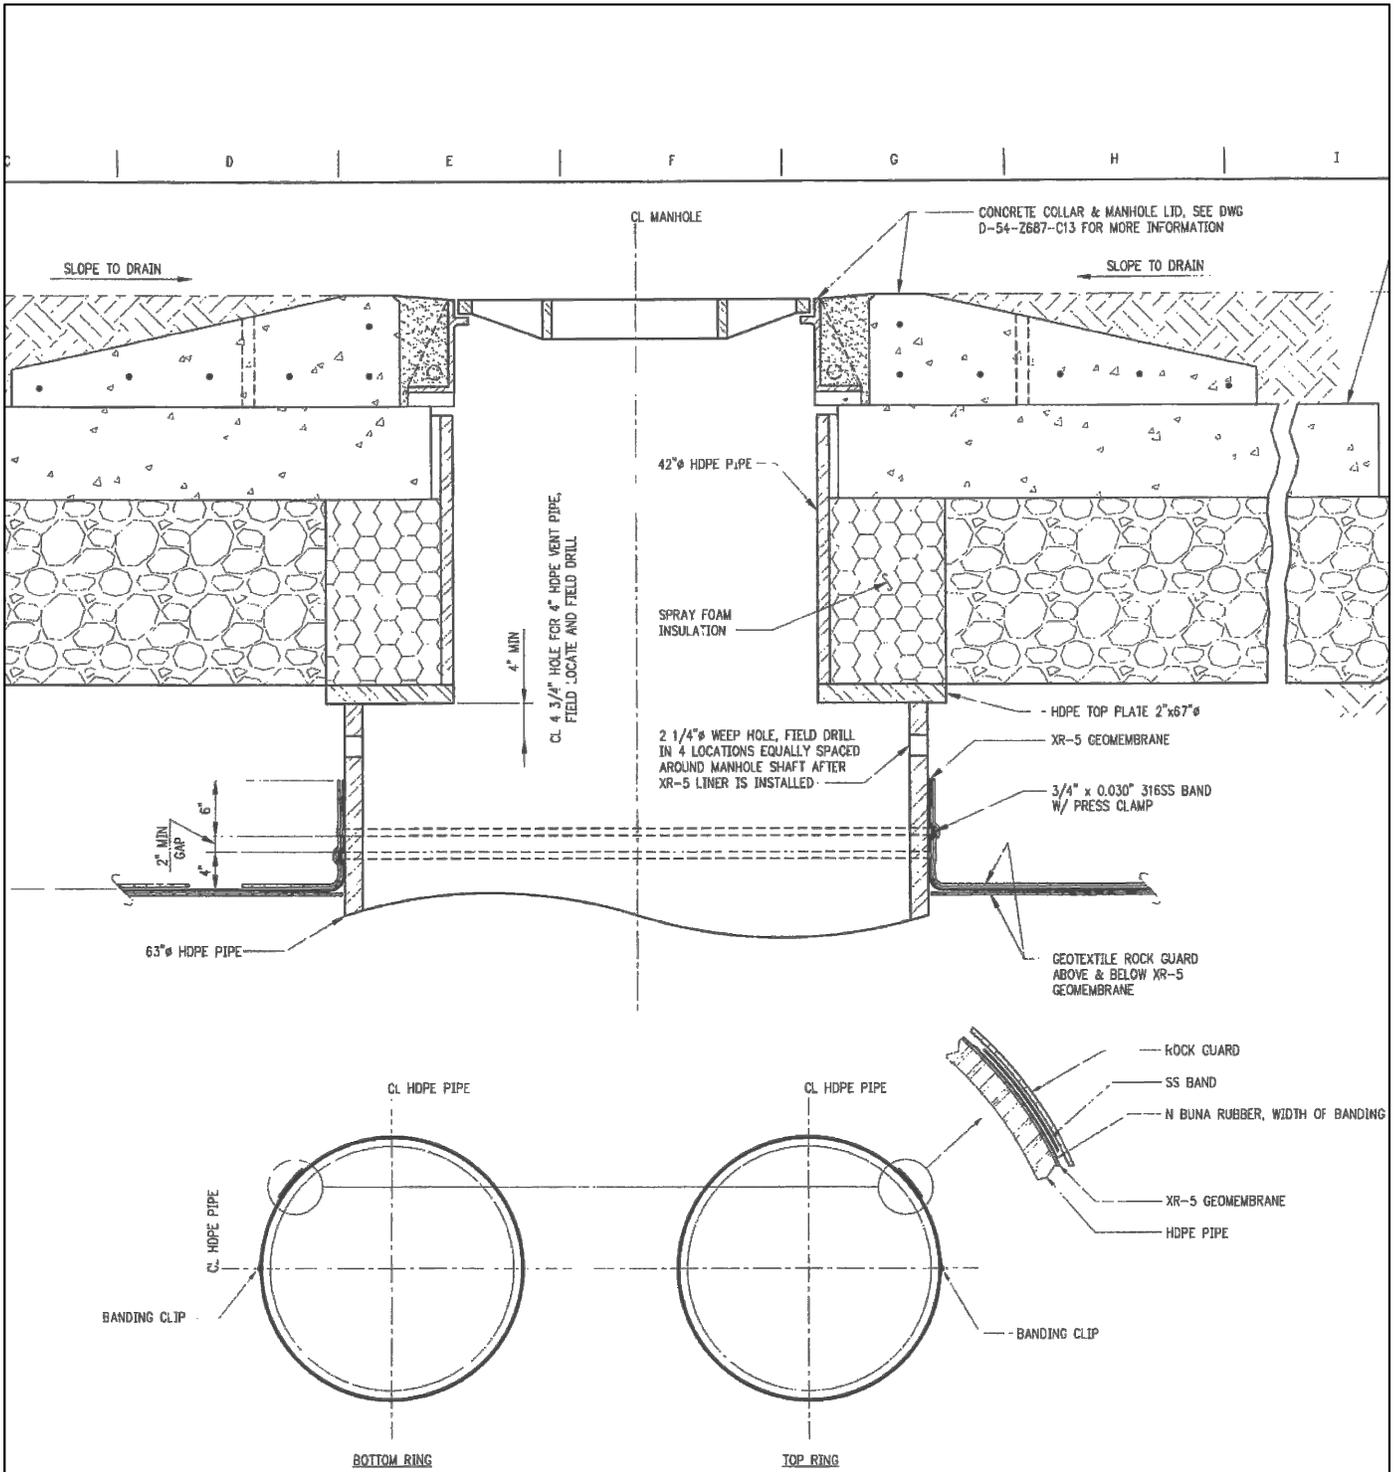
5

TYPICAL LINER TO SHAFT ATTACHMENT DETAIL  
NOT TO SCALE

IWWS CONNECTION DETAIL  
LINER INTEGRITY EVALUATION  
VALDEZ MARINE TERMINAL  
VALDEZ, ALASKA

SOURCE: ALYESKA PIPELINE SERVICE CO., 2014.  
"VALDEZ MARINE TERMINAL, VMT IWWS LIFECYCLE  
REPAIRS (2014), TYPICAL LINER TO SHAFT  
ATTACHMENT DETAIL," DRAWING D-54-Z687-C2, 14  
FEB 2014.

The IWWS includes four to five catch basins, two manholes, and two draw sumps (one for each tank) in each secondary containment cell. Originally, the IWWS was connected with cast iron bell and spigot piping leading out of each containment cell through the dikes into the facility's ballast water treatment system. The IWWS was upgraded over the last four years to replace the original concrete catch basins with high density polyethylene (HDPE) catch basins and line the cast iron piping with smaller diameter HDPE piping. An XR-5 geomembrane is attached to the catch basins, manholes, and draw sumps using stainless steel band clamps or batten bars and overlaps the surrounding CBA liner. The overlaps were sealed with Voclay® panels and hot roofing tar. Geosyntec's understanding of the connection details related to the IWWS and other liner repairs are presented in Figures 3 and 5, both from APSC-provided drawings. The liner repairs are detailed in the Golder reports [Golder, 2015, 2016, 2017, 2018].

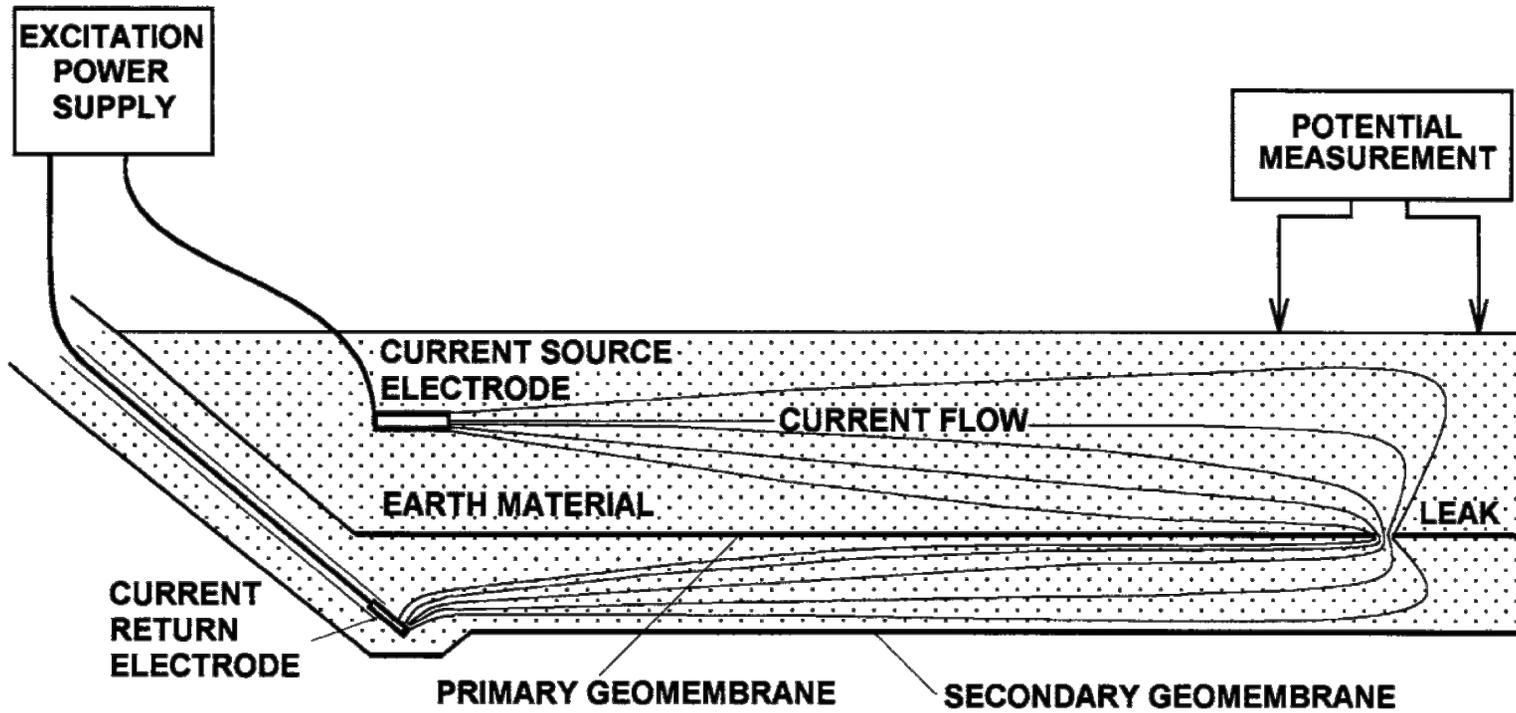
SOURCE: ASTM STANDARD D7007

ELECTRIC LEAK LOCATION SURVEY LINER INTEGRITY EVALUATION VALDEZ MARINE TERMINAL VALDEZ, ALASKA	
<b>Geosyntec</b> consultants	
PROJECT NO: WG2487	OCTOBER 2018
FIGURE 6

ELL relies on the concept that the liner material acts as an insulator and does not easily conduct electricity and the materials above and below the liner (generally soil) act as a good conductor of electricity. To perform an ELL survey, a high voltage is applied to the cover material using a power source that is grounded to the subgrade below the liner. An ELL surveyor can then walk in a grid pattern over the cover material with a dipole instrument to measure voltage. Recorded voltage anomalies indicate areas where the cover material is in direct contact with the subgrade completing the electrical “circuit”

and indicating a defect in the liner. Figure 6 presents a schematic of ELL from ASTM D7007.
