## APPENDIX A – Figures and Photo Documentation

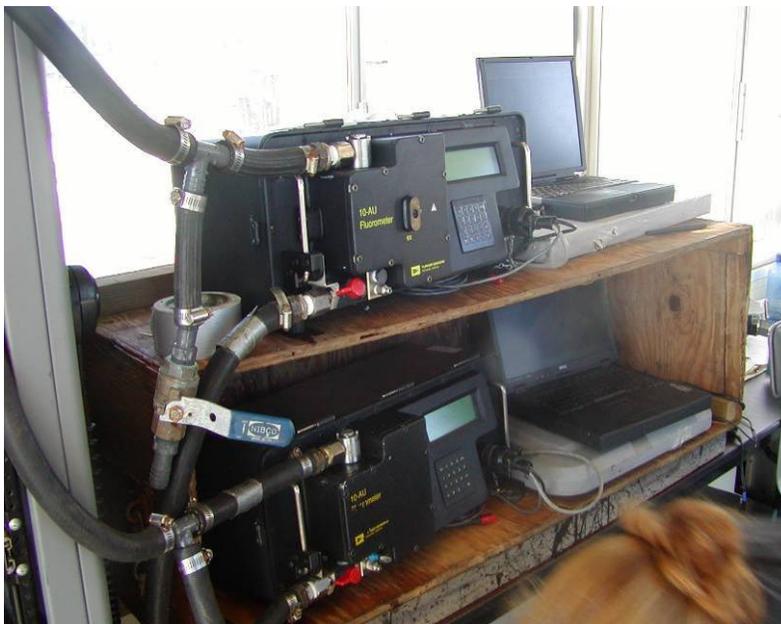
Figure 1 Parallel Turner 10 AU fluorometers (with intakes at 1 and 2-m) used for OHMSETT heavy fuel oil studies.

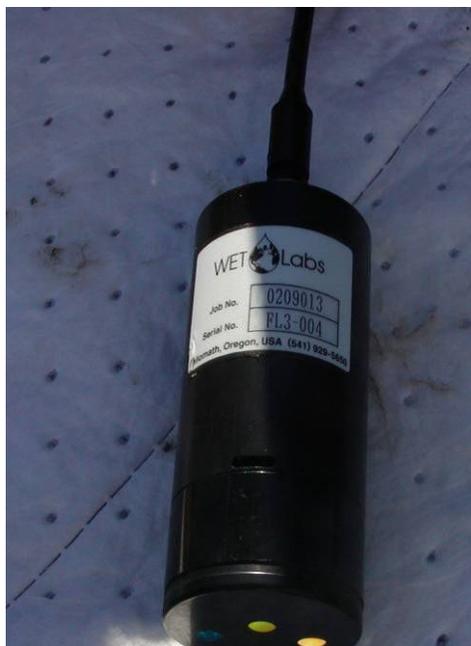
Figure 2 WET Labs in situ fluorometer

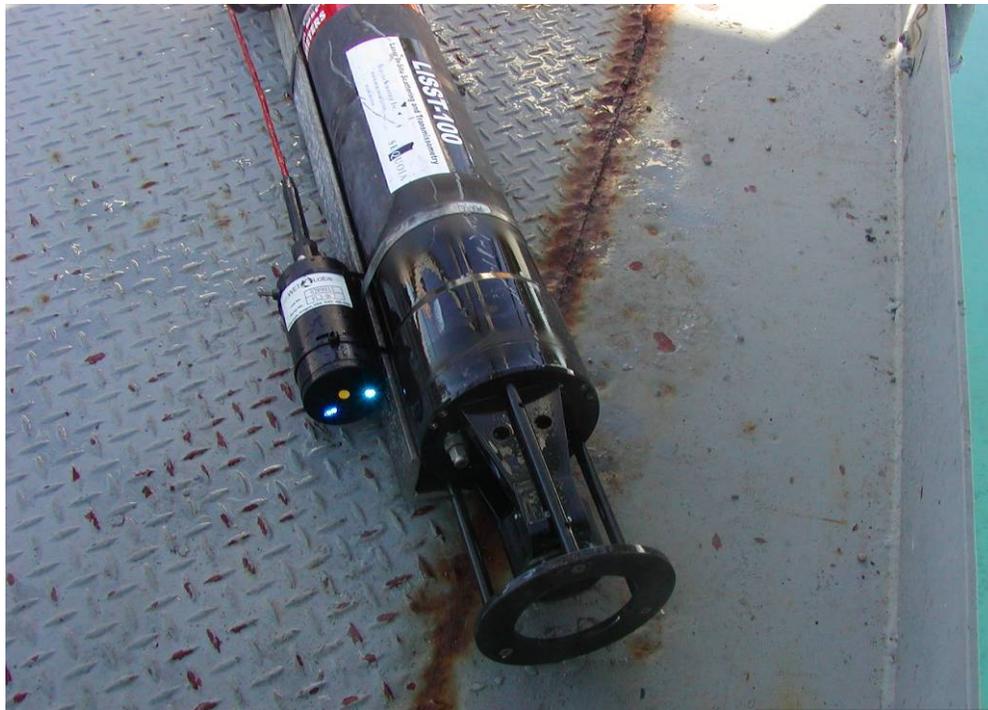
**Figure 4** LISST – 100 Particle Size Analyzer with WET Labs Fluorometer attached.

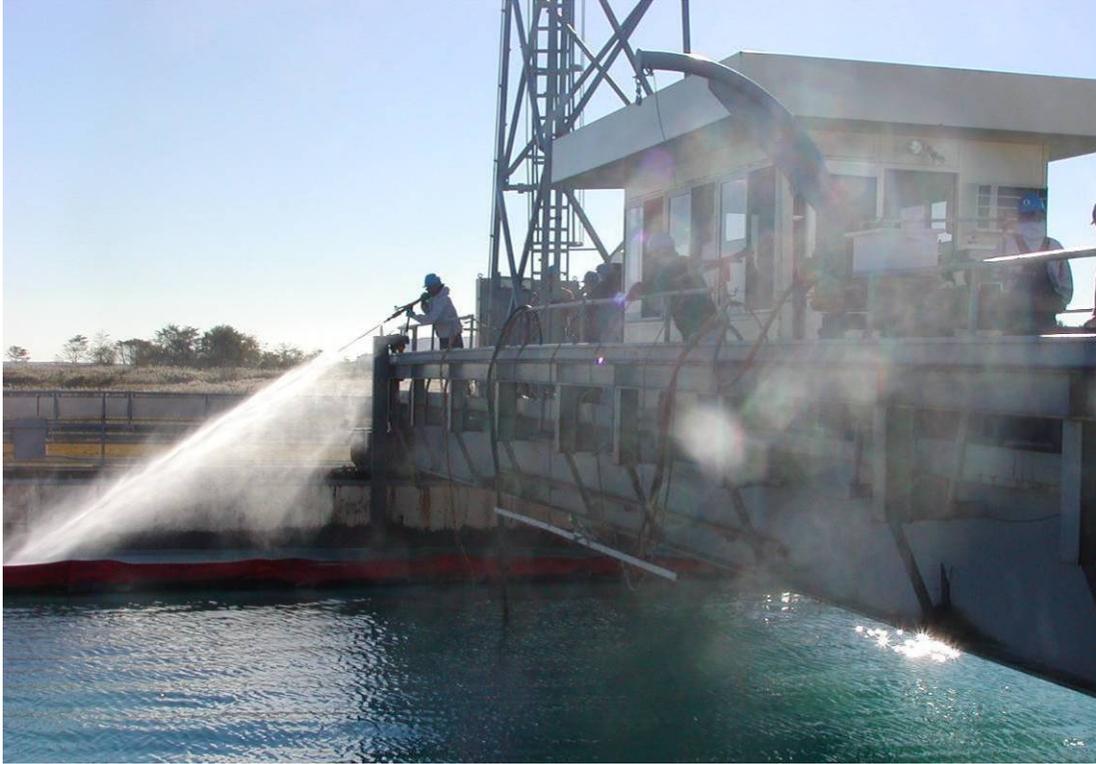
**Figure 9** Removal/herding remaining surface oil (outside of the test area) before testing – October 13, 2003.

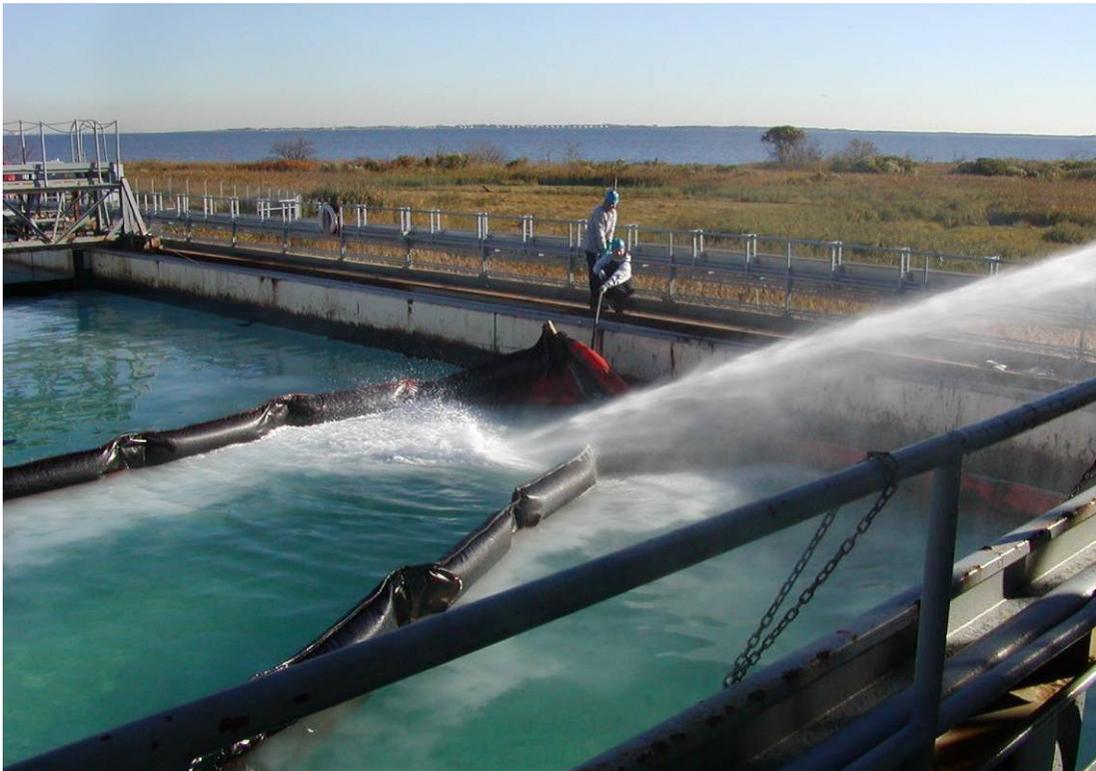
**Figure 10** Removal of remaining surface oil from inside secondary containment boom before test initiation on October 13, 2003.

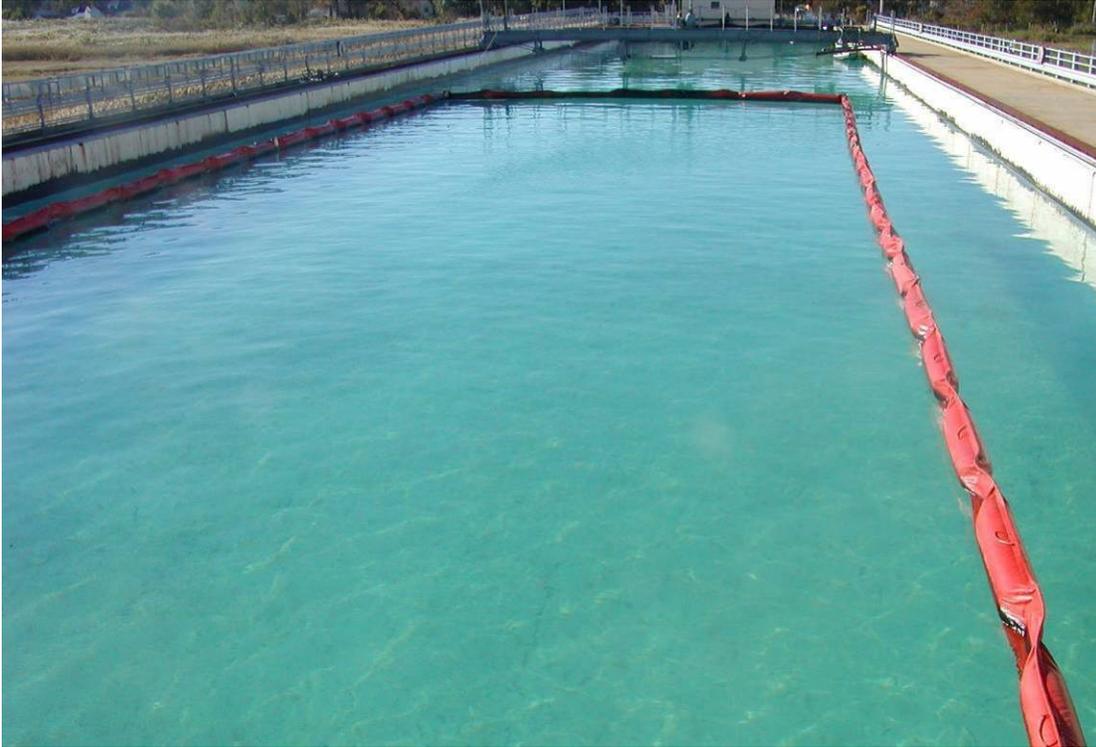
**Figure 11** Cleaned tank before initiation of dispersant trials, October 13, 2003.

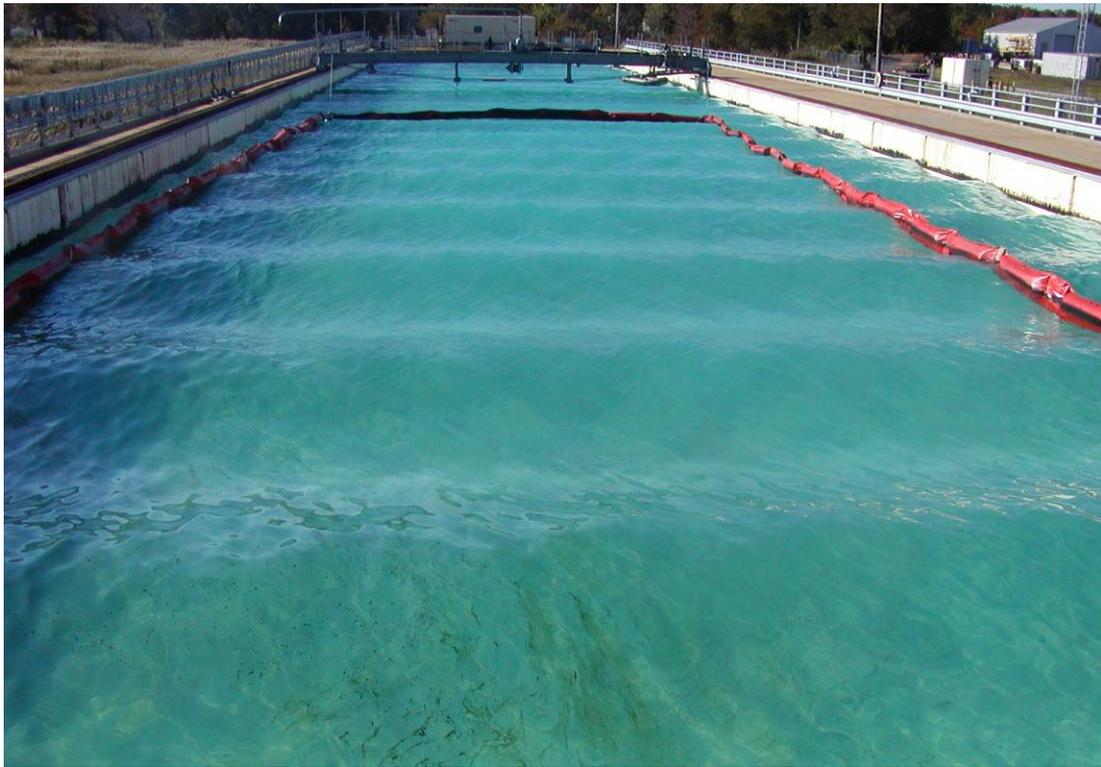
**Figure 14** Wave train before initiation of control test (No. 10) IFO 180 fuel oil, no dispersant, and wave generator set at 33 cycles per minute (cpm). Note trace of oil that was washed off/dripped from oil application manifold before test was started. Photographed looking south toward wave generator.

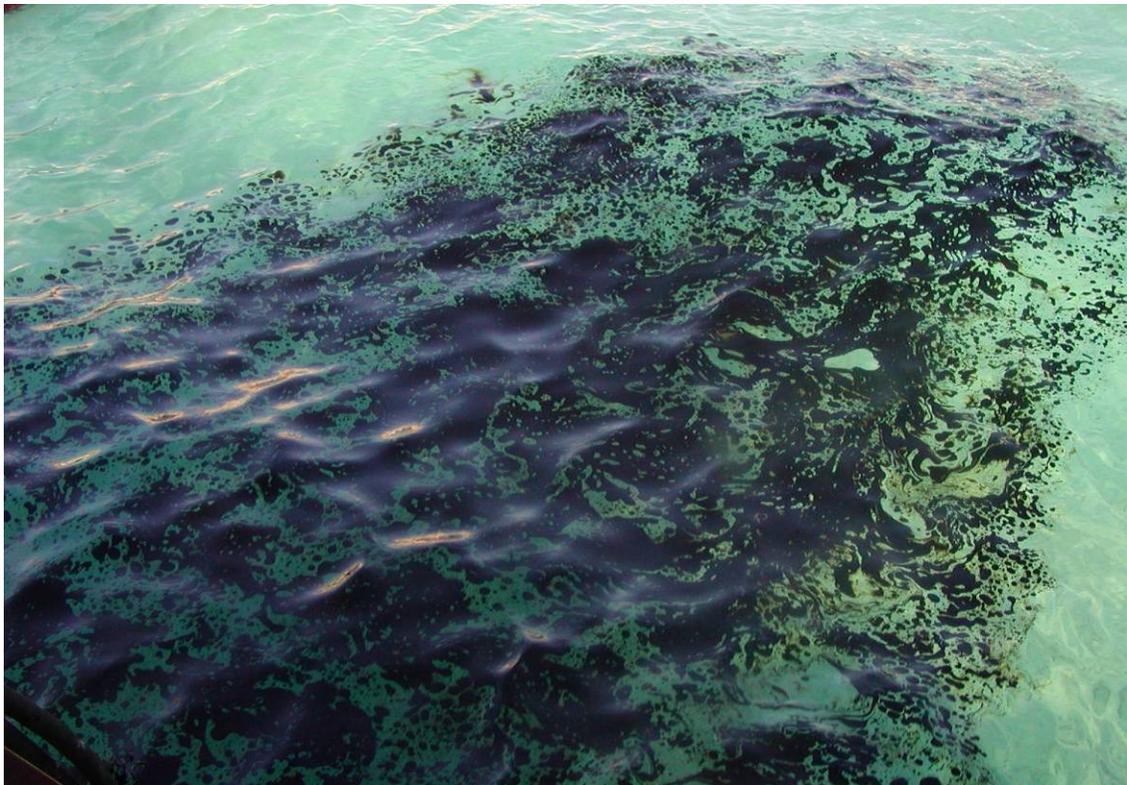
**Figure 16** Untreated IFO 180 control slick (~15-20 seconds after application to the water surface).

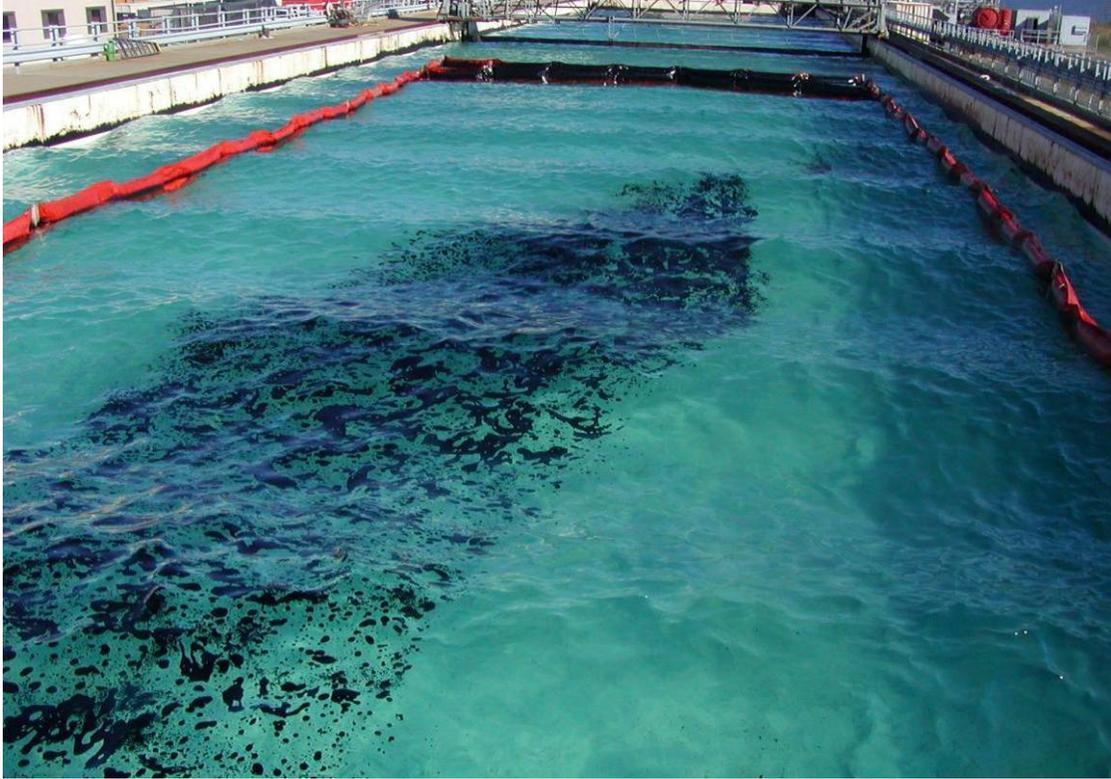
**Figure 17** IFO 180 control slick ~50-60 seconds after introduction to tank (looking north)

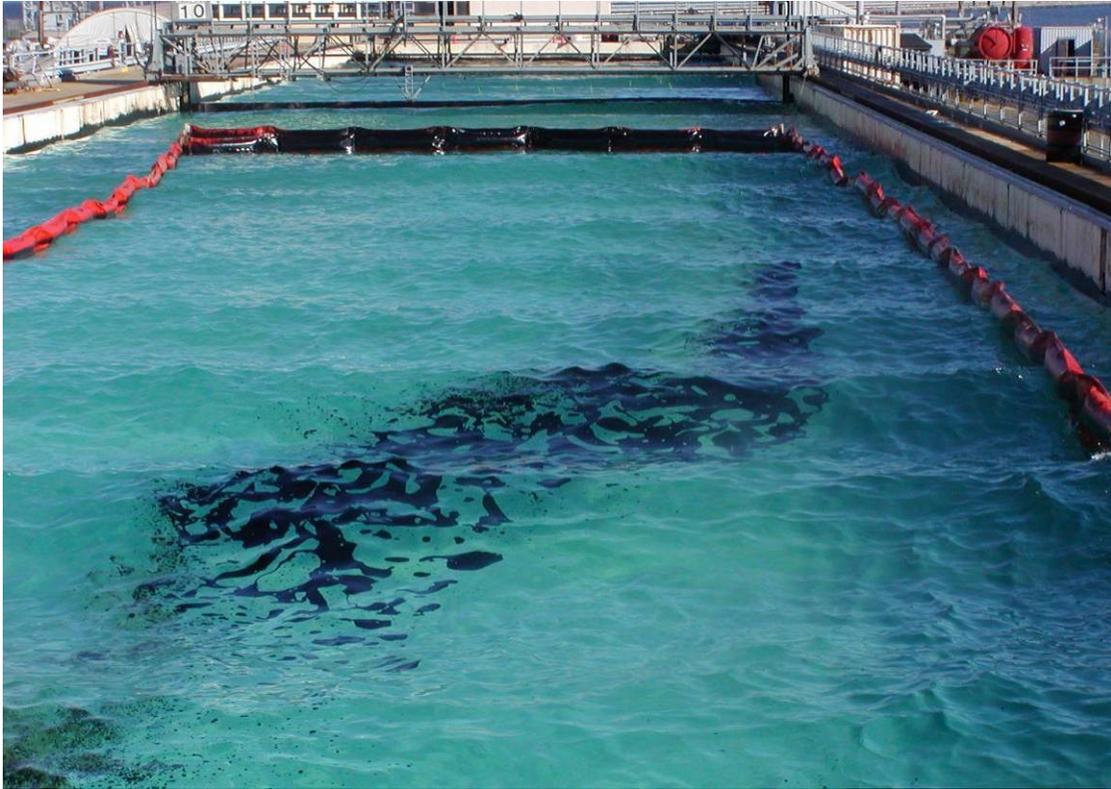
**Figure 18** LISST particle size analyzer and WET Labs fluorometer suspended from movable bridge (2 m depth) during control Test No. 10. Note surface oil but no oil cloud below surface.

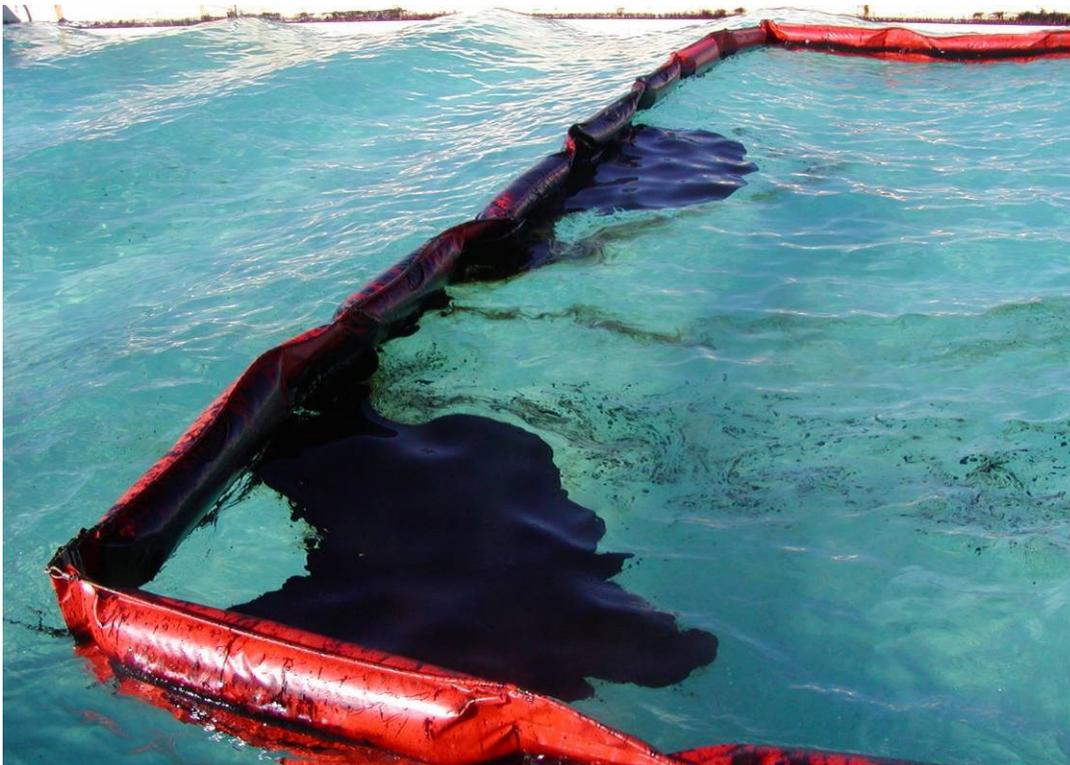
**Figure 21** Captured oil at south end of test enclosure boom at termination of IFO 180 control Test No. 10.

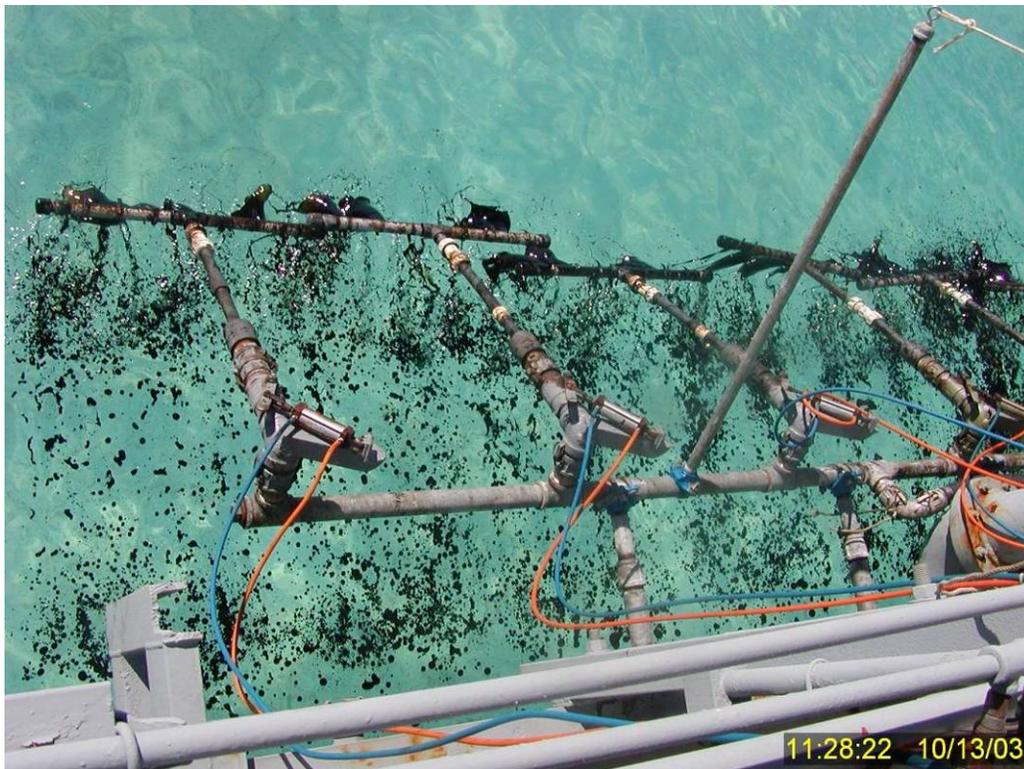
Figure 24 IFO 180 fuel oil addition to tank for Test No. 11 at 11:28:22 hrs, October 13, 2003.

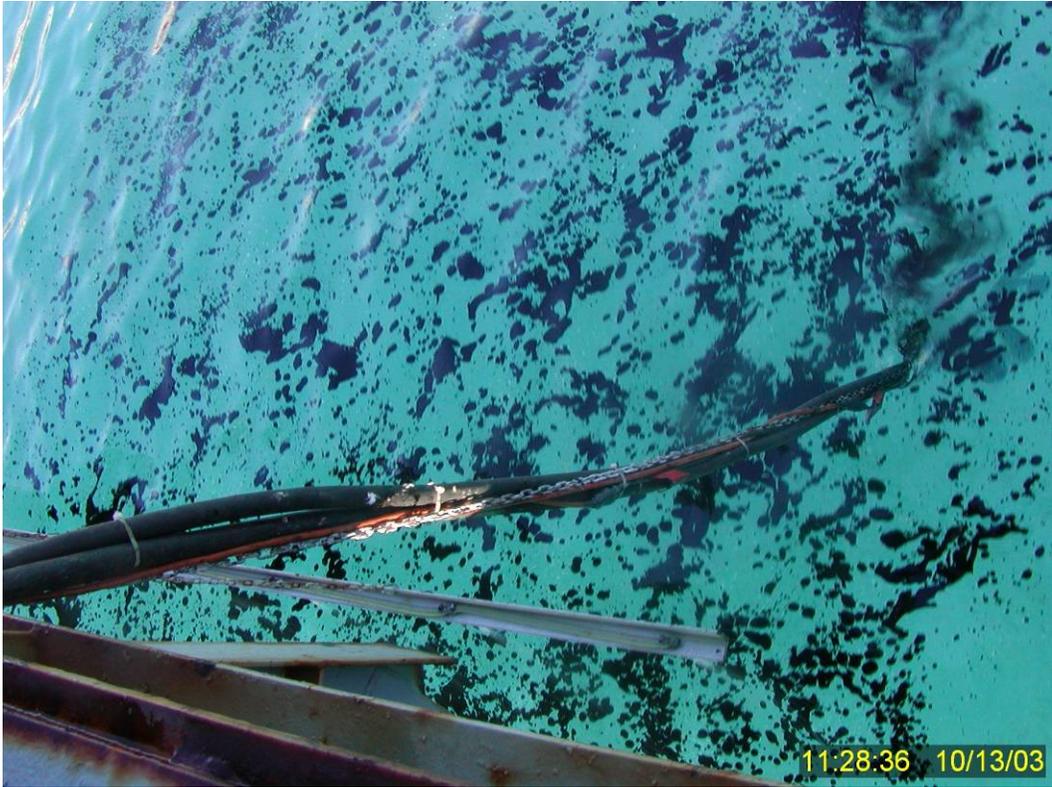
Figure 25 Test No. 11: Dispersant spray boom and in situ fluorometer cable 14 seconds into test.

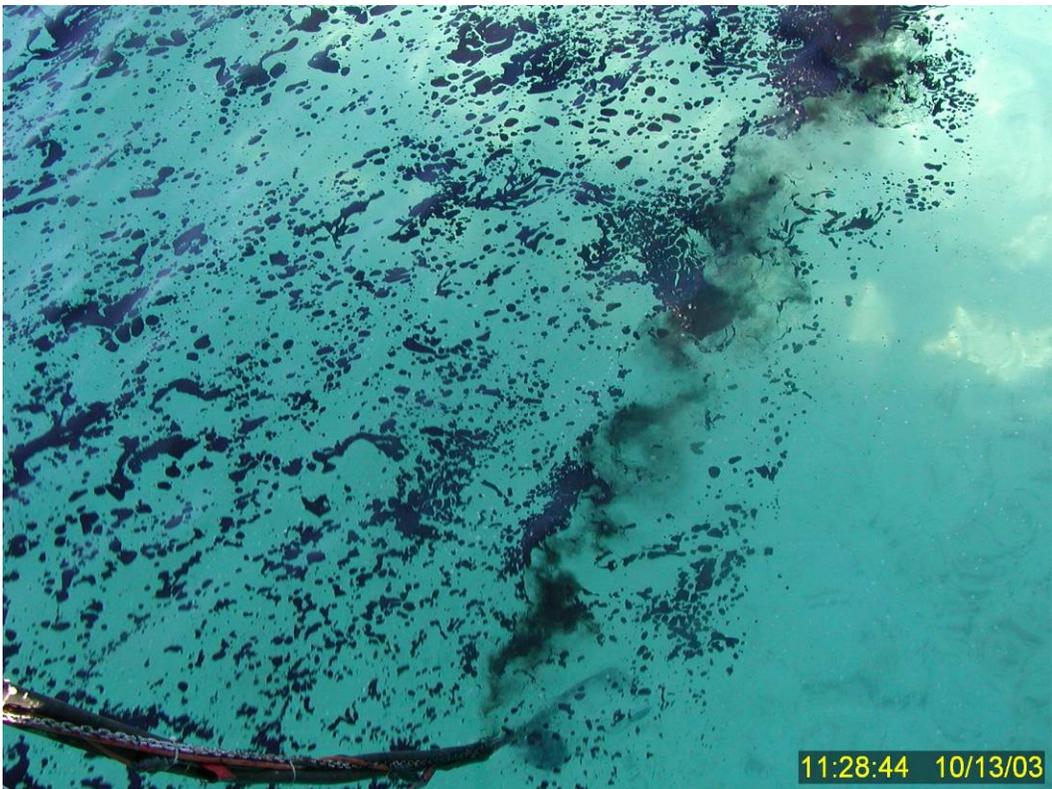
Figure 26 Test No. 11: Minor (and anomalous) dispersion/entrainment of IFO 180 fuel oil due to turbulence introduced by dragging fluorometer cable through dispersant-treated surface oil.

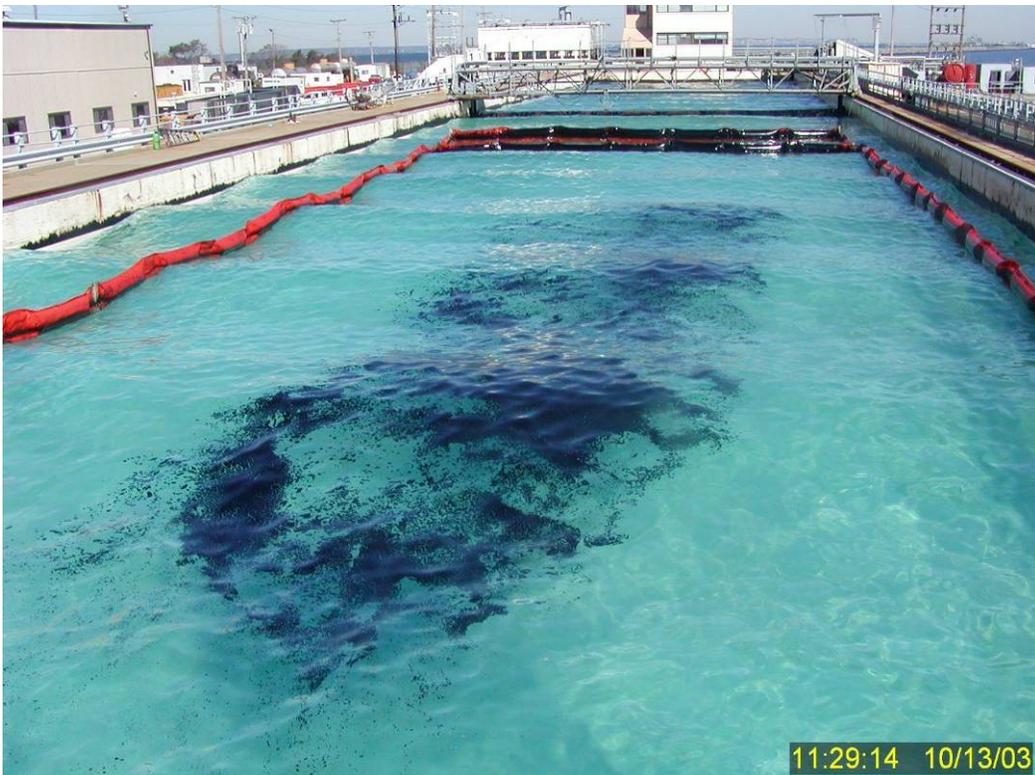
**Figure 27** Test 11: Dispersant-treated IFO 180 ~ 40 seconds into experiment. Note lack of any significant oil entrainment into the water column.

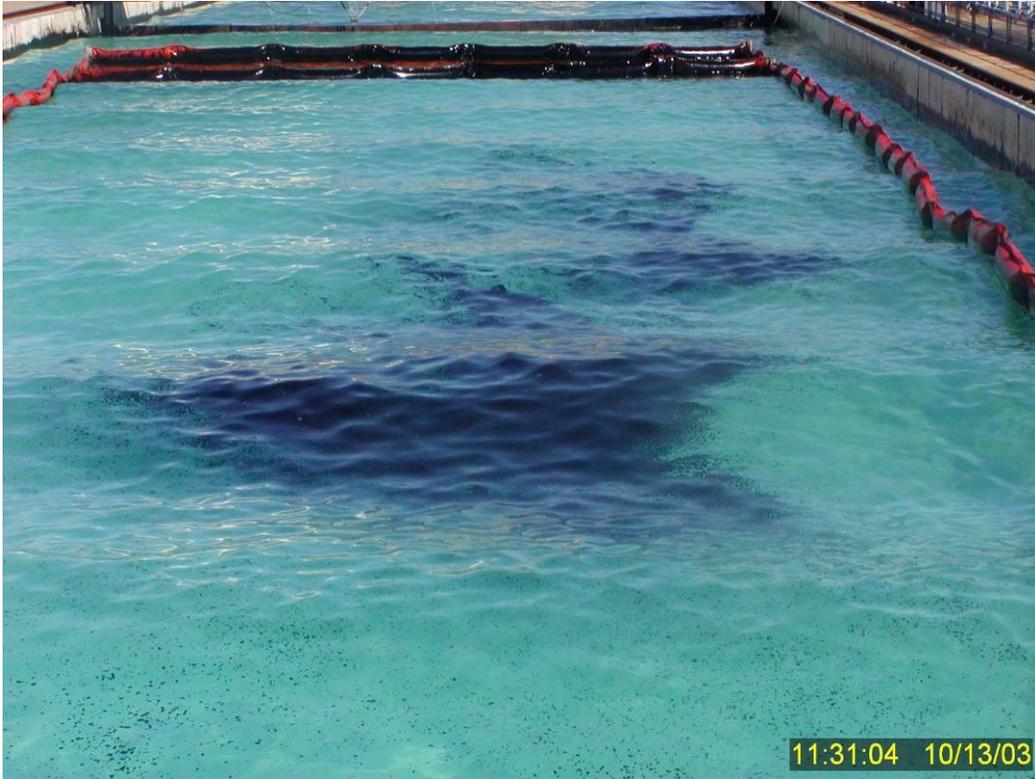
**Figure 28** Test 11: Dispersant-treated IFO 180 ~50 seconds into experiment. Still no significant oil entrainment with this dispersant under these test conditions.

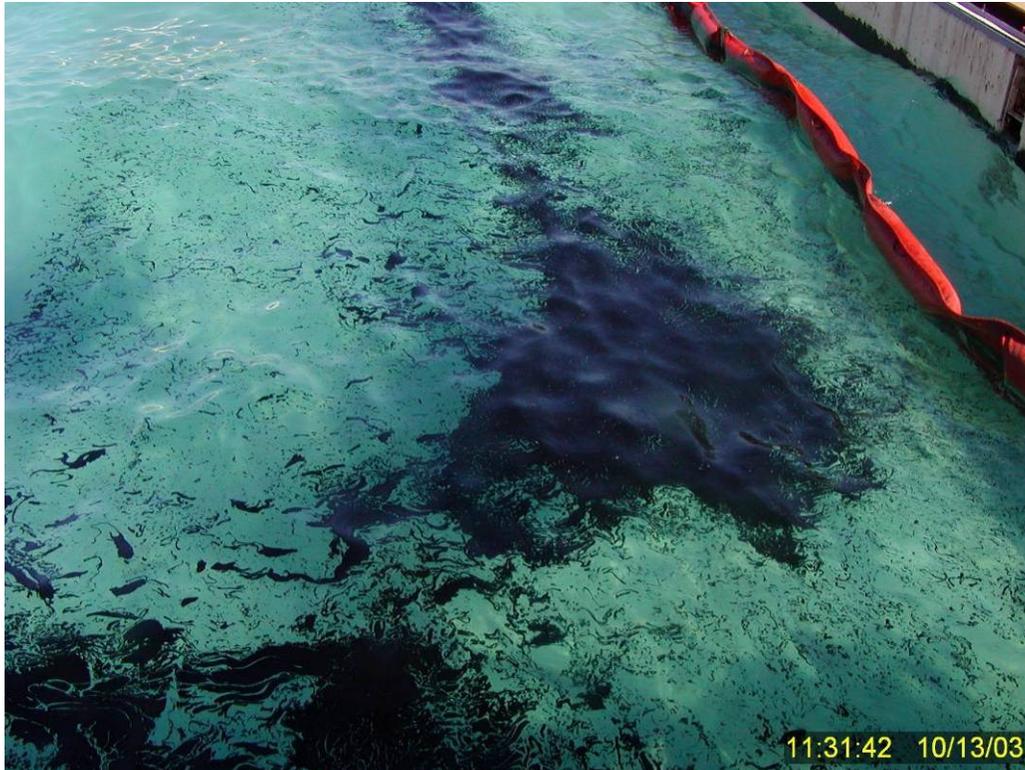
**Figure 31** Test No. 11: Drift of non-dispersing IFO 180 ~ 3.25 minutes after treatment.

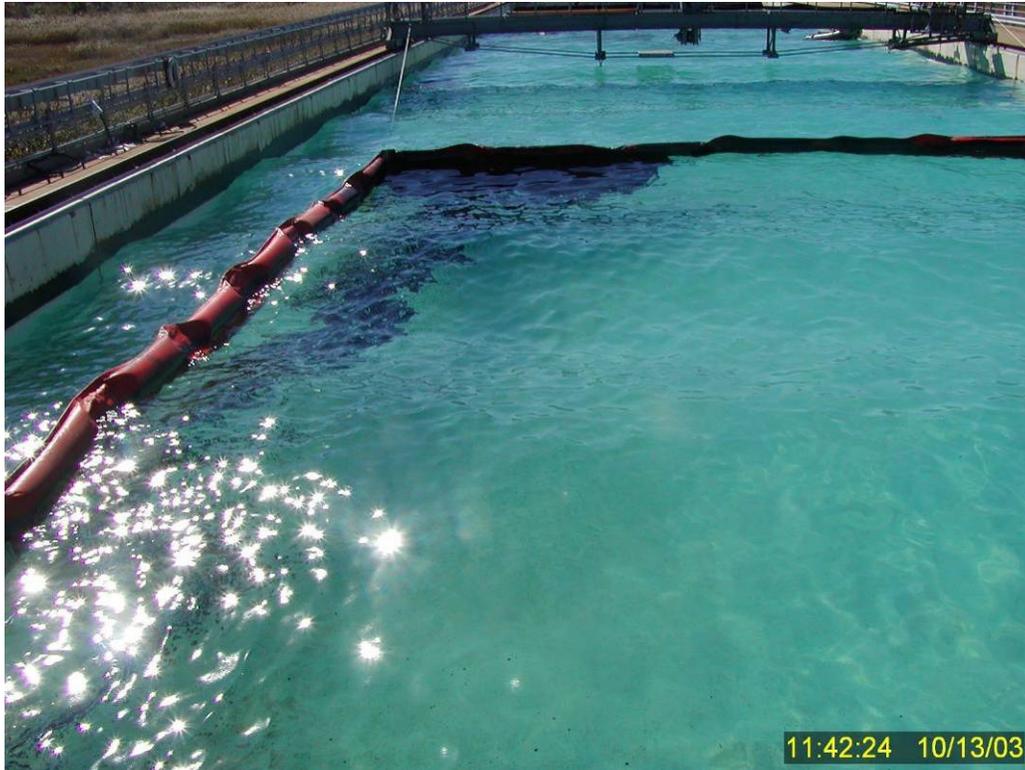
**Figure 32** Test No. 11: Close-up photo of surface slick from Figure 31. Note the lack of any oil entrainment into the water column with this poorer performing dispersant under these test conditions.

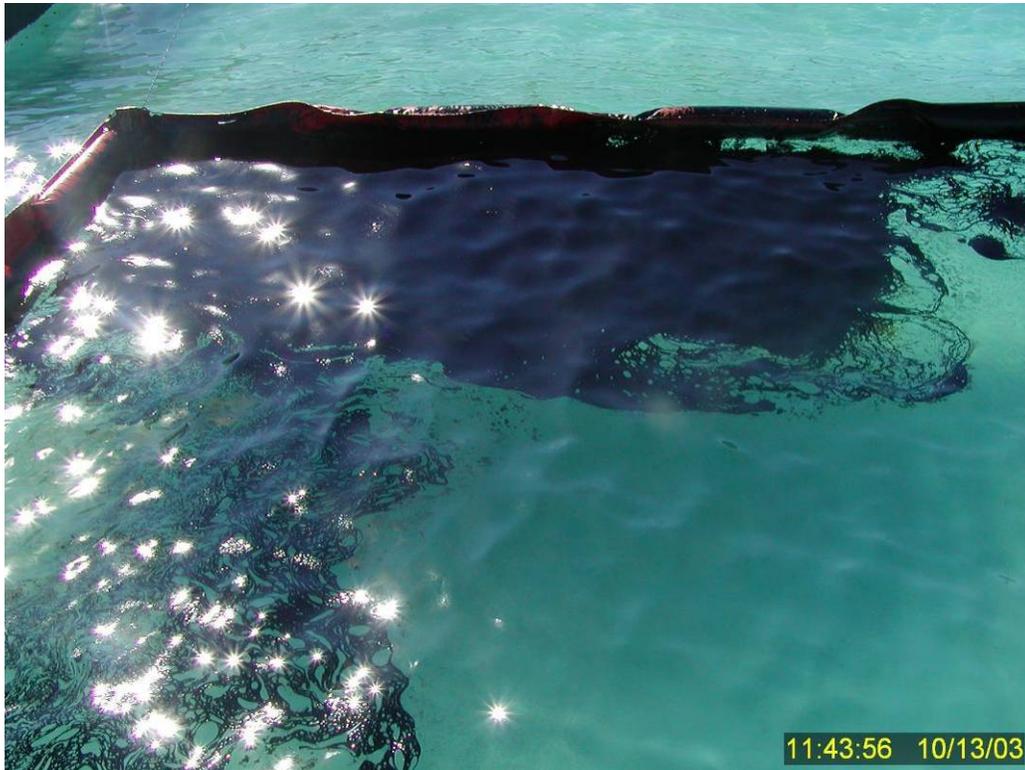
Figure 34 Test No. 11: Close up of non-dispersed surface oil in south-east corner of test boom ~ 22 minutes after initiation of the test. Note the lack of any oil outside the boom.

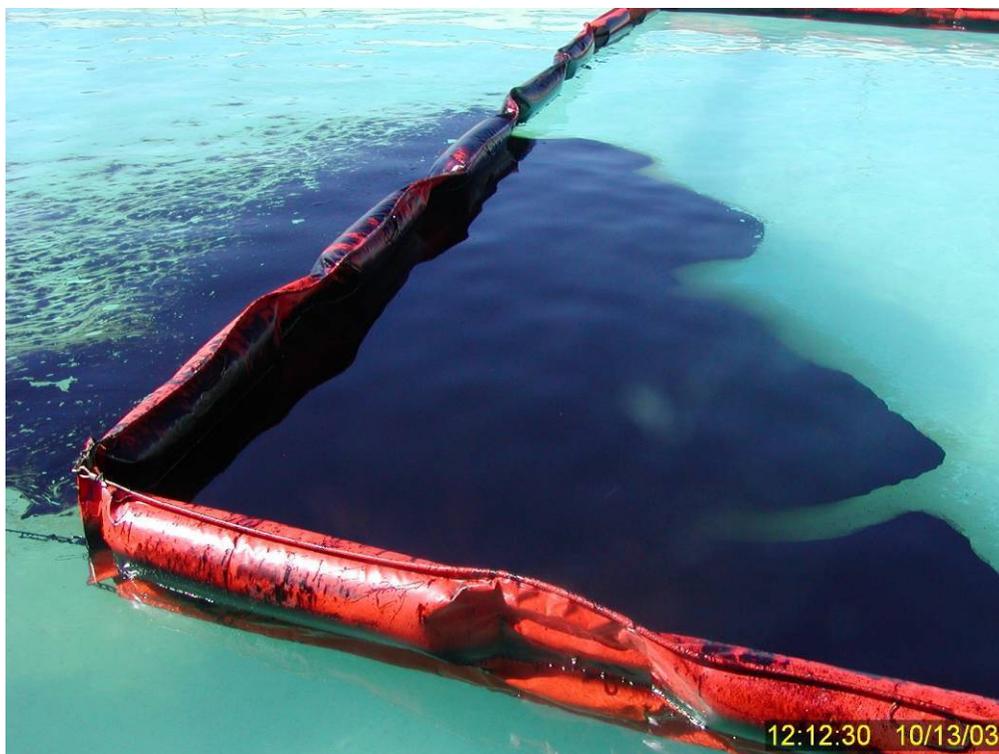
**Figure 35** Test 11: Non-dispersed IFO 180 fuel oil within containment boom ~30 minutes after the conclusion of the test. By this time some residual IFO 380 oil from earlier tests had drifted against the outside of the containment boom used for the test.

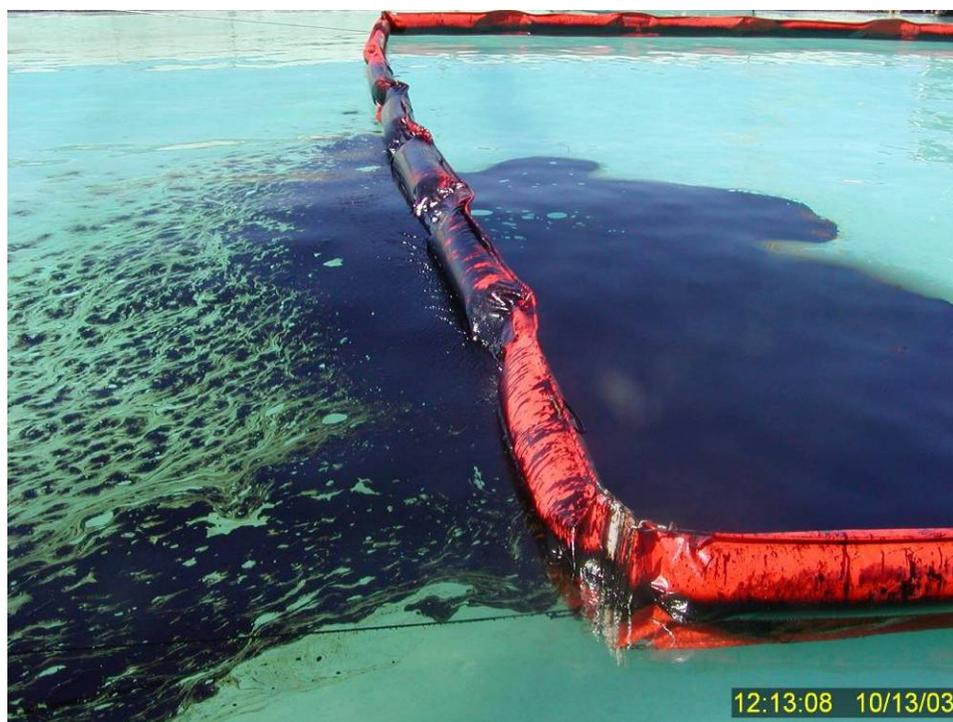
**Figure 36** Test 11: Close-up of southeast corner of containment boom showing the different appearance of the residual IFO 380 from earlier tests with the non-dispersed IFO 180 from Test 11 before recovery.

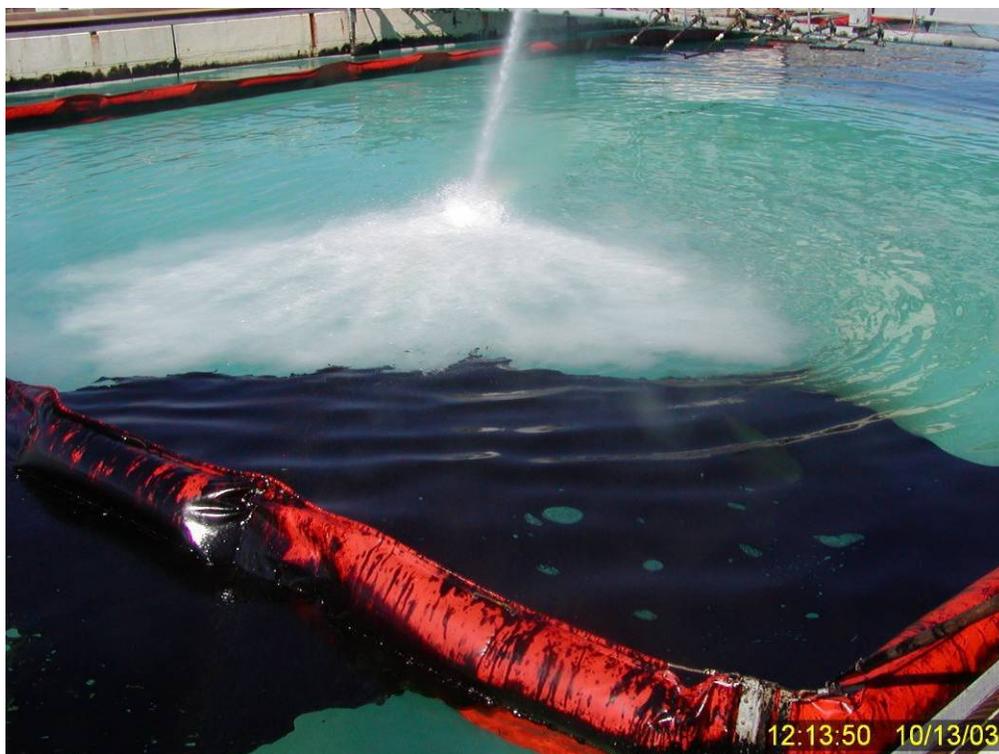
**Figure 37** Test No. 11: Use of fire monitor spray to herd surface oil into corner of boom to facilitate recovery by vacuum. Note the spray is directed to water surface 10-15 feet from oil to avoid accidental entrainment.

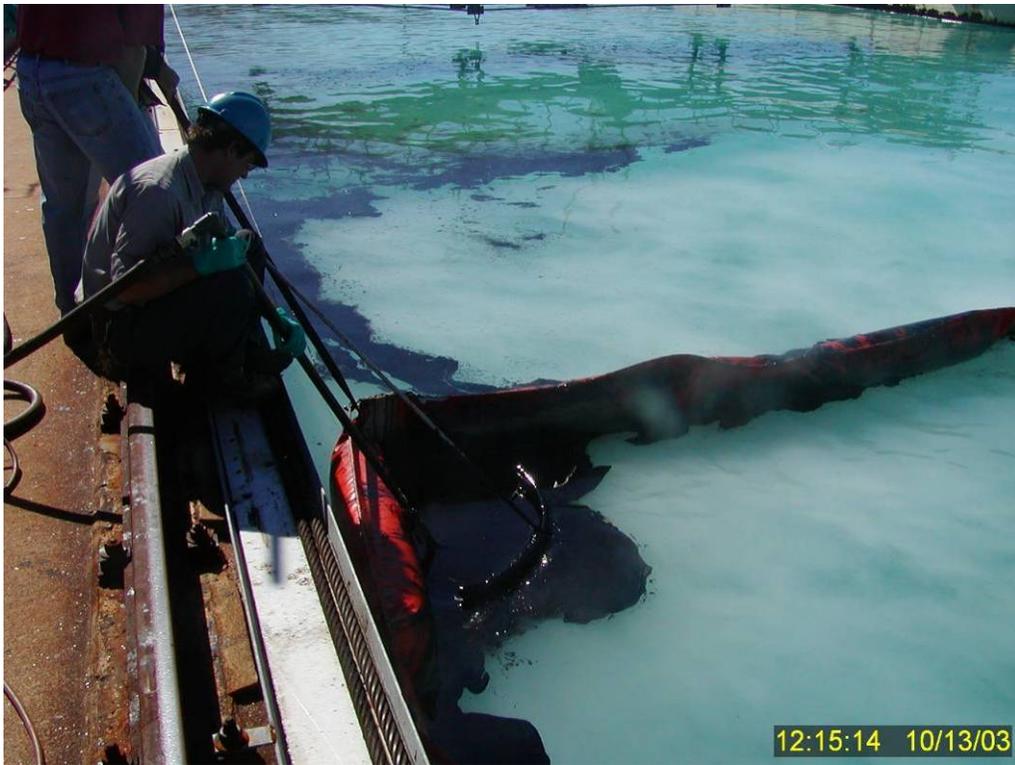
**Figure 39** Test No. 11: Squeegee and vacuum hose recovery of surface oil at termination of test.

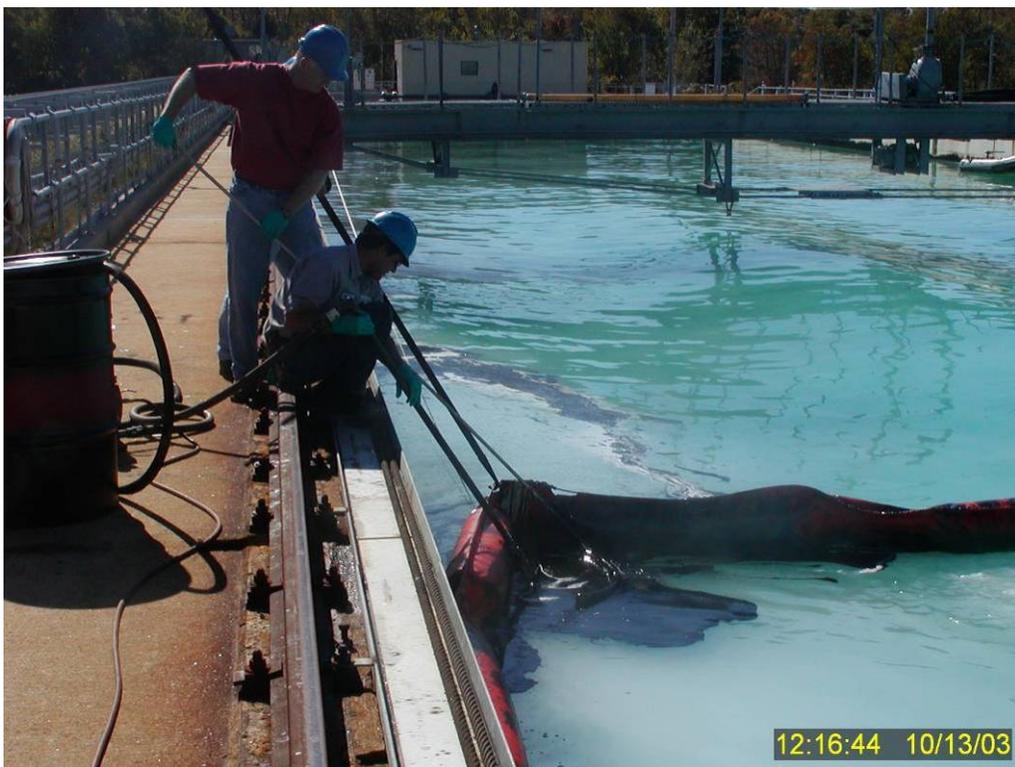
**Figure 40** Test No. 11: Vacuum recovery of non-dispersed surface oil at conclusion of test. A separate oil drum (on left) is used to contain the oil from each test to allow later quantification of recovered oil after allowing for oil/water separation. Collected oil is analyzed for water content by the lab at OHMSETT.

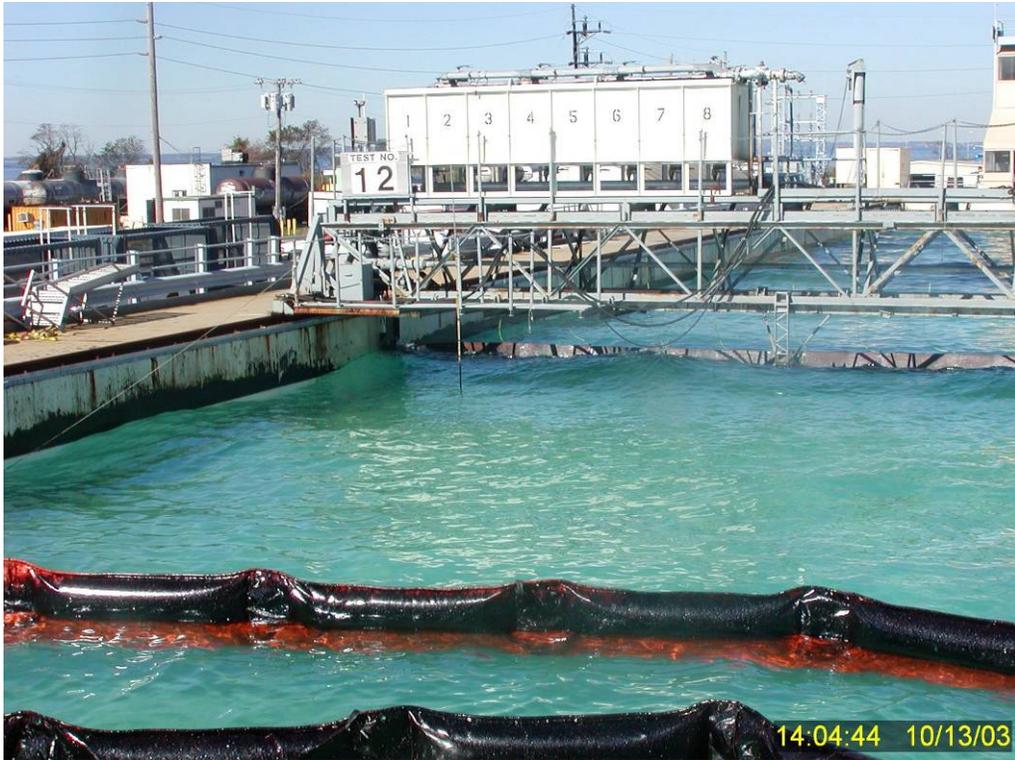
Figure 41 Initiation of Test No. 12: IFO 180 fuel oil treated with Agma at measured DOR of 1:148 and higher-energy waves at 33.3 cpm.

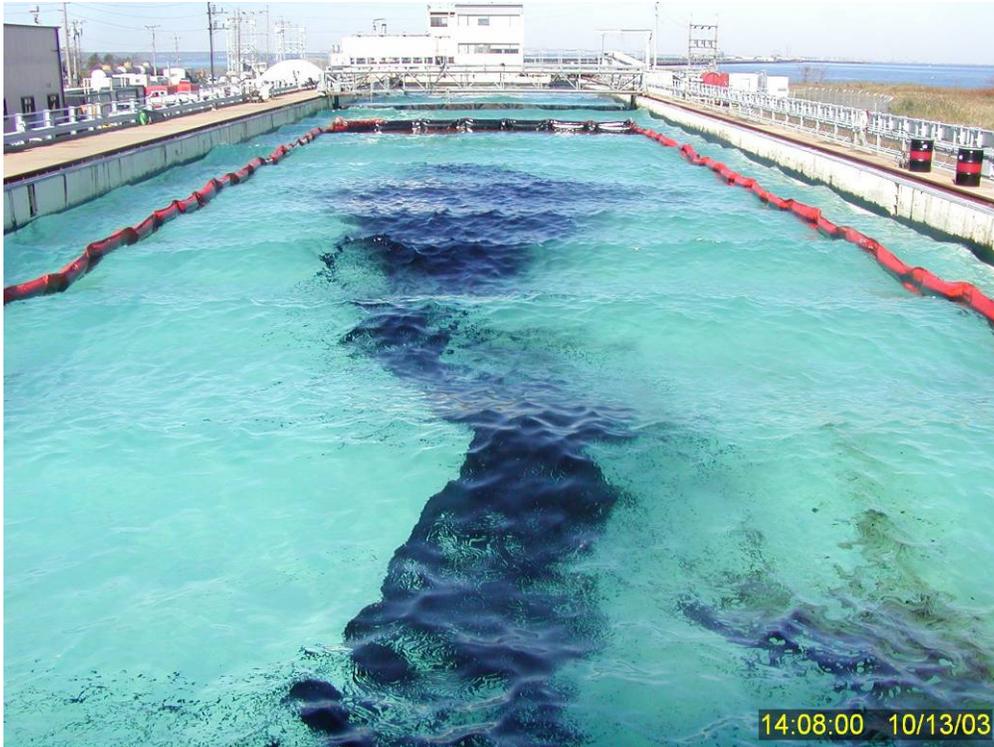
**Figure 43** Test No. 12: IFO 180 four minutes after treatment with Agma dispersant. Note water clarity and lack of significant dispersion/entrainment into the water column.

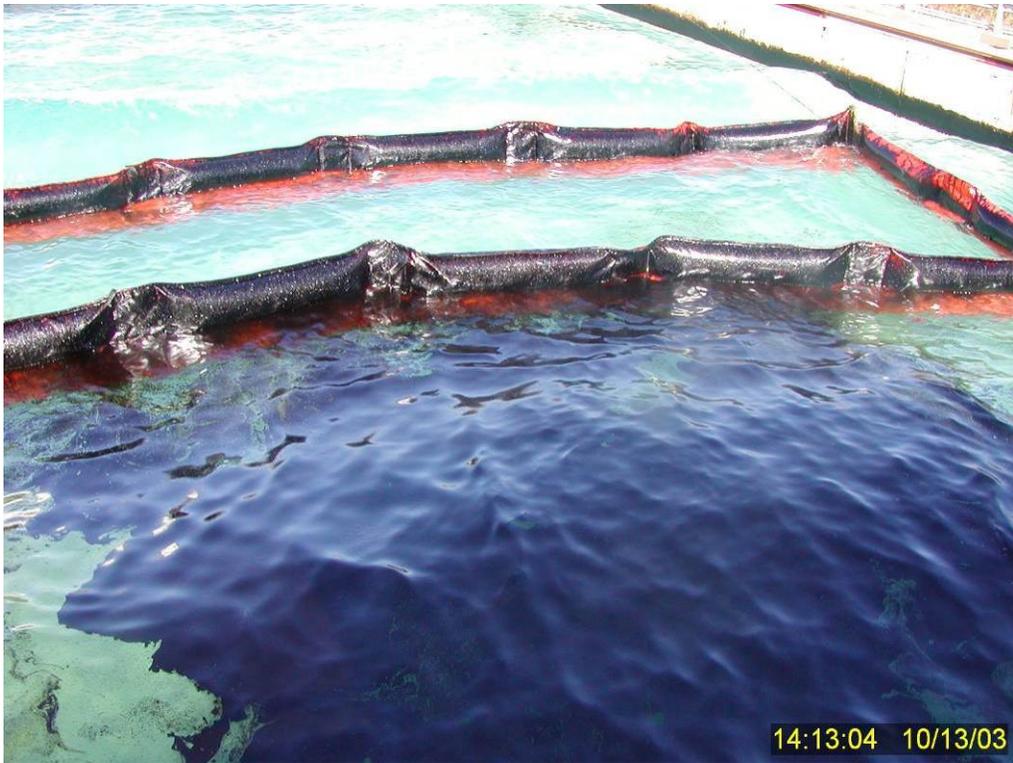
**Figure 45** Surface (non-dispersed) oil contained within experimental zone (note the clean water within the secondary containment boom) nine minutes after initiation of Test No. 12.

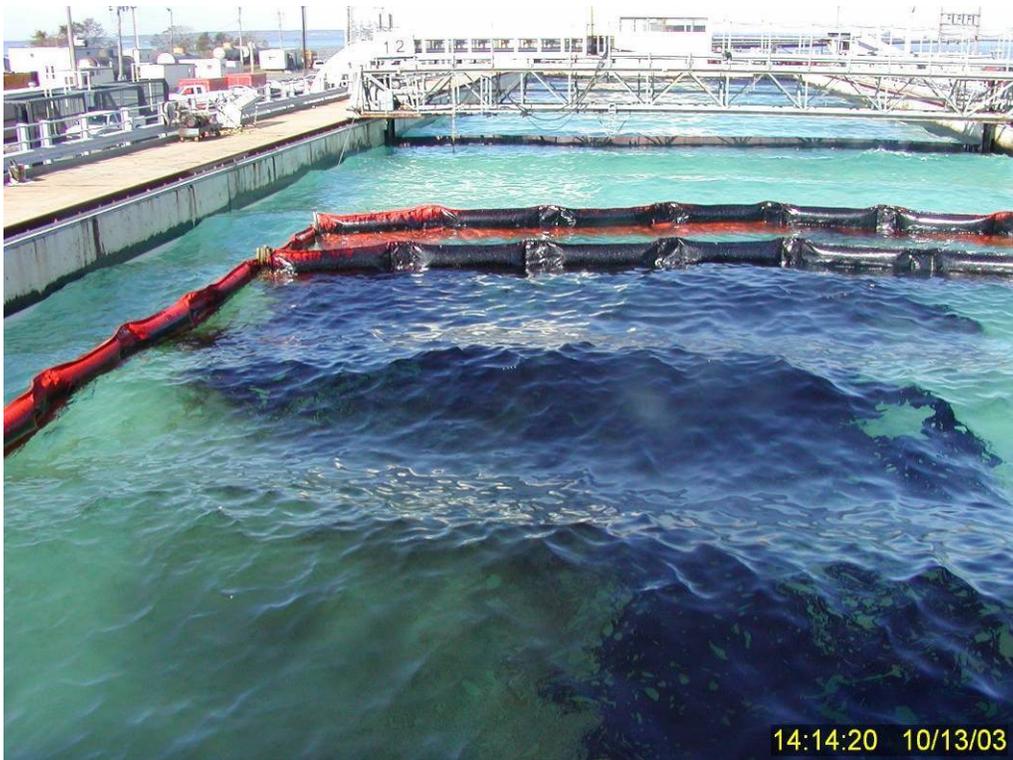
**Figure 46** Mixture of surface and some subsurface (dispersed) oil ten minutes into Test No. 12. This dispersant was only marginally successful under these conditions, but with time there was more evidence of oil entrainment into the water column.
