## APPENDIX A – Figures and Photo Documentation

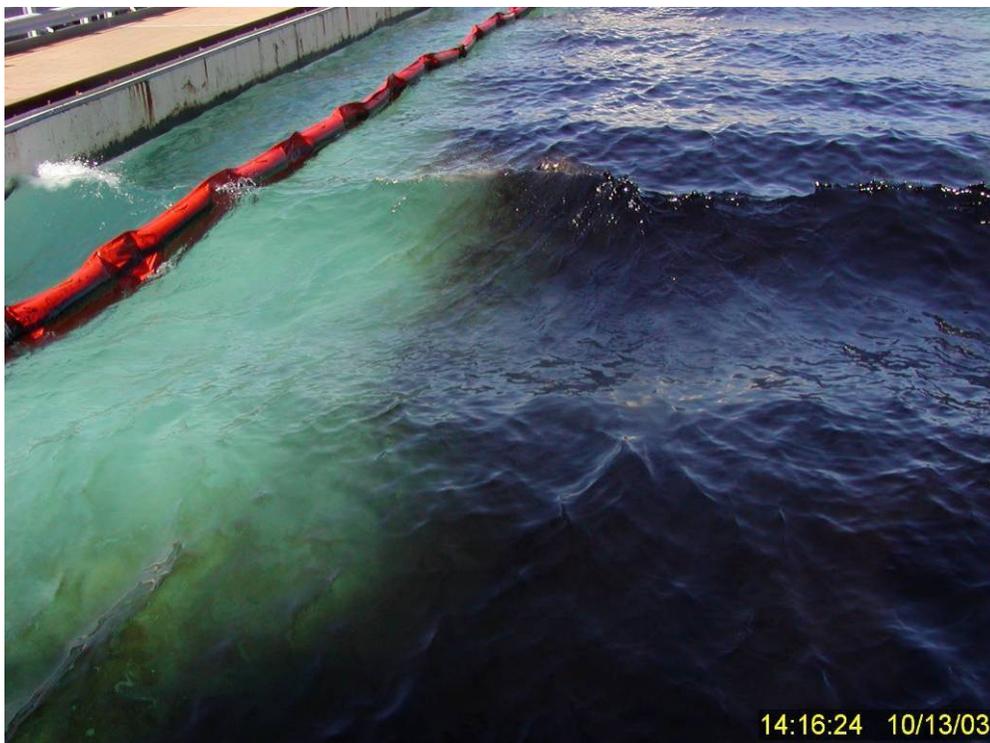
**Figure 48** Lateral spread of subsurface (dispersed) oil twelve minutes after dispersant treatment. Note 2-4 inch breaking wave in upper third of photograph and rough texture of water surface showing lack of coherent oil slick.

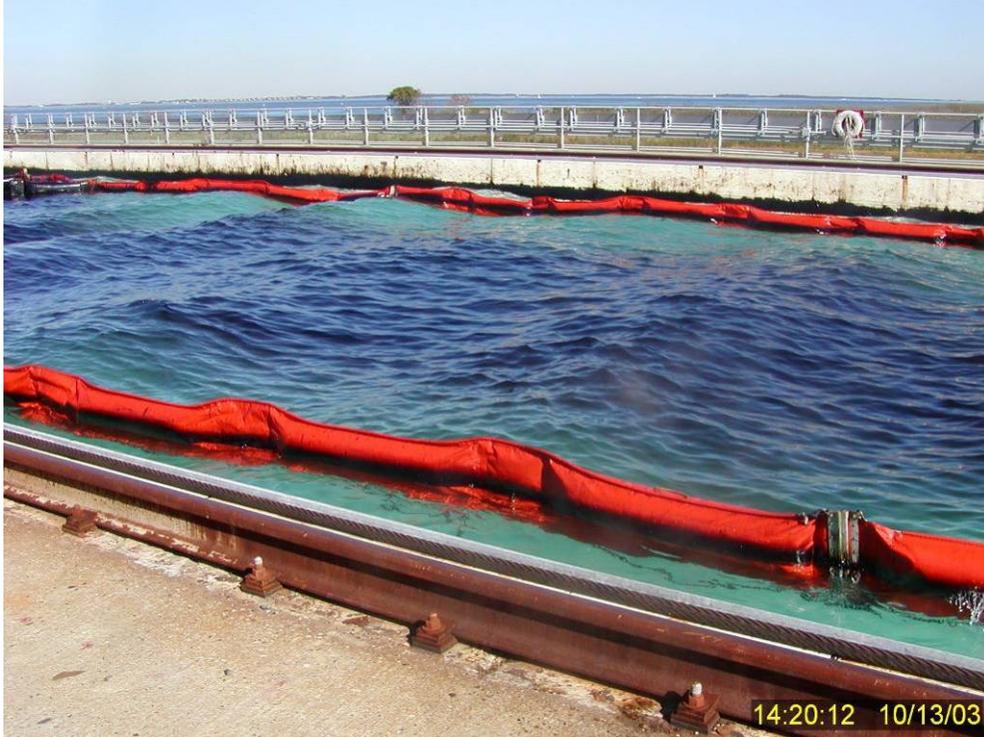
**Figure 49** Poorly dispersed subsurface oil and surface oil residues viewed from the side of the wave tank 16 minutes after initiation of Test Number 12.

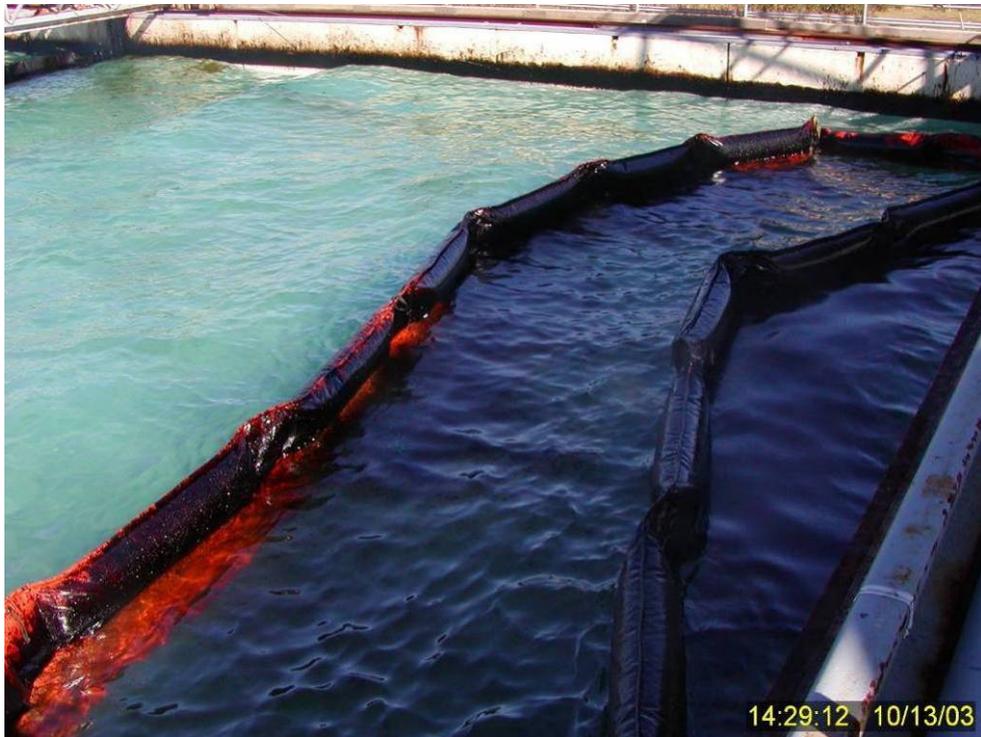
**Figure 52** Overhead photograph of smooth nondispersed surface oil within primary containment boom (on right) and subsurface dispersed oil visible within secondary containment boom. Note there is also some non-dispersed surface oil along the upper edge of the secondary boom but not outside of it.

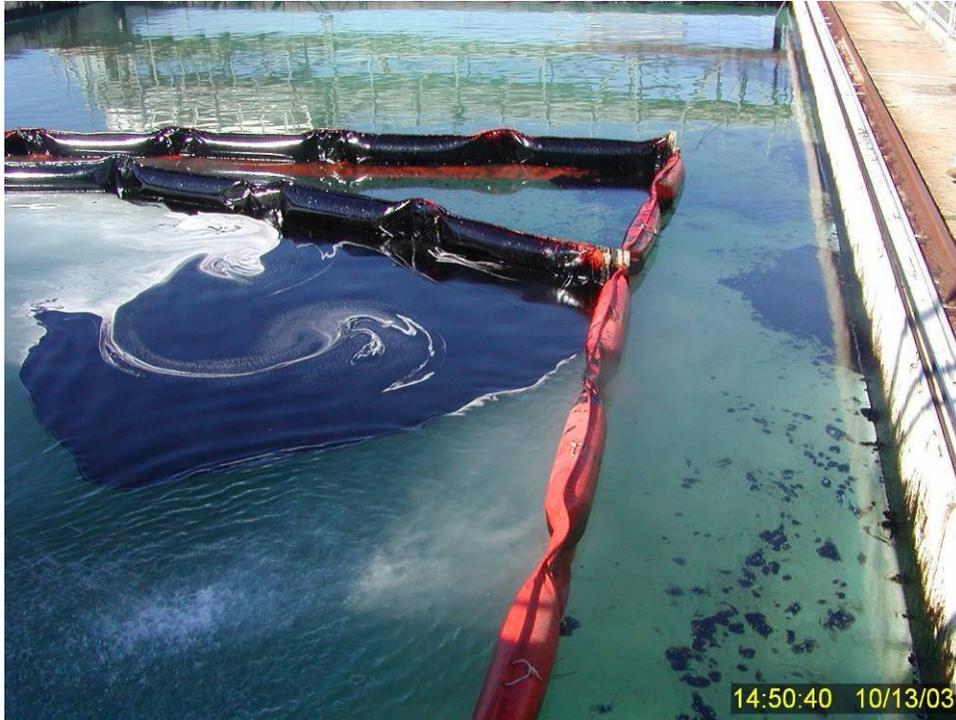
**Figure 55** Non-dispersed surface oil being herded into the north-east corner of the primary containment boom for collection. Note the surface oil between the containment boom and tank wall that apparently escaped during the test or resurfaced very soon after it was terminated.

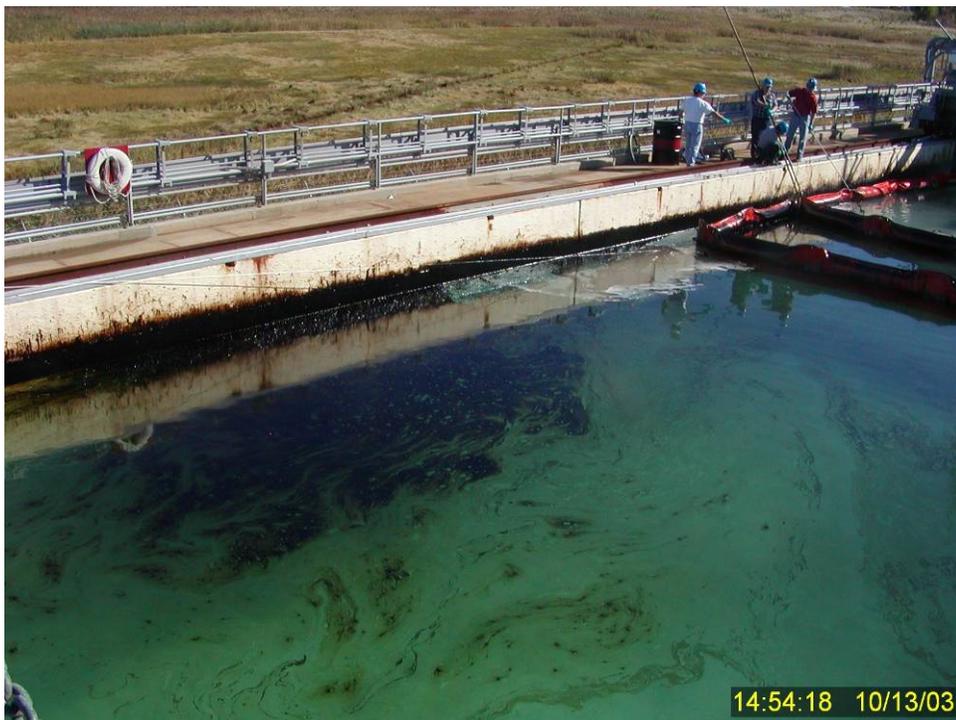
**Figure 56** Residual surface oil outside both the primary and secondary containment booms 20 minutes after the cessation of turbulence at the conclusion of Test No. 12 (see also Figure 55). Presumably this was from partially-dispersed oil that was entrained by increased turbulence around the containment boom during the test, although it may also have been lost due to splash-over.

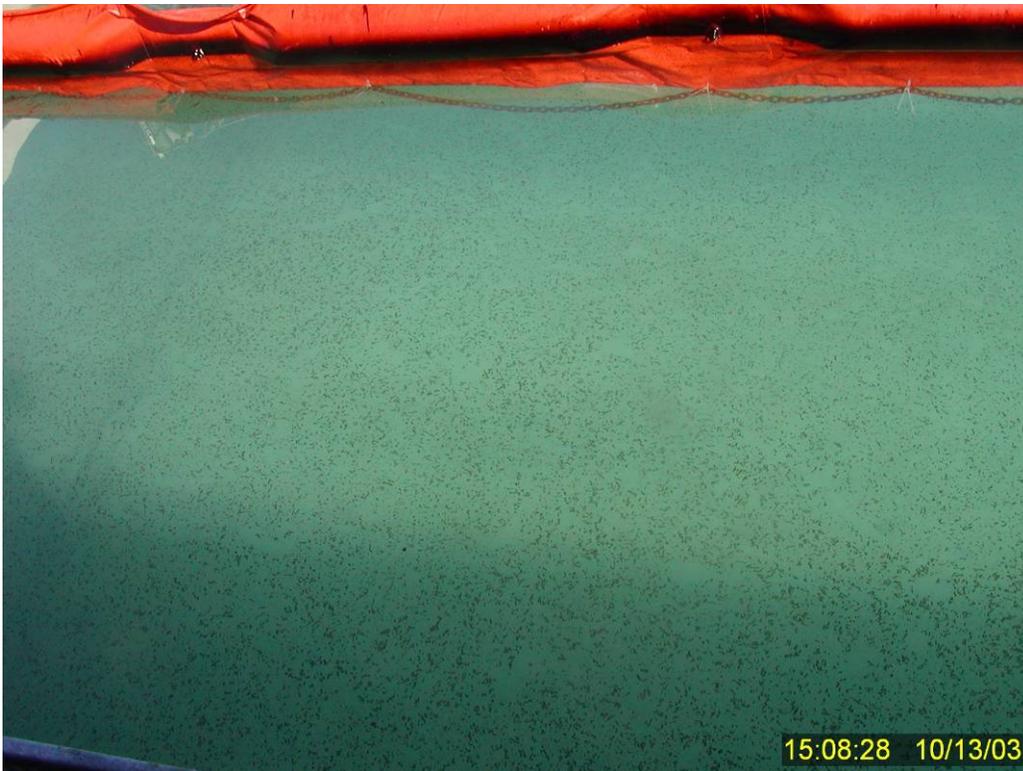
**Figure 58** Resurfacing dispersed oil between the western tank wall and containment boom approximately 35 minutes after termination of wave turbulence at the end of Test No. 12.

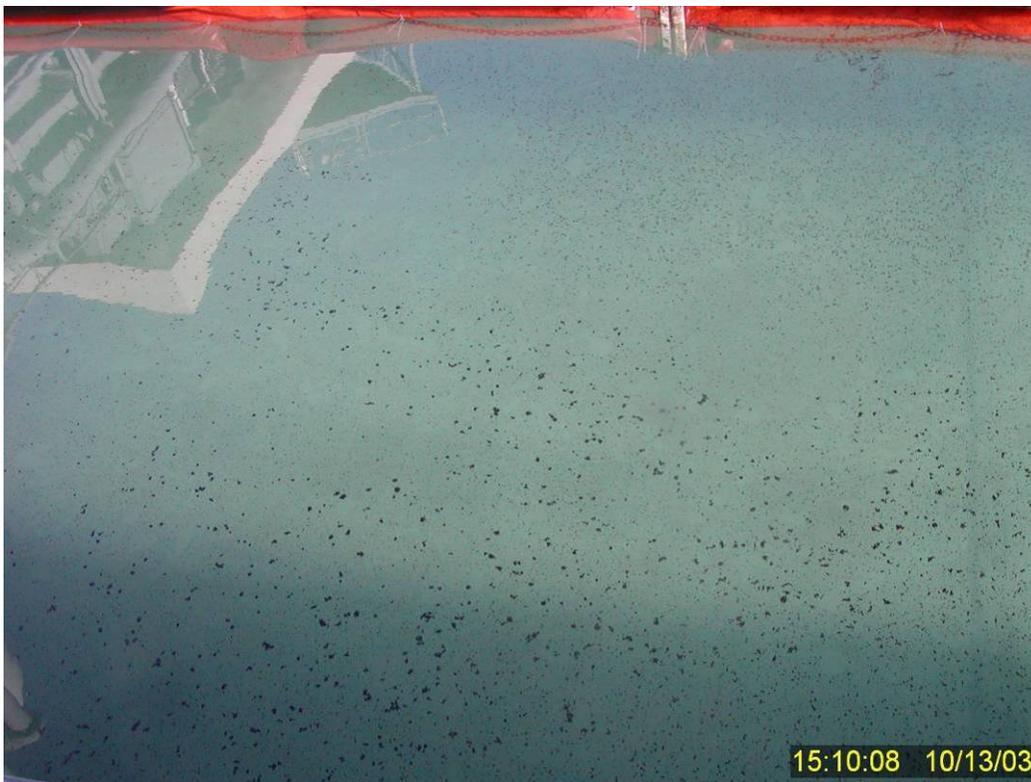
**Figure 59** Close-up photograph of agglomerating oil droplets resurfacing between the western tank wall and containment boom ~ 36 minutes after turbulence was terminated at the end of Test 12.

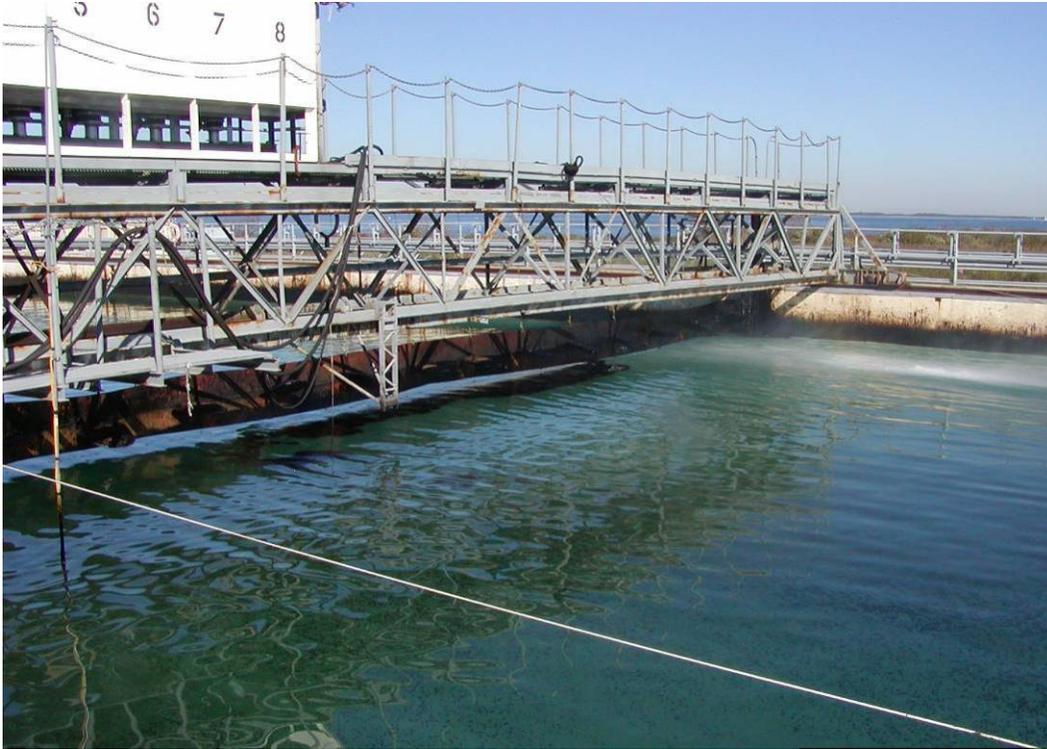
**Figure 61** Final 13 October 2003 cleaning/polishing the wave tank by using the fire monitors to drive any remaining surface oil beneath the permanent curtain at the extreme north end of the tank.

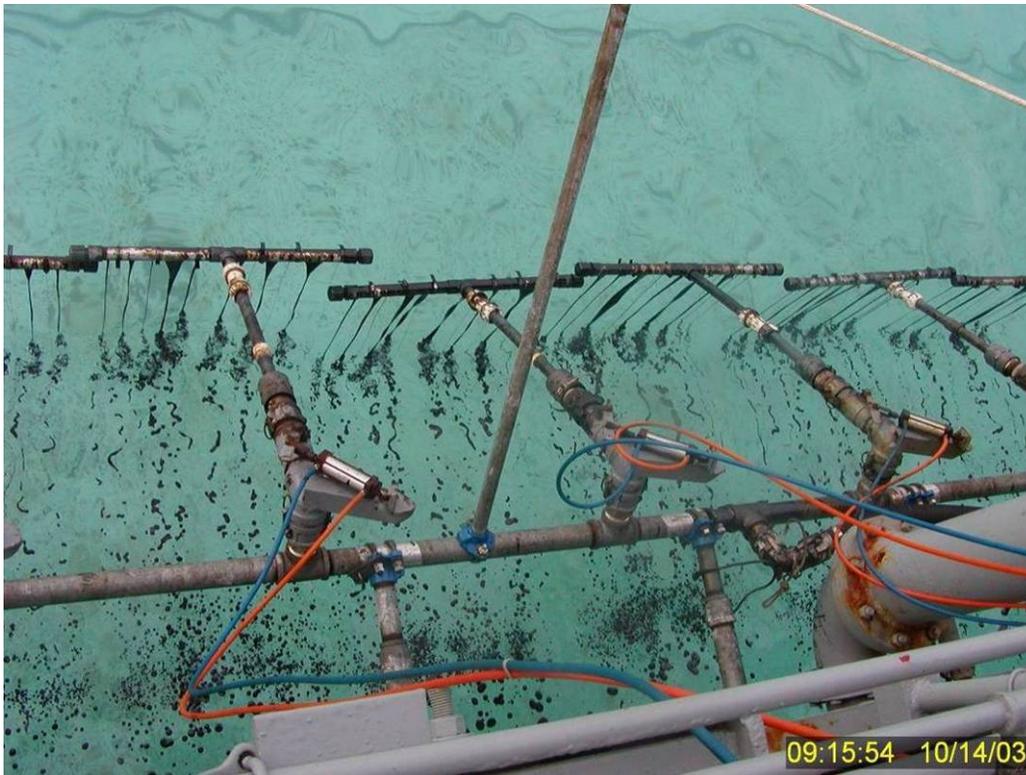
**Figure 63** Addition of IFO 180 fuel oil to water surface for Test No. 13 at ~0916 hrs.

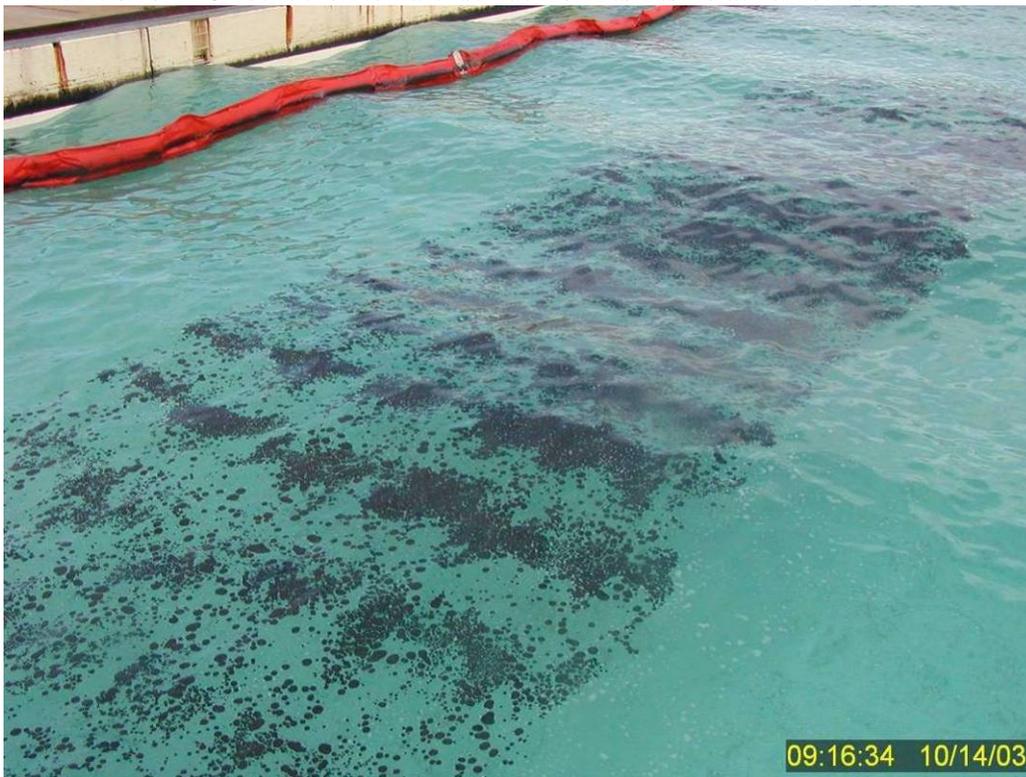
**Figure 64** Appearance of IFO 180 fuel oil ~20 seconds after SD25 dispersant application in Test No. 13. Note the uneven (patchy) distribution (lower left-hand corner) before the oil had a chance to spread. This caused much of the dispersant to actually land on the water resulting in under dosing the slick.

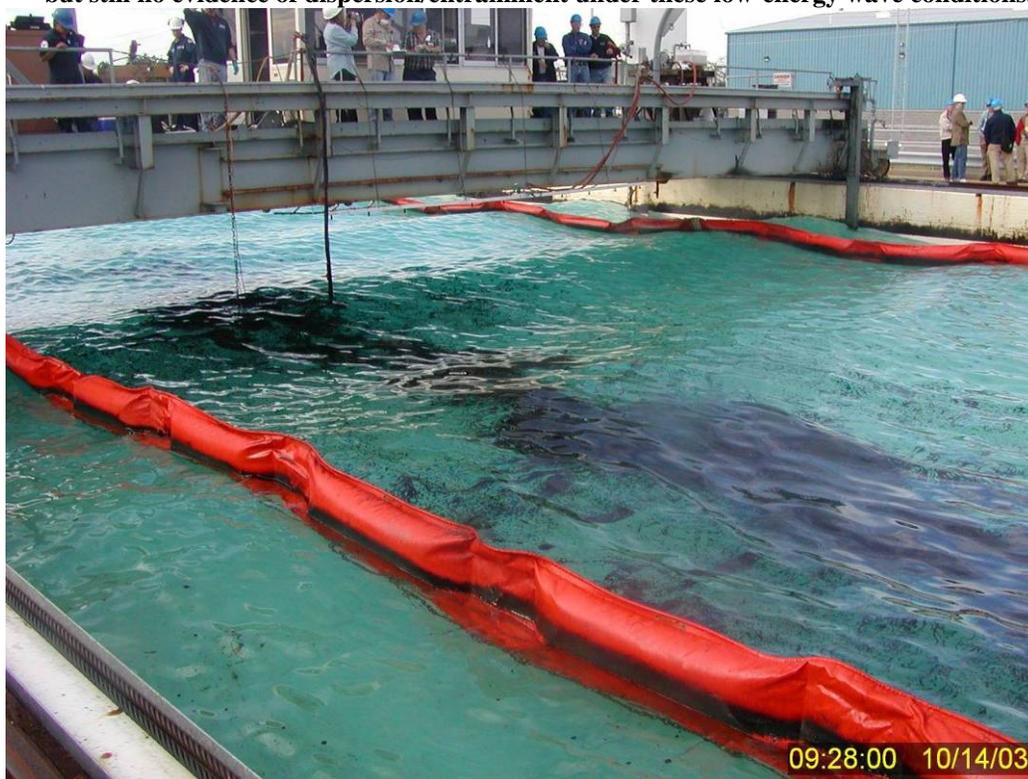
**Figure 66** Movable bridge positioned over the slick 12 minutes after dispersant application. Note the fluorometer cables passing directly through the slick to provide data from 1- and 2-m directly beneath the oil.

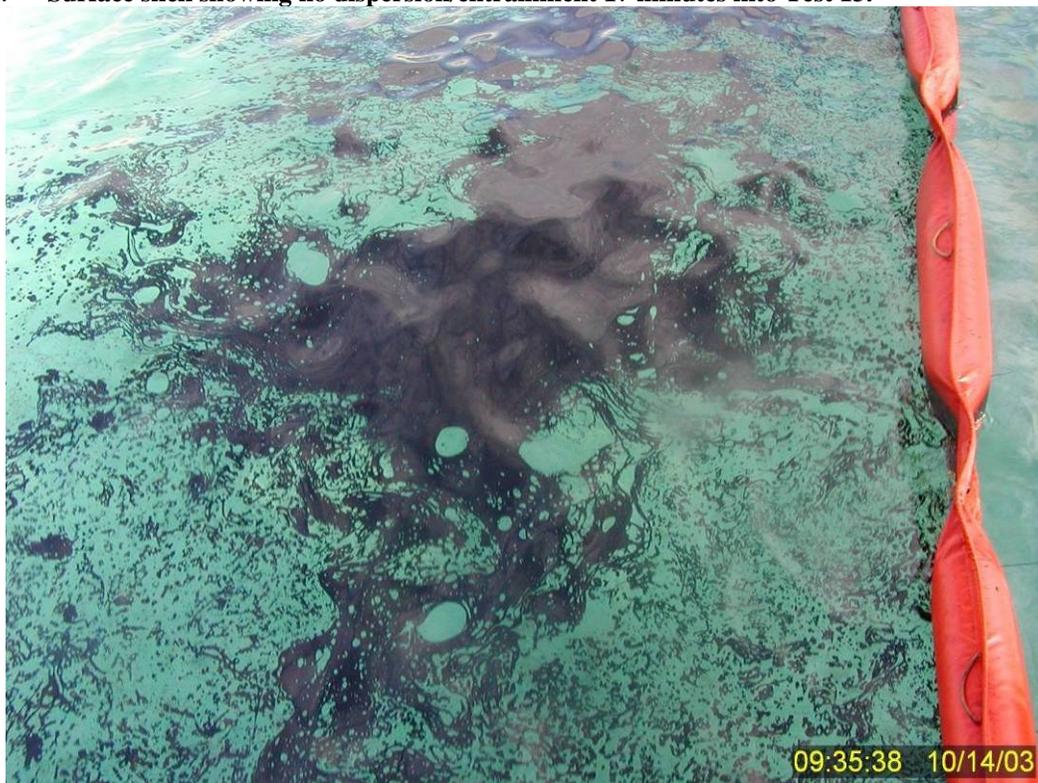
**Figure 68** Close up of surface slick from the bridge positioned directly over a larger patch of nondispersed surface oil 19 minutes into Test 13. There was no evidence of any chemically enhanced or natural dispersion noted.

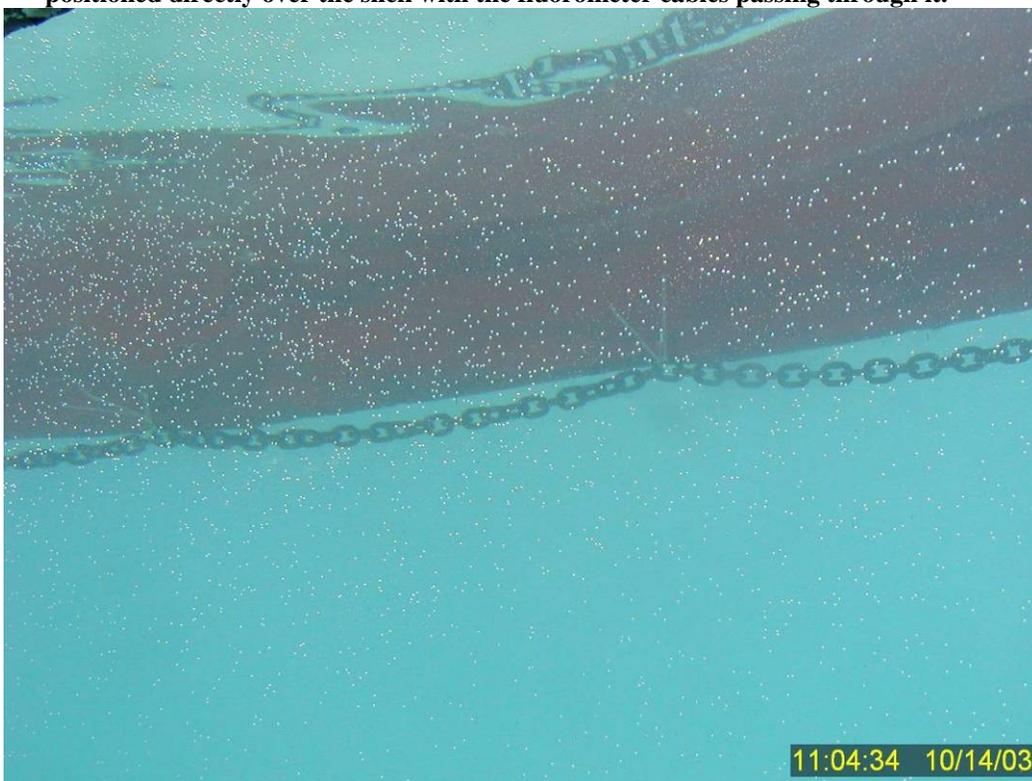
**Figure 69** With very light winds from the north, most of the oil drifted to the southeast corner of the containment boom (against the prevailing wave train). This photo shows the movable bridge positioned directly over the slick with the fluorometer cables passing through it.

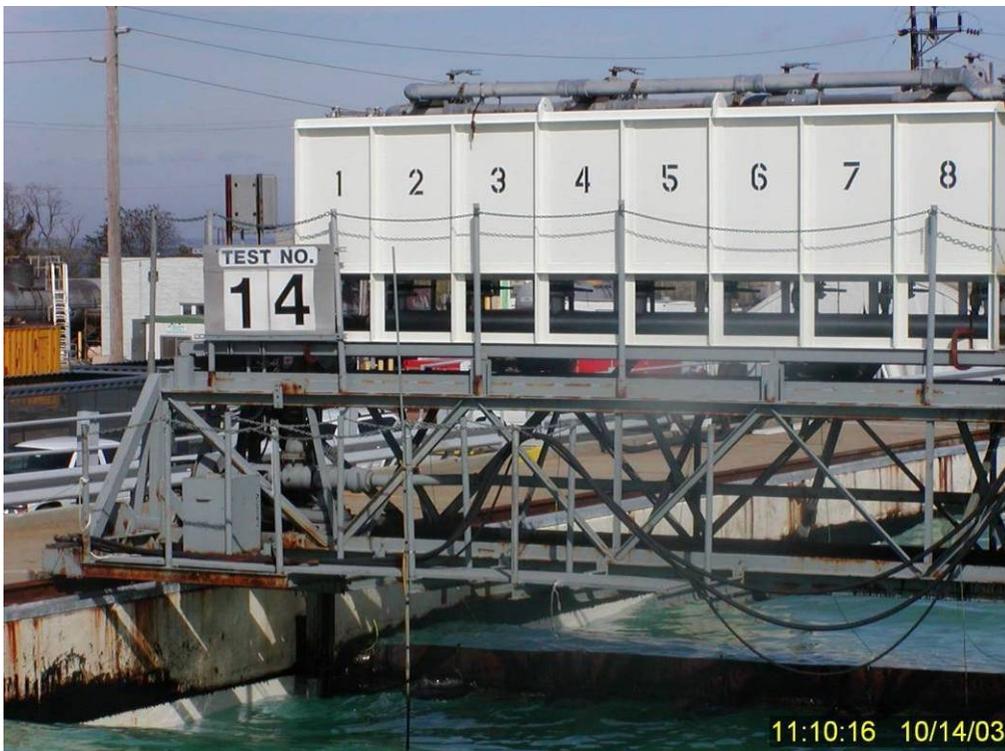
Figure 71 Secondary containment zone at the north end of the test tank showing no oil splash-over during Test 13.

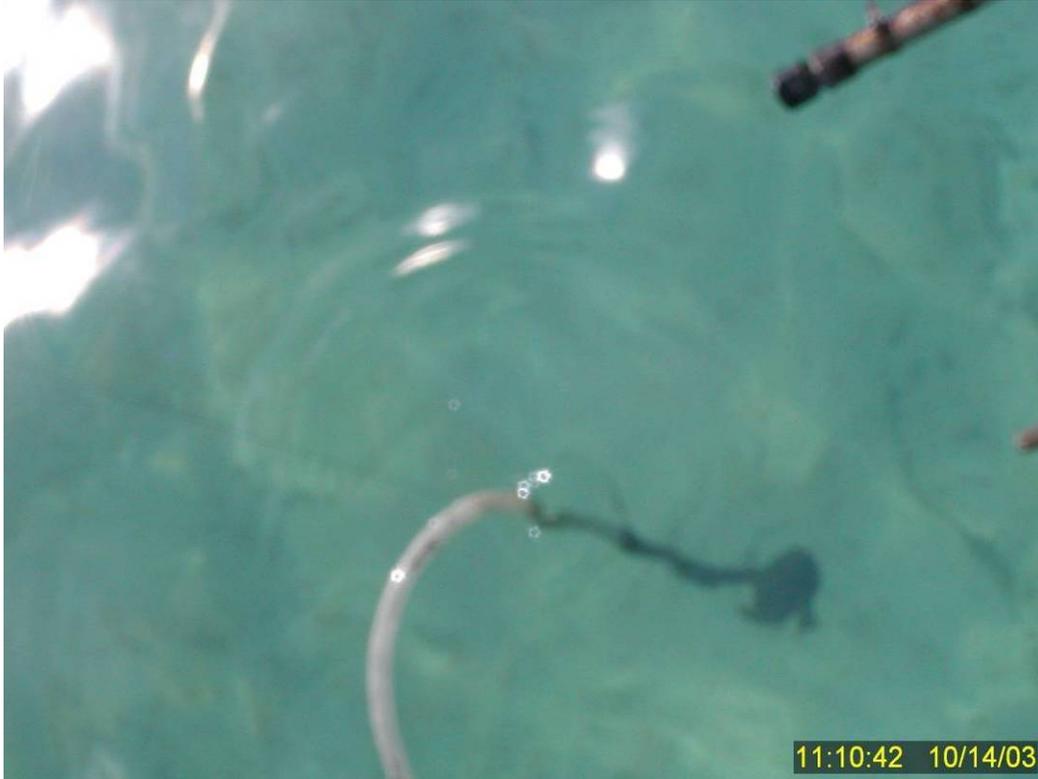
Figure 72 Set up for Test 14: IFO 180 fuel oil, Corexit 9500 at a nominal DOR of 1:50, and low-energy waves at 30 cpm.

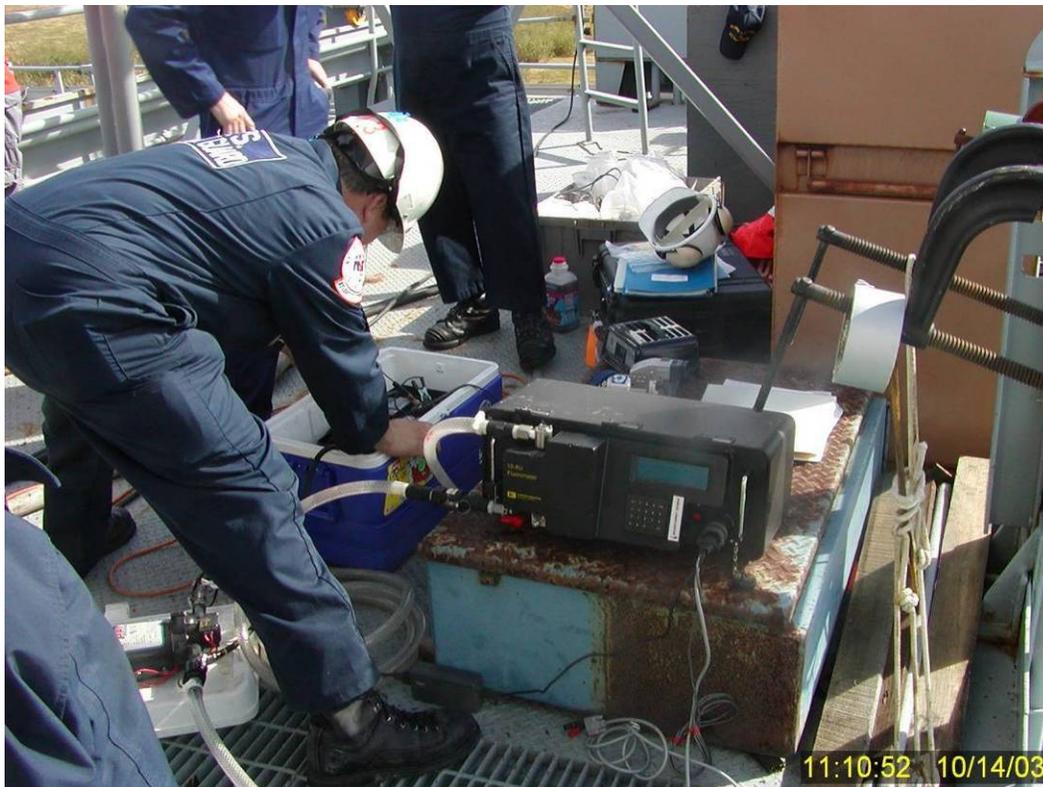
**Figure 73** Submersible pump for USCG SMART fluorometer system deployed from the movable bridge.

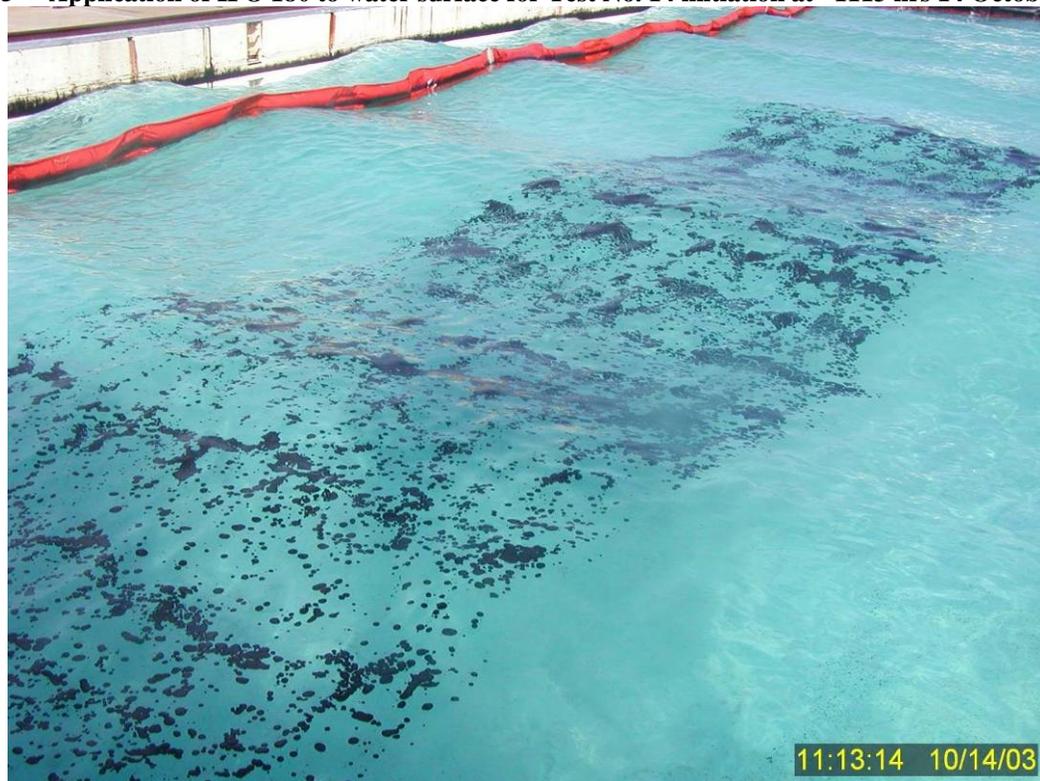
Figure 75 Application of IFO 180 to water surface for Test No. 14 initiation at ~1113 hrs 14 October 2003.

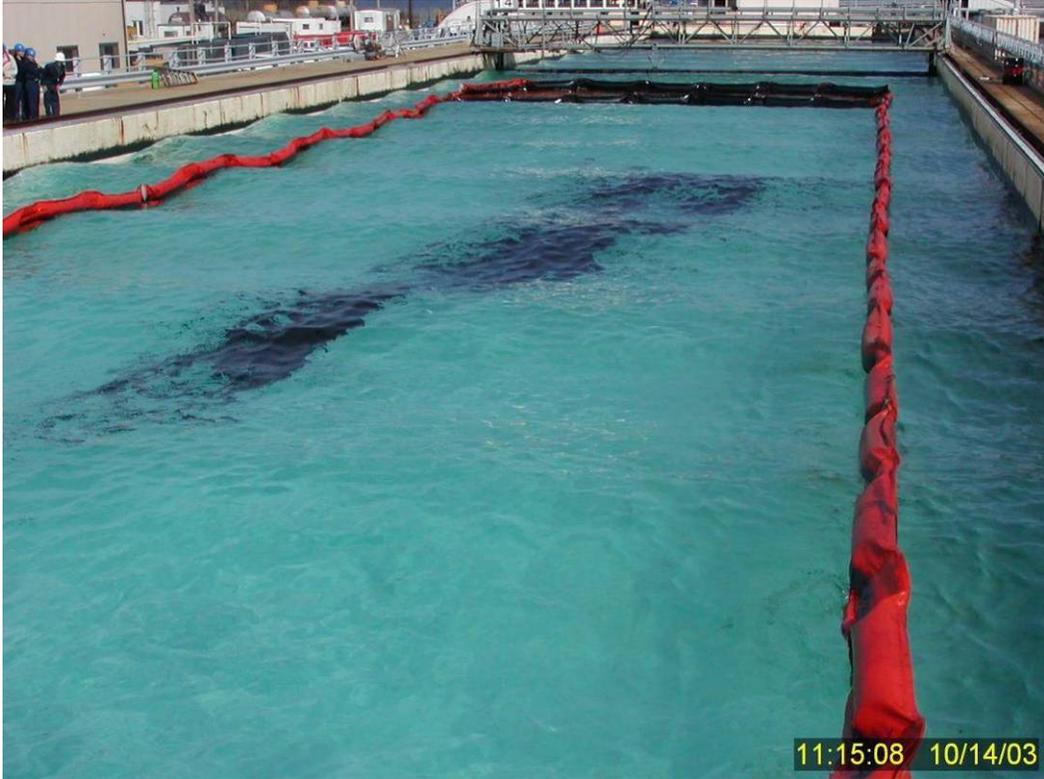
Figure 76 Quarter-sized oil patches and initial IFO 180 fuel oil spreading during the first 20 seconds of Test 14 (~ 12 seconds after dispersant application). Note: patchy oil distribution causes much of the dispersant to land directly on the water surface resulting in under dosing of the oil.

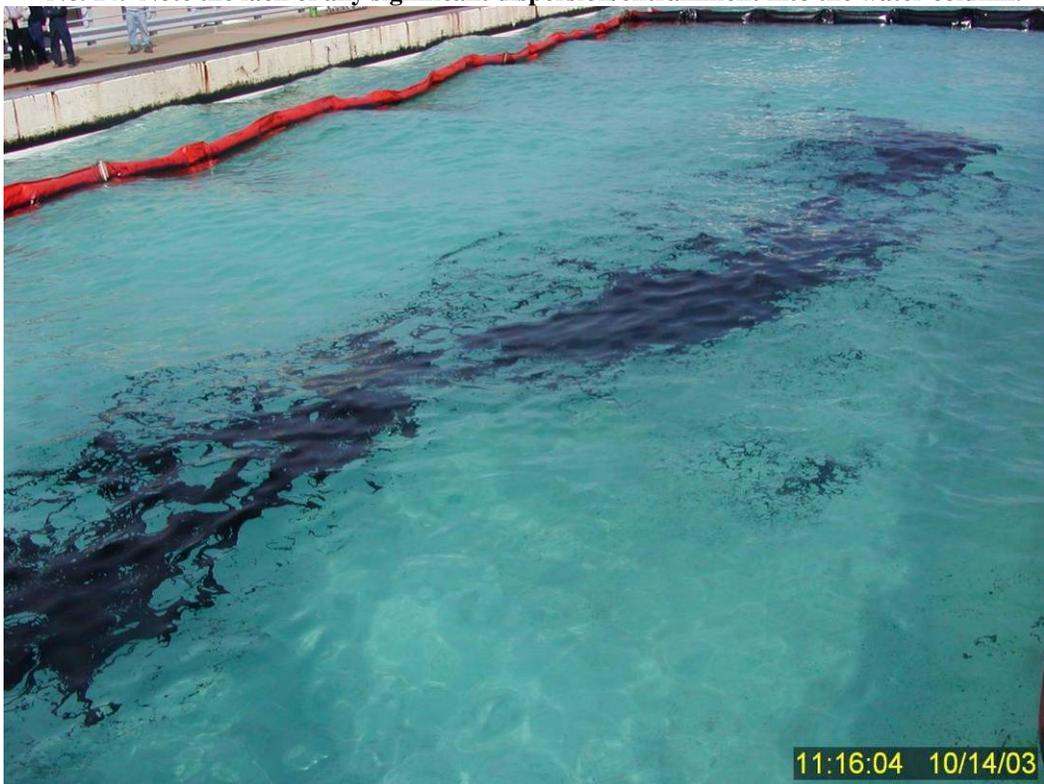
**Figure 77** Appearance of the surface IFO 180 oil slick two minutes after dispersant 9500 application in Test No. 14. Note the lack of any significant dispersion/entrainment into the water column.

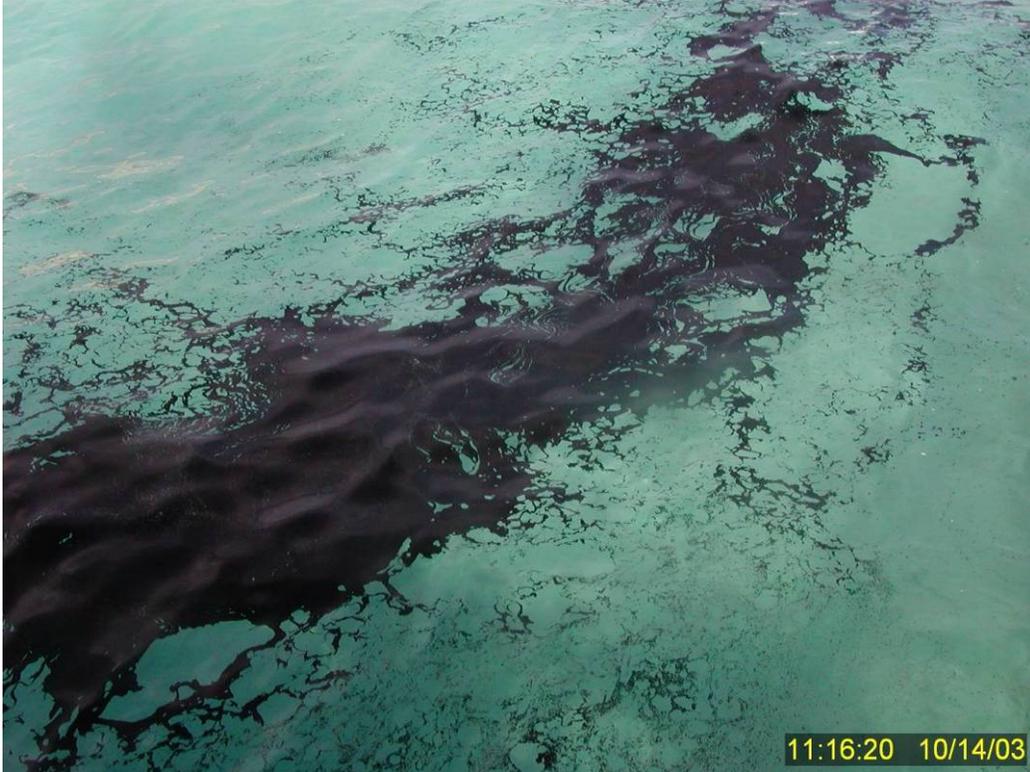
**Figure 78** Overhead view of IFO 180 fuel oil three minutes after Test No. 14 treatment with Corexit 9500 under light energy (low wave turbulence) regime.

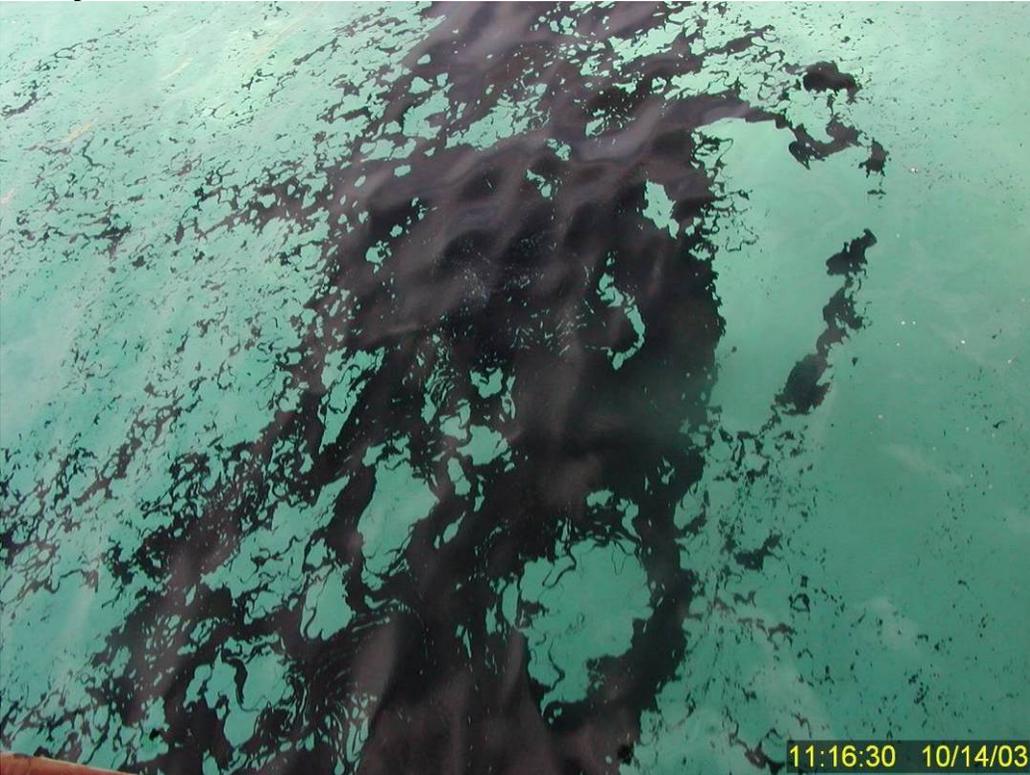
**Figure 79** Close up of surface slick three minutes after Test No. 14 dispersant application showing no dispersion/entrainment.

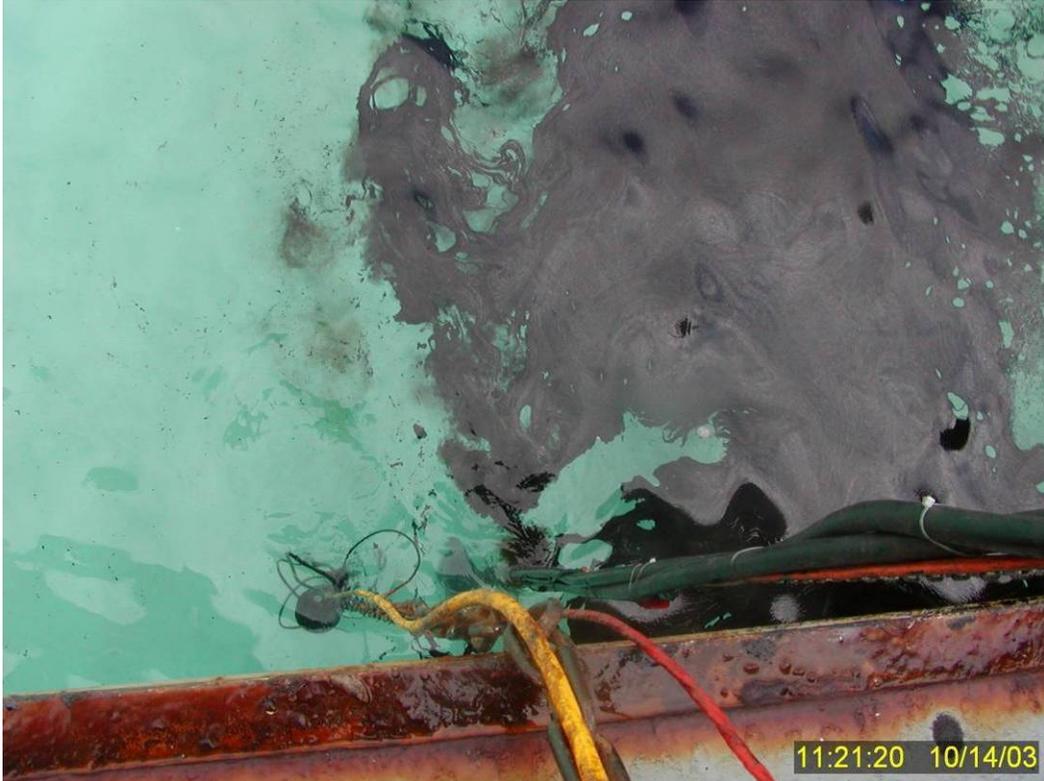
**Figure 80** Surface oil slick showing no significant dispersion/entrainment three minutes after treatment.

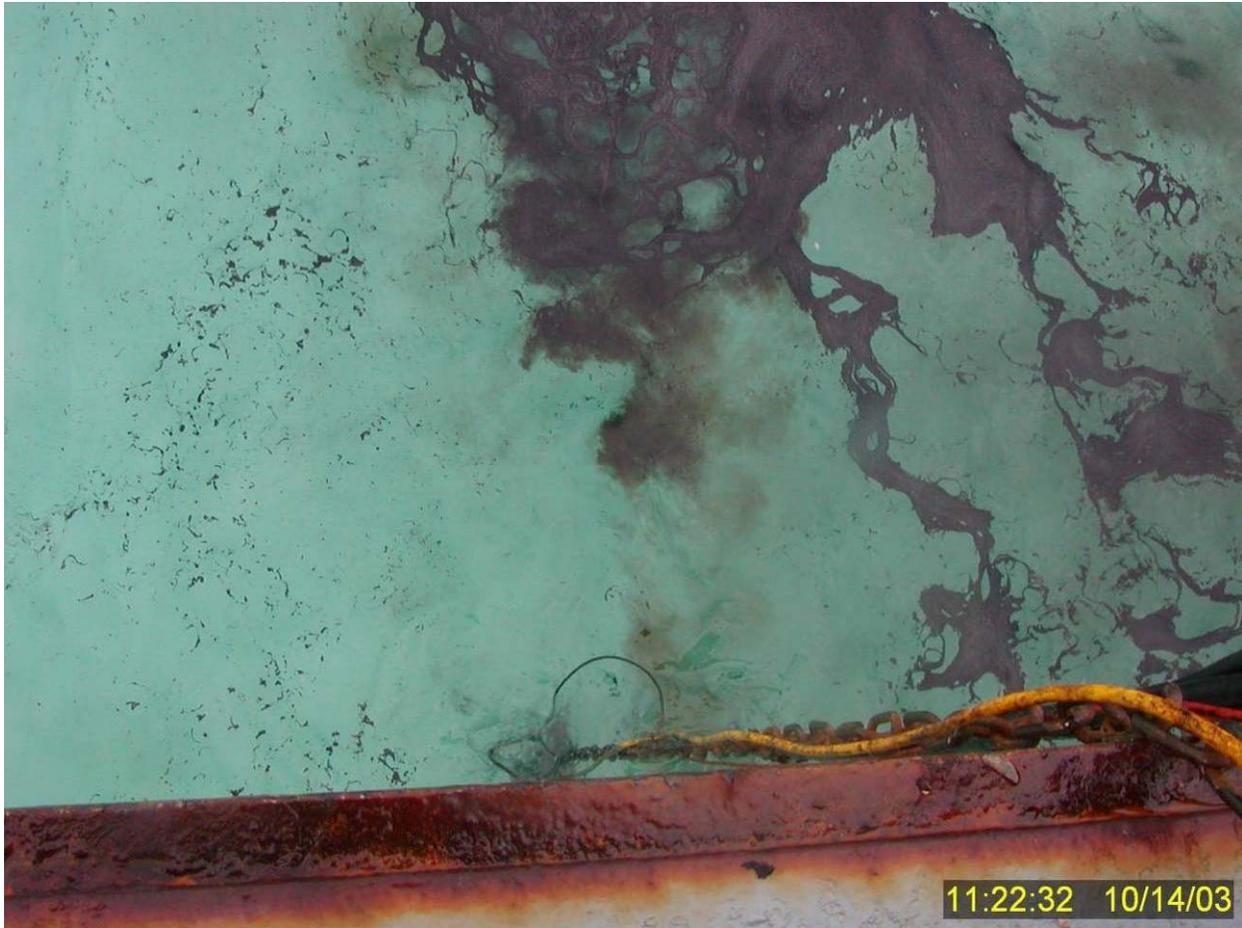
**Figure 82** Minor and very localized dispersion/breakup/entrainment of surface oil enhanced by minor turbulence introduced by dragging the fluorometer and submersible pump lines through slick at  $\sim 1/2$  knot. The yellow rectangle outlines the section of the photograph enlarged in Figure 85.

**Figure 85** Extreme close up of the center section of Figure 82 showing the difference in appearance for nondispersed surface oil (dark black with sharp edges) and the diffuse dispersed/entrained-oil plumes 10-12 inches below the water surface (dark brown to grey-black clouds). The dispersion in this particular test was caused by slightly enhanced turbulence from dragging the fluorometer cables through the water and surface slick, so its generation was an anomaly and not representative of the rest of the tank under these low-energy wave conditions. It is useful, however, because the water clarity and highly localized dispersion facilitate documentation of the stark contrast between surface and subsurface dispersed oil. In slightly higher-energy tests with very effective dispersion, the water-column instantly turns black, and it is almost impossible to visually differentiate between the surface slick and the subsurface dispersed oil plume.

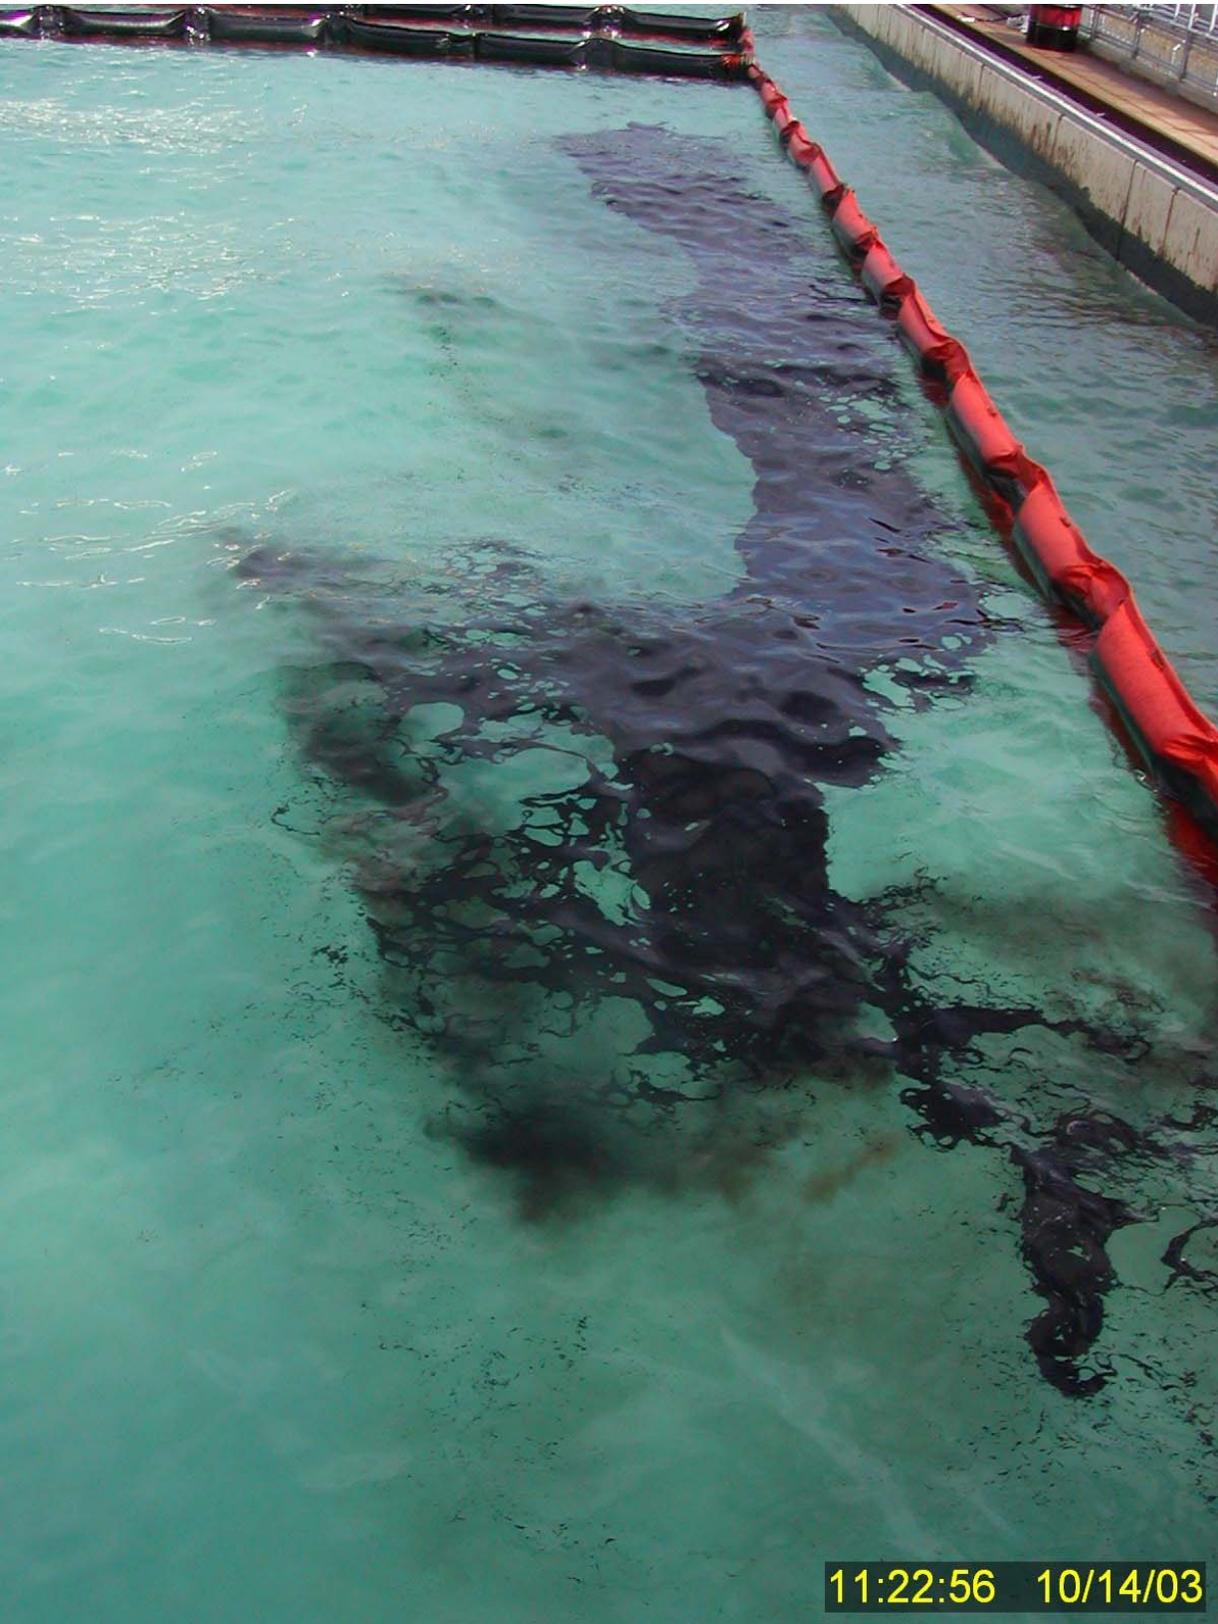
**Figure 83** Anomalous and non-representative dispersion of surface oil caused by minor turbulence from dragging the fluorometer cable through the surface slick. As a result of these observations, the experimental protocol was changed such that submersible pumps and fluorometer cables were pulled out of the water for the first observational/photo documentation pass of the movable bridge over the treated slick. For subsequent observational transects, the cables were carefully positioned to enter the water at the edge of the surface slick to minimize this artificial disturbance and enhanced dispersion.
