## APPENDIX A – Figures and Photo Documentation

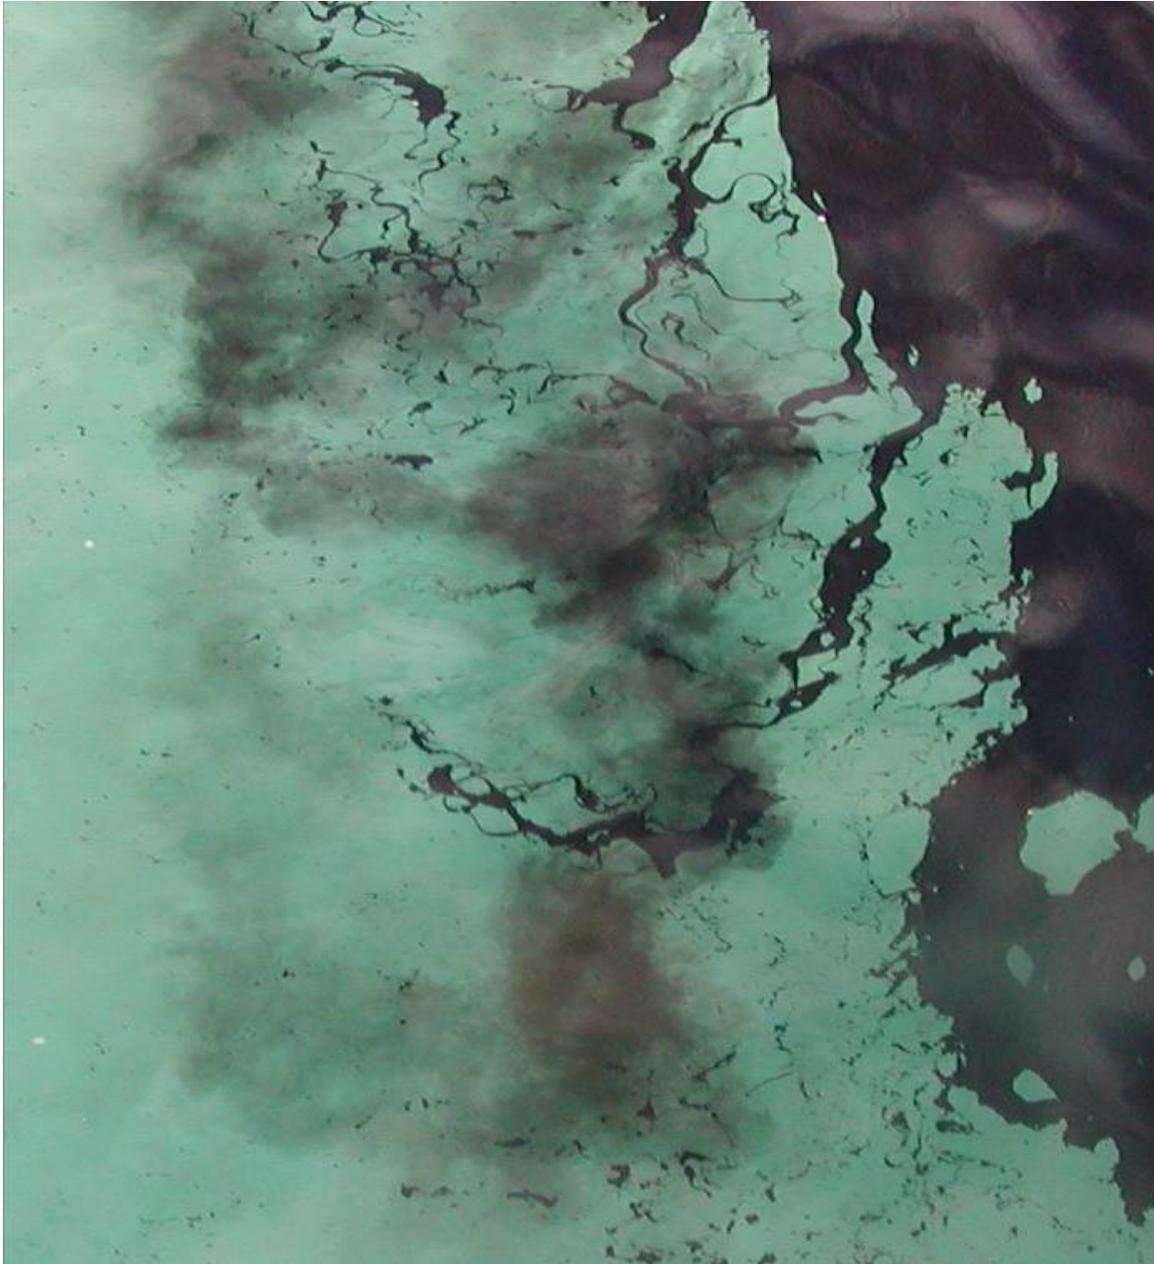
**Figure 84** Localized dispersion caused by dragging fluorometer cables and submersible pump lines through the surface slick.

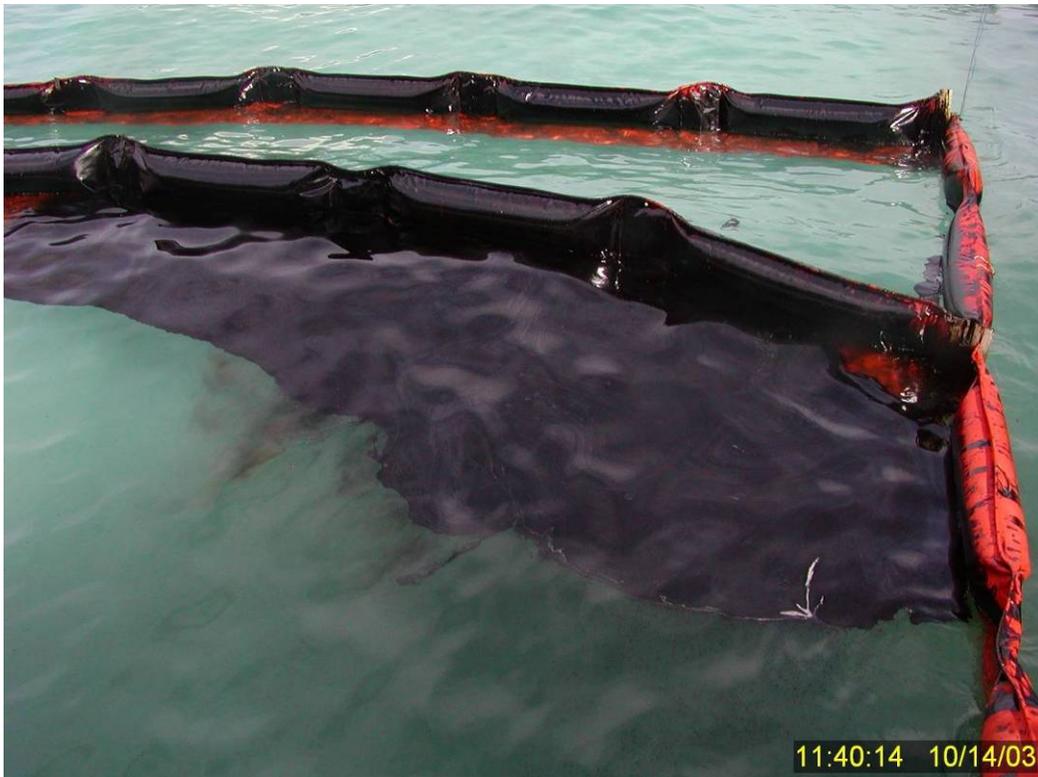
Figure 88 Secondary containment boom showing no splash over or dispersed oil plume at the termination of Test No. 14.

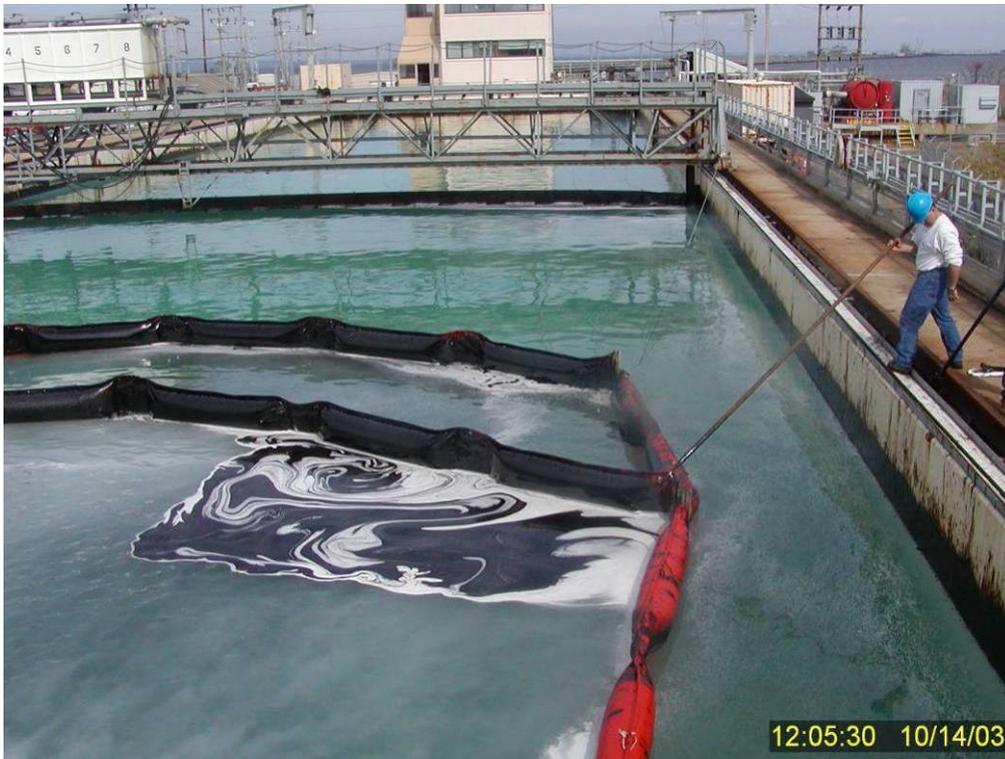
Figure 89 Non-dispersed surface oil that had been driven by the wind and waves into the northeast corner of the experimental zone during Test No. 14. Note the lack of any significant oil in the secondary containment boom at the top of the figure.

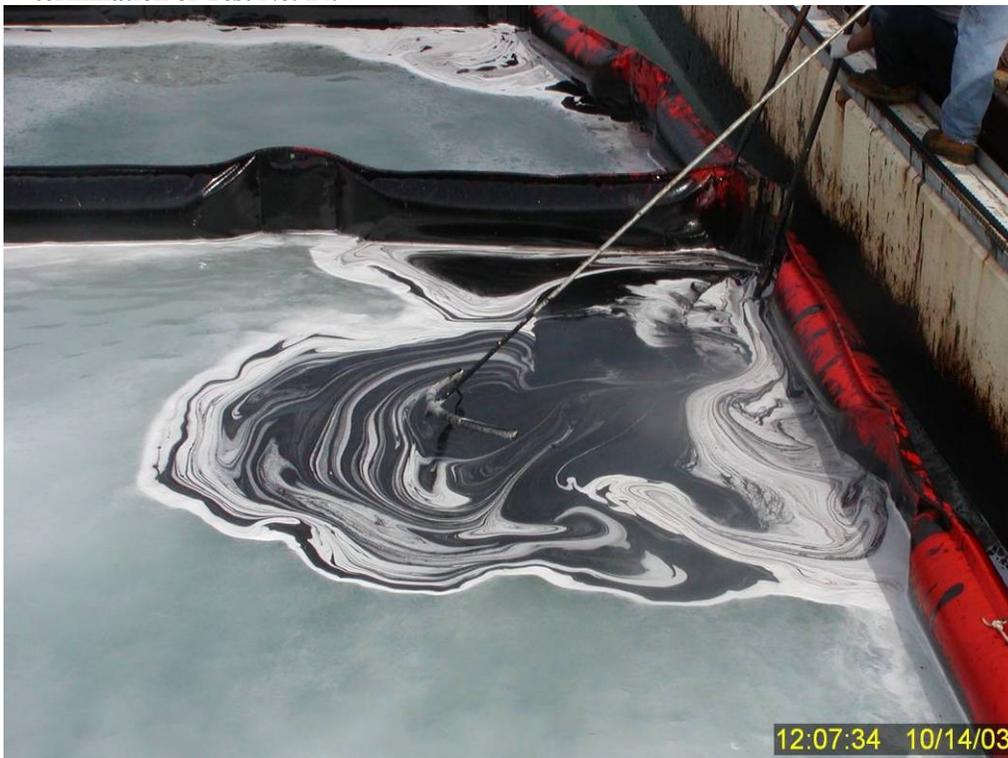
**Figure 90** Pulling the boom to the edge of the tank to facilitate collection of the remaining surface oil that had been herded by the fire monitors into the northeast corner of the experimental boom at the termination of Test No. 14.

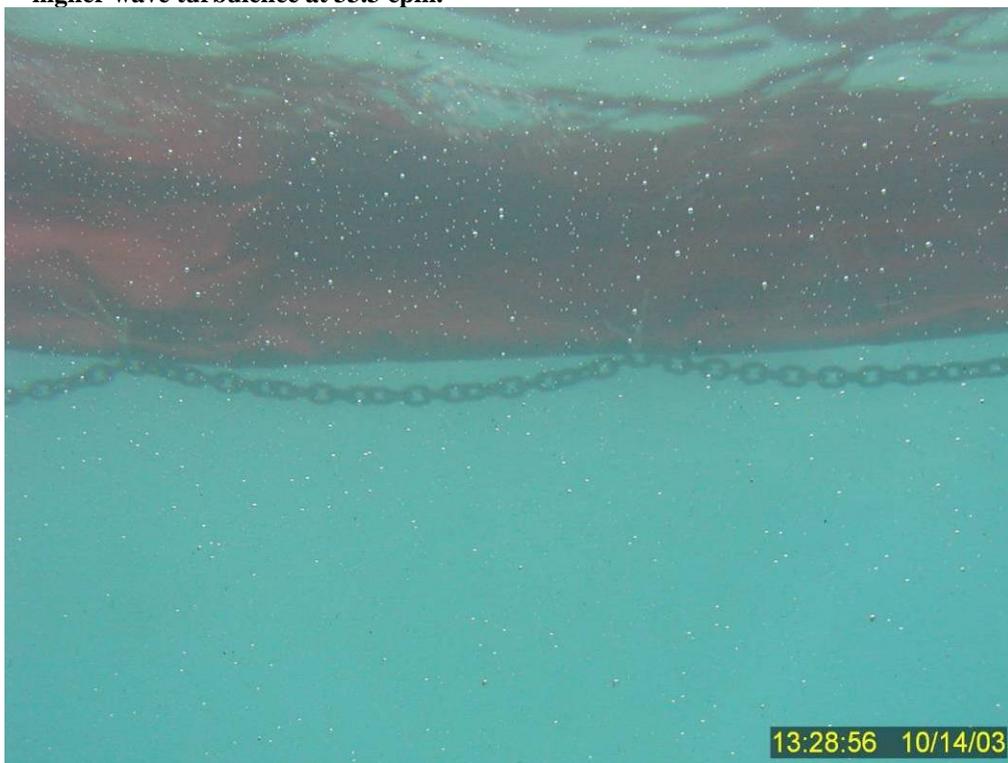
Figure 92 Initial set up for Test No. 15: IFO 180 treated with Superdispersant 25 (nominal DOR 1:50) and higher wave turbulence at 33.3 cpm.

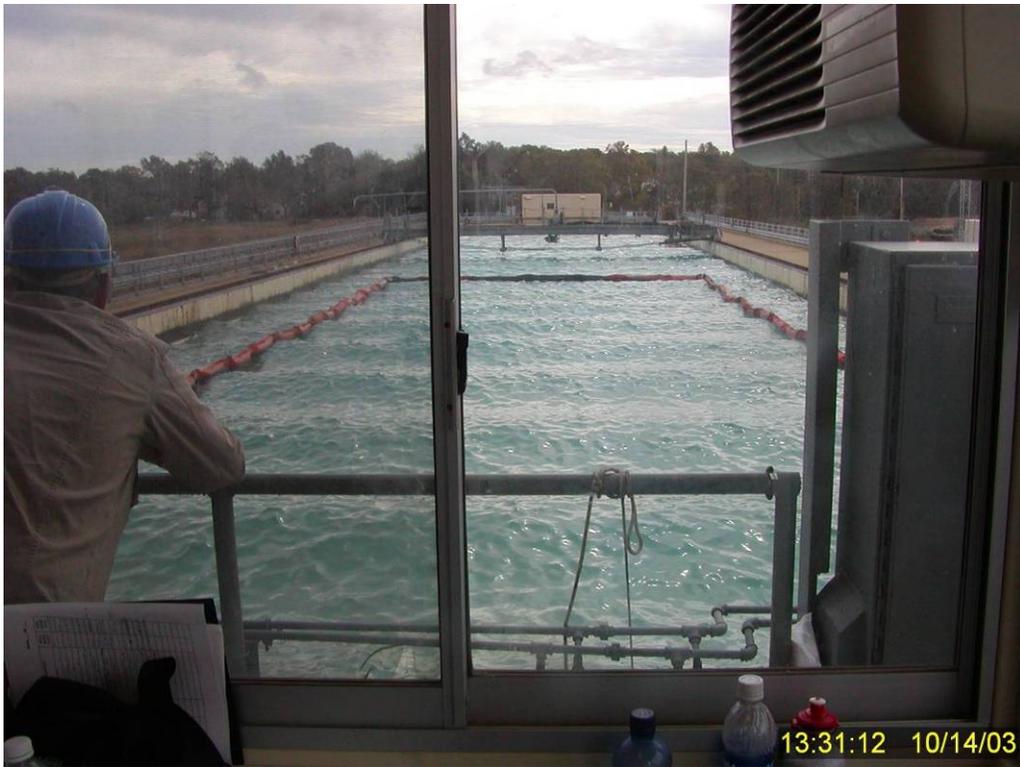
Figure 93 Containment boom from northern-most underwater window showing water clarity before Test No. 15.

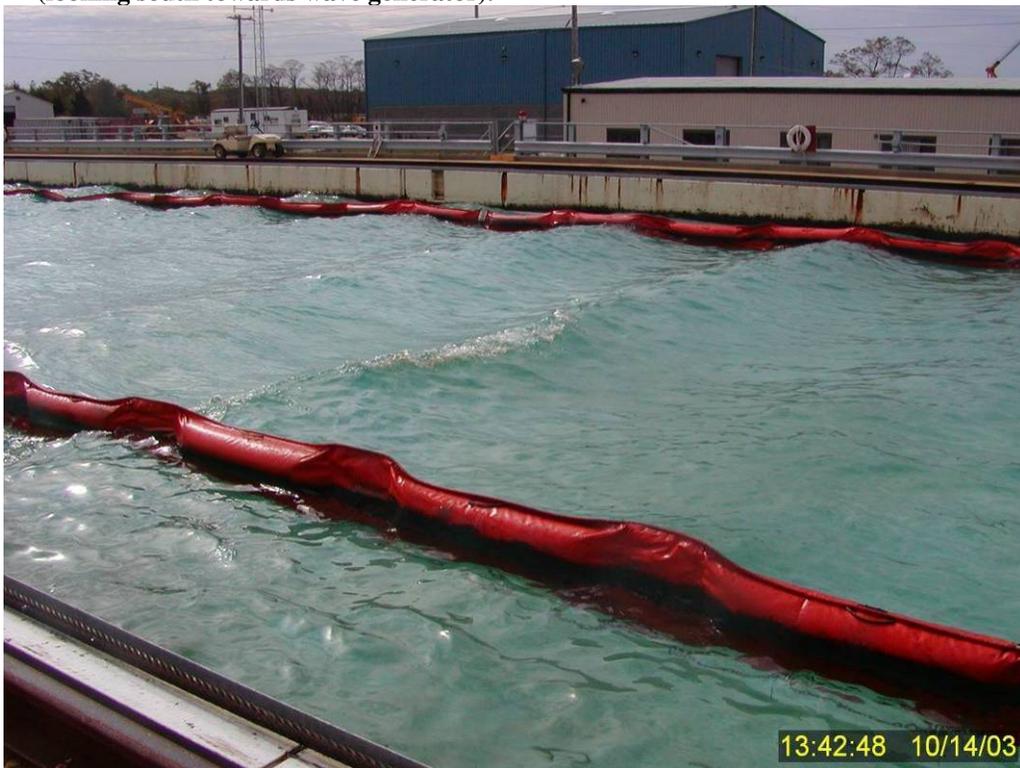
**Figure 94** Wave train viewed from the control room on movable bridge before Test No. 15 initiation (looking south towards wave generator).

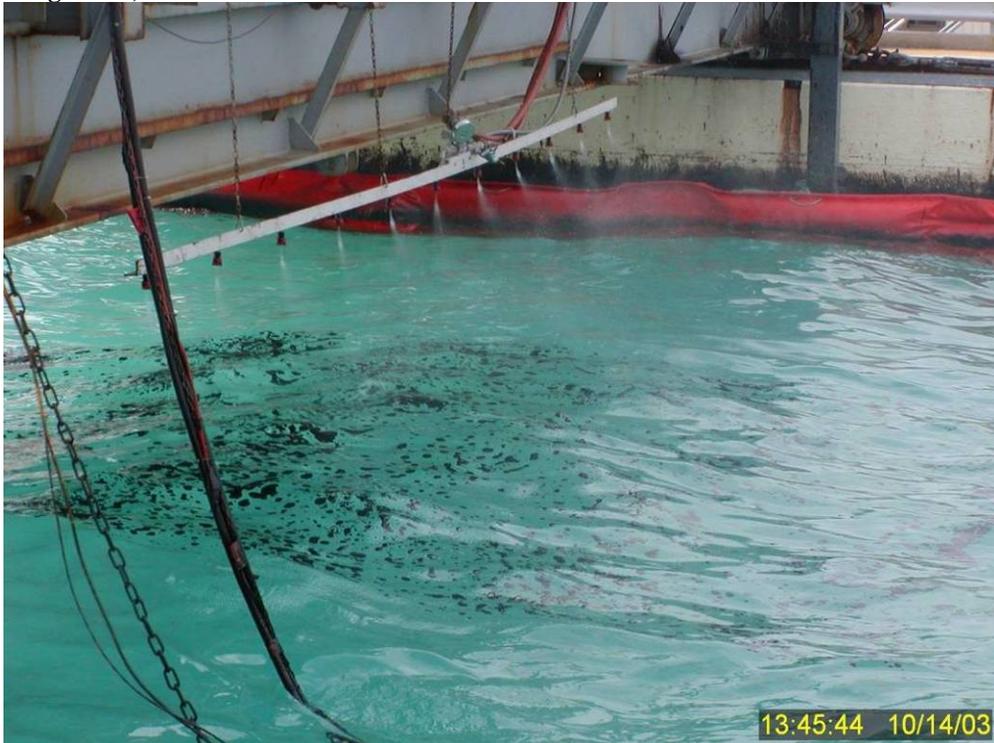
**Figure 96** Addition of IFO 180 fuel oil to the water surface at initiation of Test No. 15. For this operation, the bridge is moved at  $\frac{1}{2}$  knot to the south (from the right to the left) so that the oil on the water surface can be treated from a dispersant spray bar mounted on the other side of the bridge (see Figure 97).
