Seismic Re-Engineering of the Valdez Marine Terminal (VMT)
Contract No. 556.07.0007

Rock Slope Stability of the VMT

**The Prince William Sound
Regional Citizen's Advisory Council (RCAC)**

September 2007

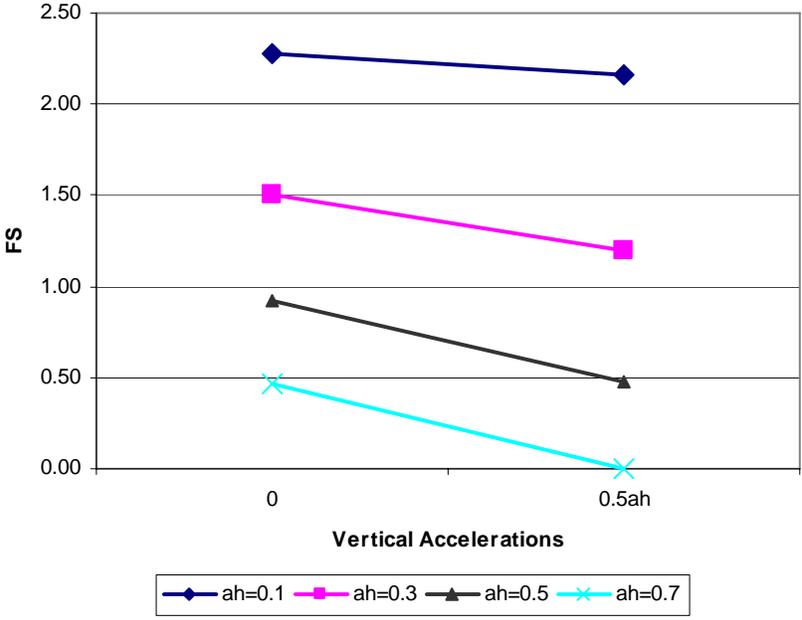
Figure 7.18C
Horizontal and Vertical Accelerations
(No pore pressure)

A kinetic analysis was performed on the joint sets of joints J3 and J4 that were kinematically unstable in the wedge failure mode. The FS ranges from 2.77 to zero under the pore pressure conditions of zero to saturated condition ($H_w/H_{slope} = 1$) without earthquake loading conditions. Under earthquake loading conditions ranging from 0.1g to 0.7g in addition to the pore pressure conditions, the FS ranges from 2.28 to zero under various pore pressure conditions. Under the earthquake conditions considering both horizontal and vertical accelerations and dry conditions ($H_w/H_{slope} = 0$), the FS ranges from 2.28 to zero under earthquake loading conditions ranging from 0.1g to 0.7g. For this wedge failure mode, the minimum external loading condition that can cause wedge failure is the pore pressure equal to $0.85H_w/H_{slope}$. If earthquake and pore pressure loadings are considered together, the $0.8H_w/H_{slope}$ with 0.1g of horizontal acceleration and the $0.55H_w/H_{slope}$ with 0.2g of horizontal acceleration will cause wedge failure to occur. The results of the kinetic analysis of the wedge failure are shown in Figures 7.18A through 7.18C.

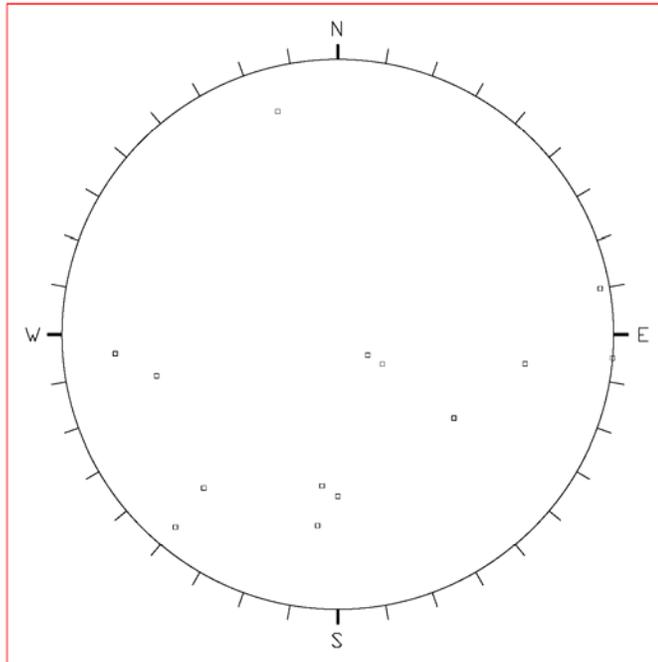
Figure 7.22 Rock Slope Stability Analysis in VMT

The major discontinuities observed in this slope are listed in Table 7.13 and the pole plot of these data is illustrated in Figure 7.22. Based on the kinematic analysis shown in Figures 7.23A and 7.23B, it is anticipated that wedge failures along the intersection of joints J3 (90/080) and J4 (55/306), and J3 and J5 (69/279) are likely. The results of the kinematic analysis are summarized in Table 7.14. The wedge failure caused by J3 and J4 was selected for analysis due to its more unfavorable conditions to the slope orientation than the other wedge intersection of J3 and J5.

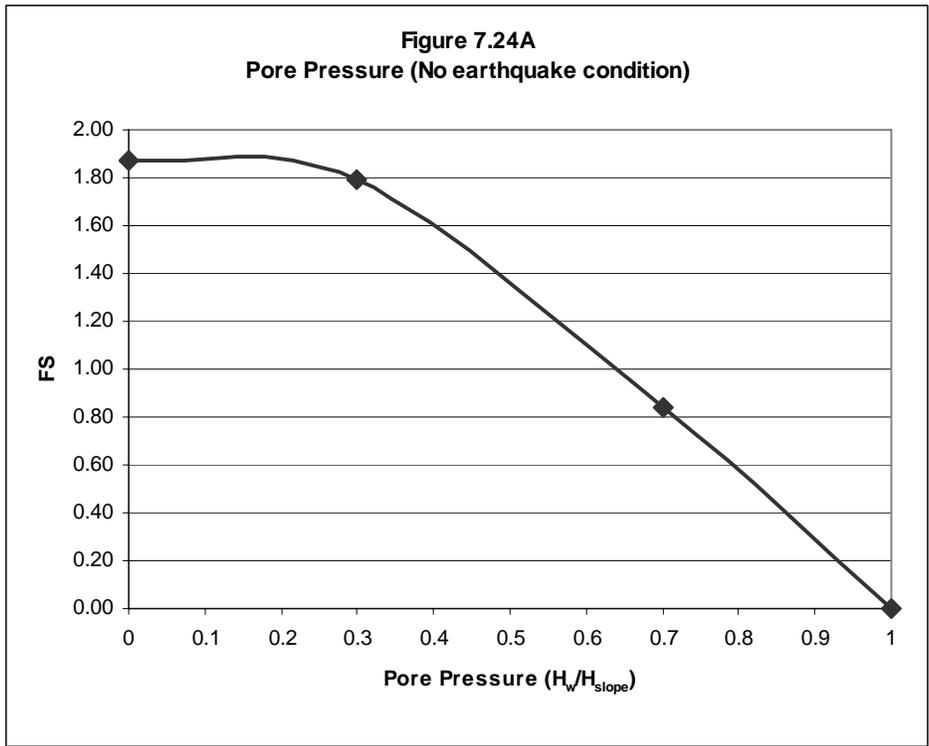
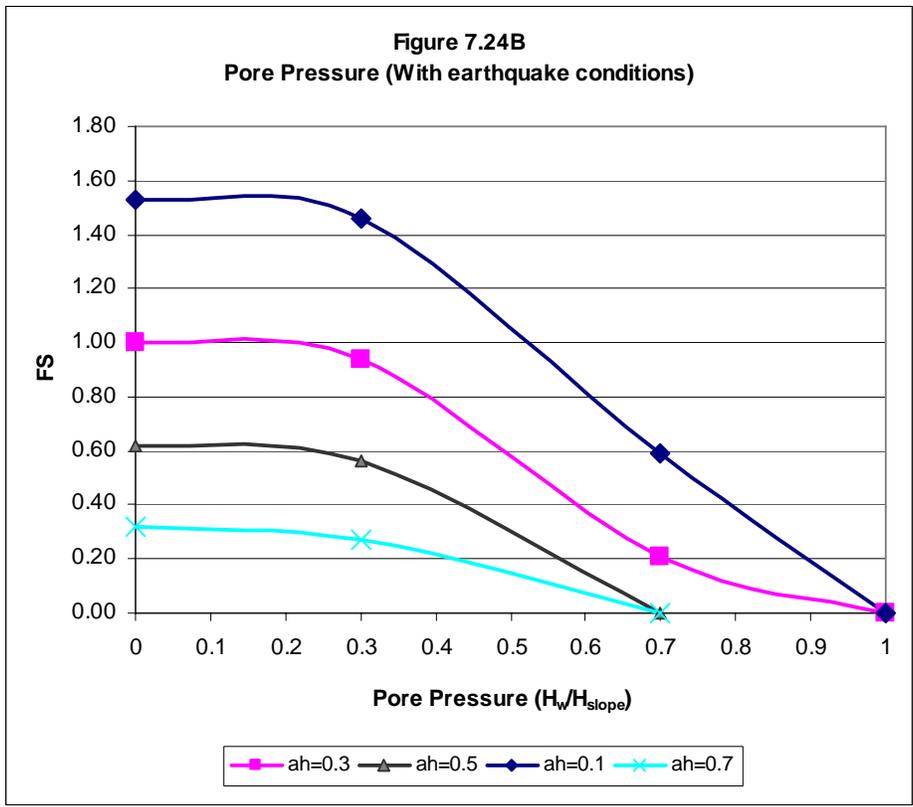
It appears that the slope is stable under current conditions at the time of our field investigations. However, The FS for the potential wedge failure ranges from 1.87 to zero under the pore pressure conditions of dry condition ($H_w/H_{\text{slope}} = 0$) to saturated condition ($H_w/H_{\text{slope}} = 1$) without earthquake loading. Under earthquake loading, ranging from 0.1g to 0.7g in addition to the pore pressure conditions, the FS ranges from 1.53 to zero. When vertical acceleration ($0.5a_h$) was imposed in addition to the horizontal acceleration, the FS is reduced somewhat as shown in Figure 7.24C. For this wedge failure mode, the minimum external loading condition that can cause wedge failure is the pore pressure equal to $0.65H_w/H_{\text{slope}}$. If both earthquake and pore pressure loadings are considered, the $0.5H_w/H_{\text{slope}}$ with 0.1g of horizontal acceleration will cause wedge failure to occur. The results of the kinetic analysis of the wedge failure are shown in Figures 7.24A through 7.24C.

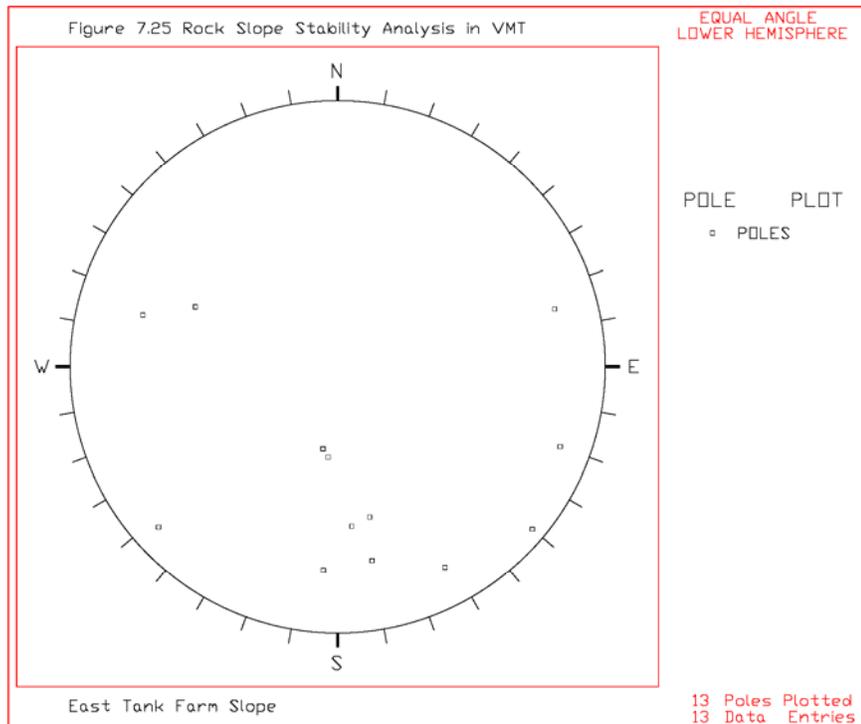
The major discontinuities measured in this slope are listed in Table 7.16 and the pole plot of these data is illustrated in Figure 7.25. Based on the kinematic analysis shown in Figure 7.26 and Figure 7.28, it is anticipated that a planar failure by foliation J3 (90/080) and a wedge failure by the intersection of joints J1 (65/351) and J2 (60/113) may occur. The results of the kinematic analysis are summarized in Table 7.17.

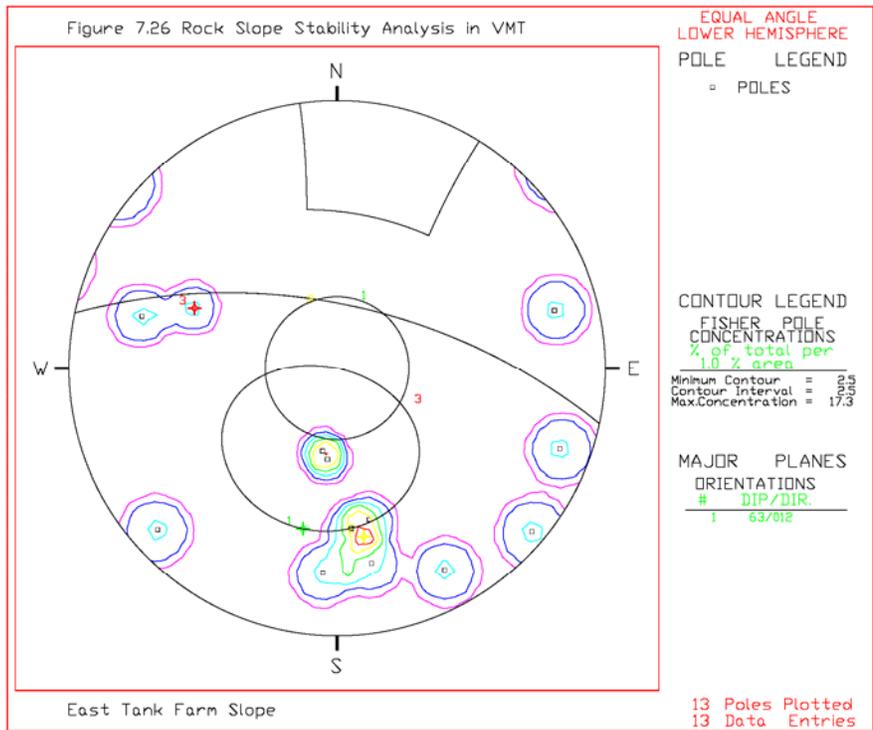
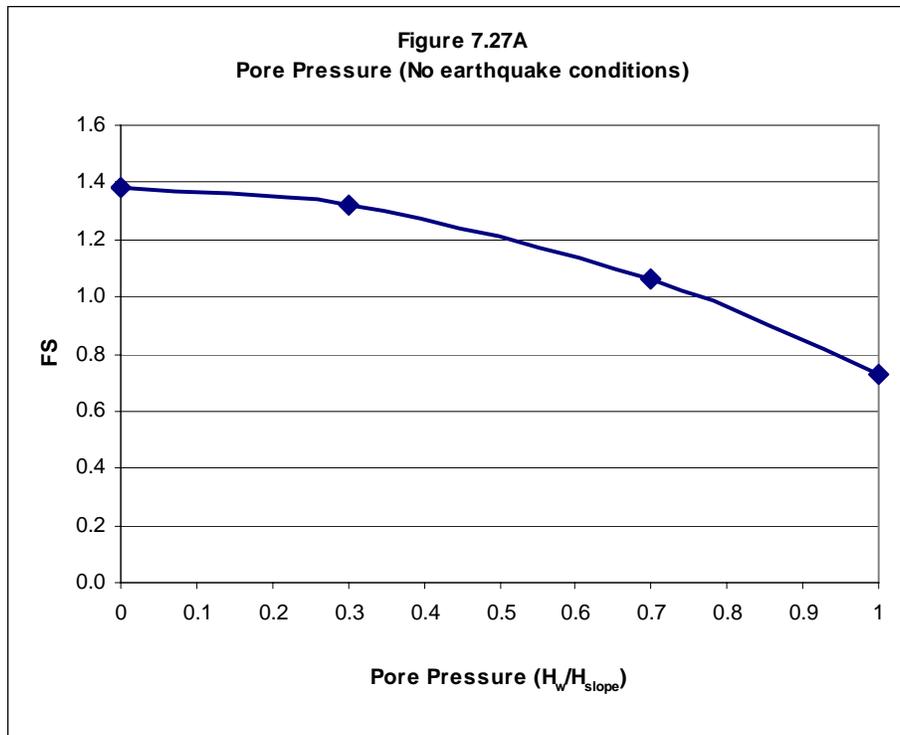
For the earthquake conditions considering both horizontal and vertical accelerations and dry conditions ($H_w/H_{\text{slope}} = 0$), FS ranges from 1.12 to 0.12 for the earthquake loading conditions ranging from 0.1g to 0.7g. For the planar failure mode, the minimum external loading condition that can cause a planar failure is a pore pressure equal to $0.75H_w/H_{\text{slope}}$. If both earthquake and pore pressure loadings are considered, the $0.45H_w/H_{\text{slope}}$ with 0.1g of horizontal acceleration will cause a wedge failure to occur. The results of the kinetic analysis for the planar failure are shown in Figures 7.27A through 7.27C.
