Background Tank 93 Information

Tank 93 Floorplate Inspection Findings

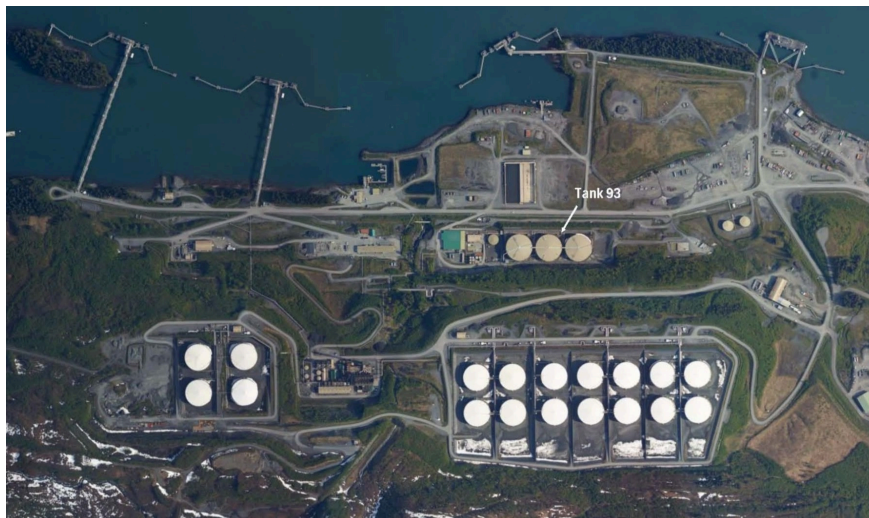
2

Tank 93 - Overview

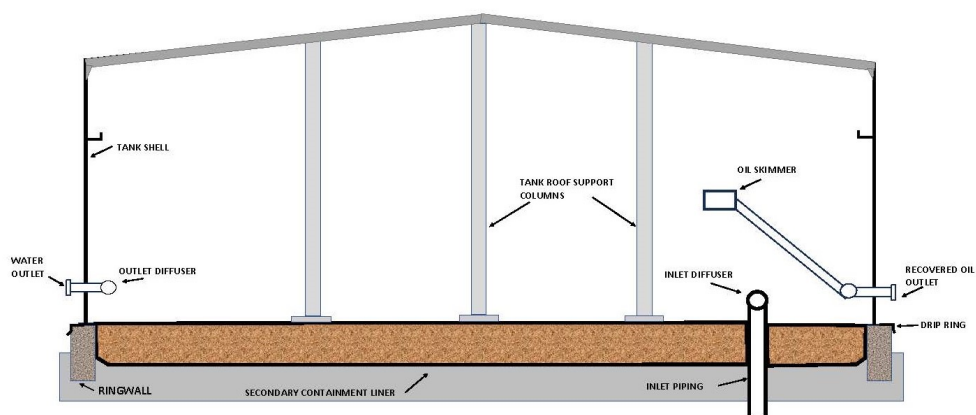
3

Tank 93 - Cathodic Protection System

- None of the Tank 93 CP data meets the -850 mV criteria for CP.
- APSC is relying on 100 mV shift criteria to show that Tank 93 is cathodically protected.
 - APSC has been using depolarized data as old as 9-years old in lieu of measuring the formation or decay of polarization.
- APSC is not collecting CP data in the outermost 10-feet of the tank perimeter.
 - This is the area of the most active corrosion.
- Replacement of the annular plate, 870 MFL indications and the installation of 46 patches suggests that the CP system is not effectively protecting the tank bottom.

- Utilize the deepest floorplate corrosion as the basis for corrosion rate and service interval calculations in all reports.
- Adjust CP monitoring practices
 - Follow NACE SP-0193 & MP-166 3.23. Measure the formation or decay of polarization.
 - Collect CP data for the tank perimeter area (0-10 feet in from shell)
- Upgrade the perimeter CP
- Better define the column condition
 - Determine the condition above 20-feet
 - Provide calculations for remaining effective structural thickness (T_{EST}) and for defining the minimum allowable remaining effective structural thickness as (60% T_{NOM}).
