**Briefing for PWSRCAC Board of Directors – May 2025**

**Project number and name or topic:** 5057 - Air Quality Review of the VMT

1. **Description of agenda item:** The Board is being asked to accept the report titled “Volatile Organic Compound (VOC) Emissions from the Snow Removal Incident at the Alyeska Pipeline Service Company’s Valdez Marine Terminal East Tank Farm in Early 2022,” by Dr. Ranajit (Ron) Sahu.

## Report Acceptance: 2022 VMT Crude Oil Storage Tank Vent Incident 4-5

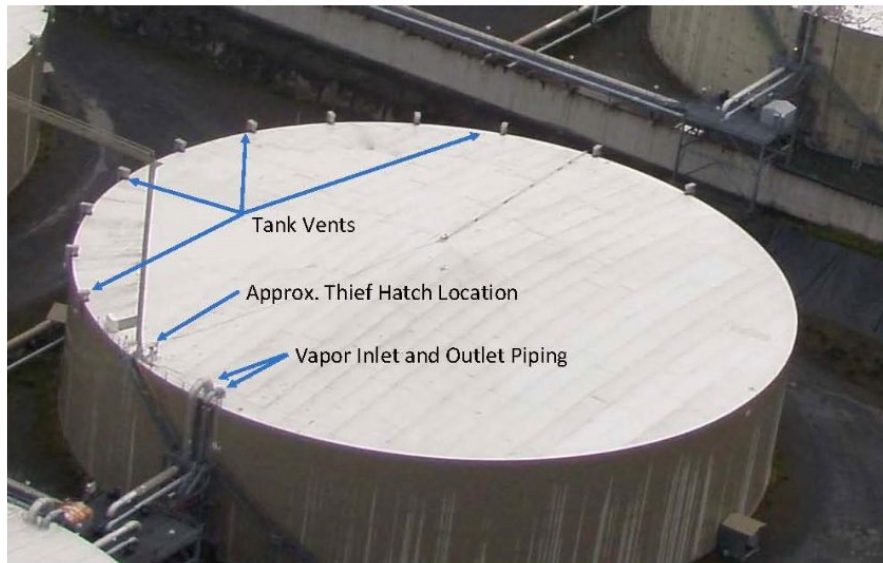
**Figure 2 – Typical Tank, with Certain Details Shown**

Also noted is the location of the thief hatch in close proximity to the vapor inlet and outlet piping. Thief hatches are used to test the tank liquid levels, tank pressure, and the headspace gaseous composition. Given that the thief hatch location is right next to where vapors are being removed and added to the tank headspace, the data collected here are not necessarily an accurate representation of the tank’s gaseous composition as whole. A better design would include more space between the thief hatch and the inlet/outlet vapor piping locations.
