Final Report: PWSRCAC Contract #6531.16.01, “Weather Buoy Demonstration Project”

Rob Campbell

Prince William Sound Science Center

August 15, 2018

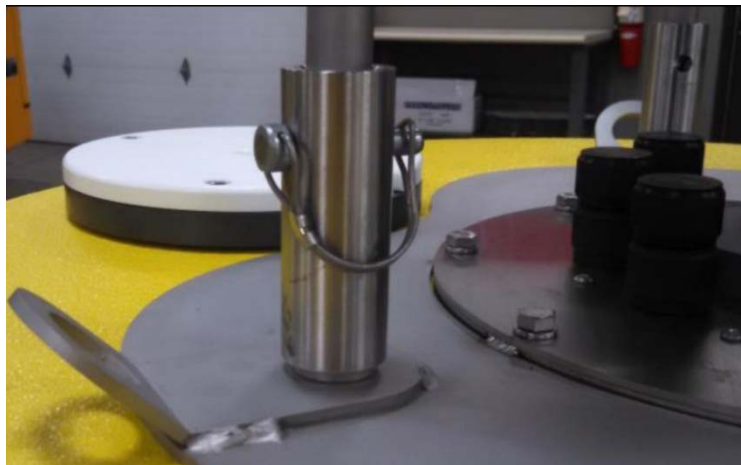
Figure 6: An image from the buoy quickstart manual showing the insertion of the clevis pins. Note that the lifting eye arrangement is different from the PWS buoy.

The pins were installed on the buoy as instructed in the buoy manual, although they were installed from inside-out, because the arrangement of the lifting eyes on the buoy were so close that the pins could not be inserted from the outside (Fig. 5, 6).
