Briefing for PWSRCAC Board of Directors – May 2021

Project number and name or topic: 5056 – Tank 8 Internal Inspection Review

Crude Oil Storage Tank 8 Maintenance Review

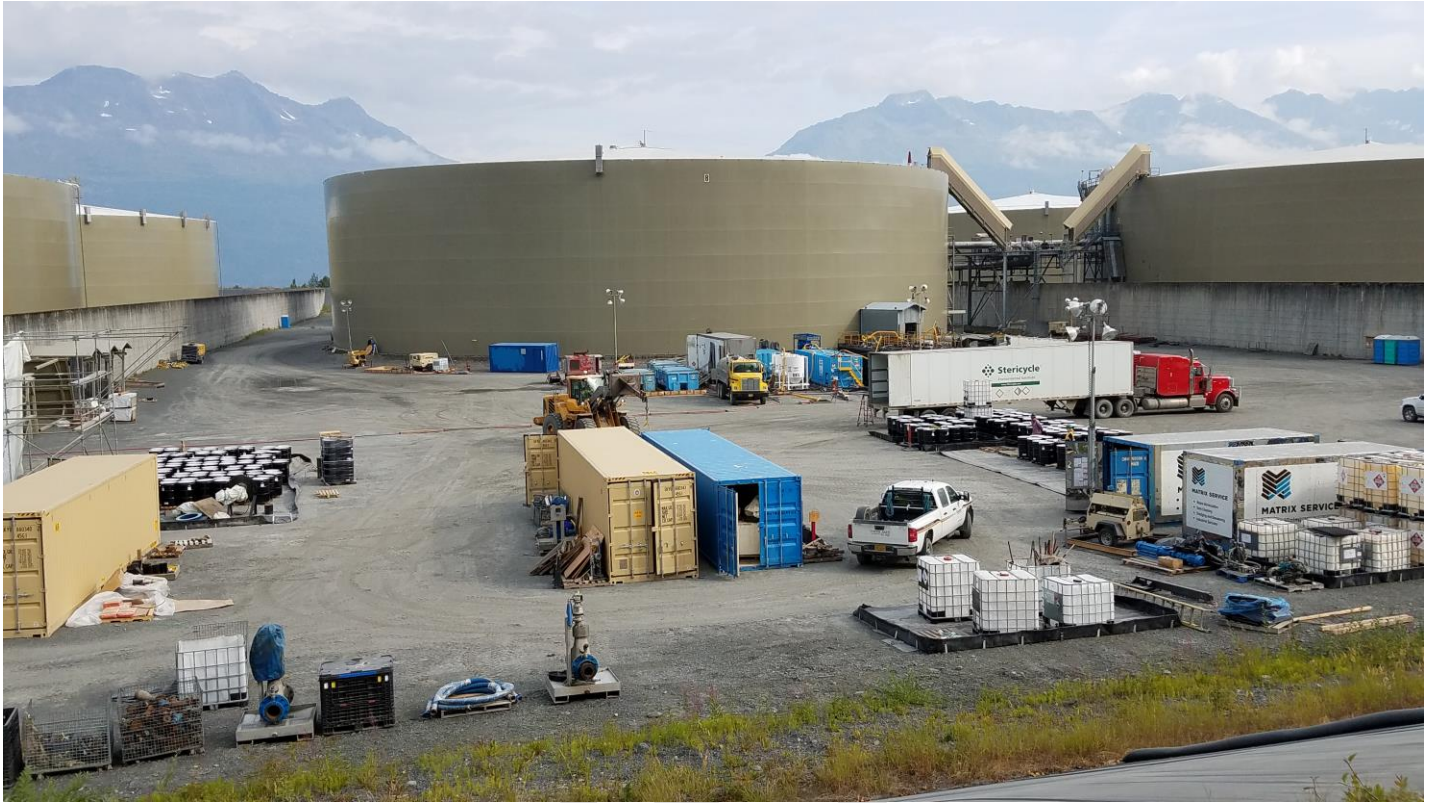
Figure 3 - Tank 8 During 2019 Out-of-Service Inspection (photo courtesy of Austin Love)

Tank 8 was removed from service for internal inspection in 2007 and 2019. After the 2019 out-of-service inspection, minor repairs were completed on the tank floor and the tank was prepared to be coated and returned to service (Figure 3). A follow-up inspection, prompted by one of APSC's engineers, resulted in the discovery of more than 160 additional locations of corrosion that had been missed during the first inspection. At that point, the decision was made to replace the tank floor and CP system. Due to issues arising from the COVID-19 pandemic in 2020, the decision was made to complete minor repairs on Tank 8 and return it to service until 2023. At that time, APSC plans to remove the tank from service and replace the tank floor and CP system.

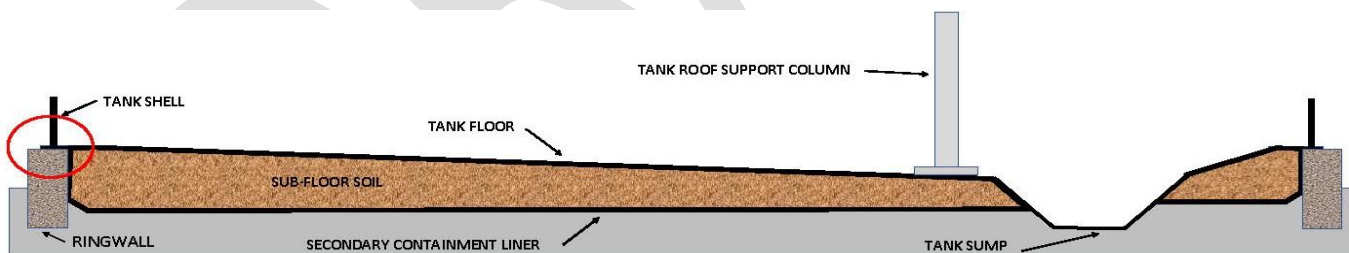
Figure 7 – Crude Tank Foundation and Subfloor Layout

Figure 7 shows a cutaway sketch of the Tank 8 foundation and subfloor layout. The Tank 8 shell (and all of the VMT crude tanks) rests on a concrete ringwall. The floorplate slopes down from the ringwall to the tank sump. The elevation of the perimeter floorplate is 3 feet, 7 inches above the elevation of the bottom of the sump. As shown in the sketch, there are roof support columns in relatively close proximity to the tank sump.

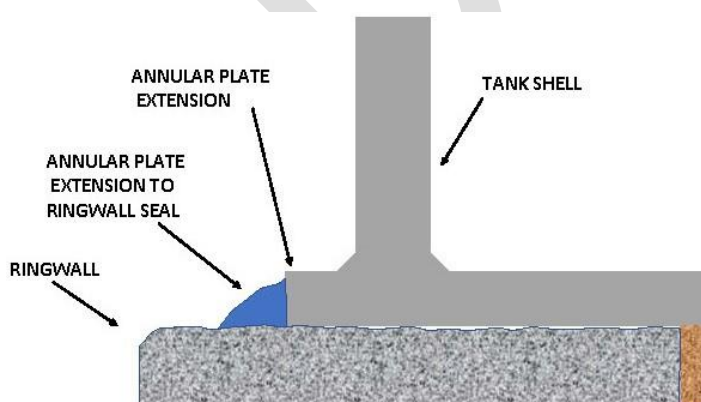
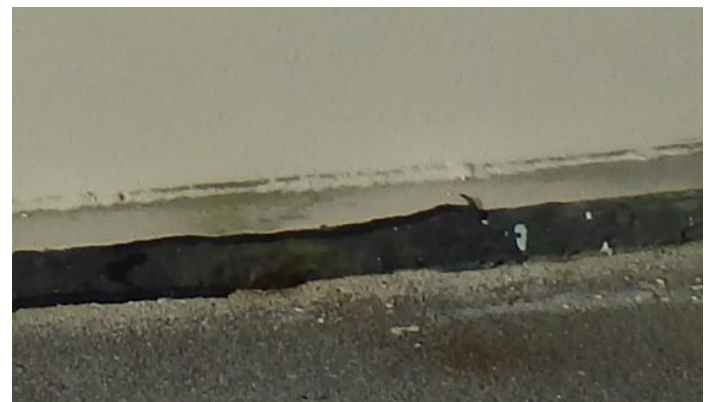
Figure 9 – Annular Plate Extension (Sealed)

Most operators seal between the annular plate extension and the concrete ringwall to prevent rainwater from migrating beneath the tank and increasing the risk of corrosion (shown in Figure 9). Operators typically use a flexible industrial grout to seal this joint in the manner shown below. Differential movement between the steel annular plate extension and the concrete ringwall may damage the seal so it requires frequent inspection and repair. In the 1980s APSC deemed that the seals were not critical and made the decision to allow them to degrade rather than to incur the continued cost to maintain them.

APSC should drain as much water as possible from beneath the tanks through the available drainage piping and CP monitoring tubes. They should replace and maintain the ringwall/floorplate seals to prevent further water intrusion beneath the floors of storage tanks at the VMT.

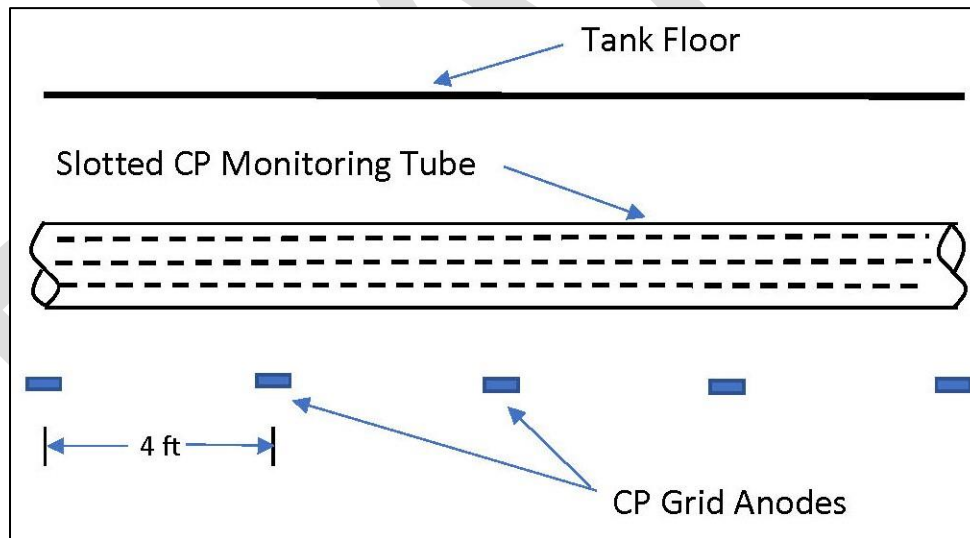
Figure 18 – Subfloor Anode/Monitoring Tube Locations

Regardless of the cause of the error, this statement is basically saying that the very negative readings include an inherent error and are invalid. If the proximity to the anode grid wires was the cause of the error as suggested by the APSC, then to collect accurate data, the operator would have to know precisely where the reference cell was in relation to each anode grid wire and they also would have to determine the minimum distance between the reference cell and anode grid wire that is necessary to collect accurate data. Figure 18 (below) is intended to depict the relative locations between the MMO anode grid wires, the slotted CP monitoring tube, and the floorplate. The CP reference cell is run beneath the tank through the slotted CP monitoring tube and data is collected at set distances from the tank shell. As can be seen from Figure 18, the reference cell will always be within 2-feet of the anode.
