Final report.

Corrosion Survey of Valdez Marine Terminal

Contract Number 559.12.01

December 20, 2012

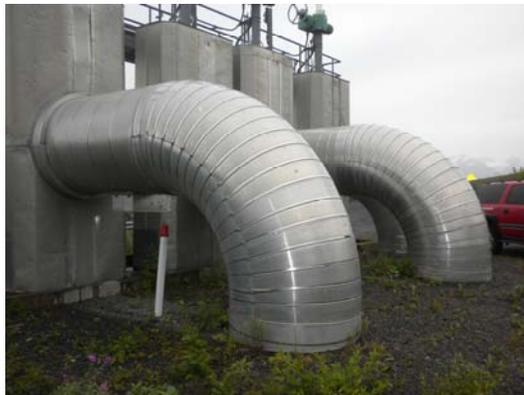
Figure 9: Insulated piping systems at the air-to-soil interface on VMT

Figure 9 shows insulated piping at the VMT. Only the weather-proofing aluminum jacketing is visible.

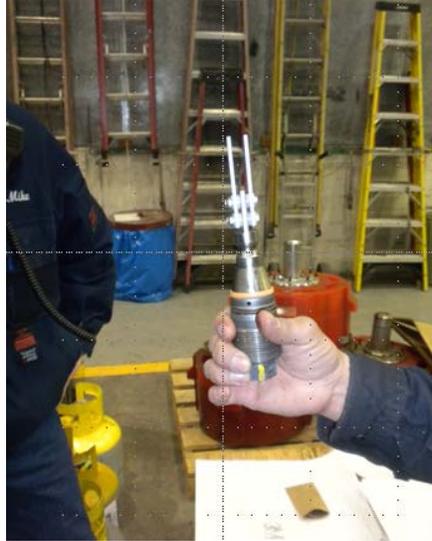
Figure 30: Corrosion coupons attached to a coupon holder

It is obvious that a clean, flat metal sample inserted into the flowing liquid stream cannot measure the corrosion rate of the pipe wall, which has different (but normally turbulent) flow conditions along the bottom (6 o'clock position) of the pipe, the location where internal corrosion is most likely to occur in liquid pipelines.

It is important to note that stagnant crude oil with small amounts of entrained water (emulsified droplets) will separate into a water layer on the bottom of a line or dead leg in a manner similar to what happens in above-ground storage tanks (ASTs). The coupons shown in Figure 30 are usually placed into the piping from the bottom, and it would be unusual for the coupons shown to be exposed in the water layer, if any formed.

For crude oil and oily water lines, the most likely corrosion location for internal corrosion is at the bottom (6 o'clock position). The corrosion coupon probes shown in Figure 30 will not detect corrosive conditions at this location.

The coupon insertion and removal method of corrosion monitoring in use at the VMT is a long-established practice, but it has the same limitations that the localized non-destructive testing (NDT) procedures discussed for Figure 29 showed. The coupons can only measure the corrosivity of the local fluid at the locations where they are placed.

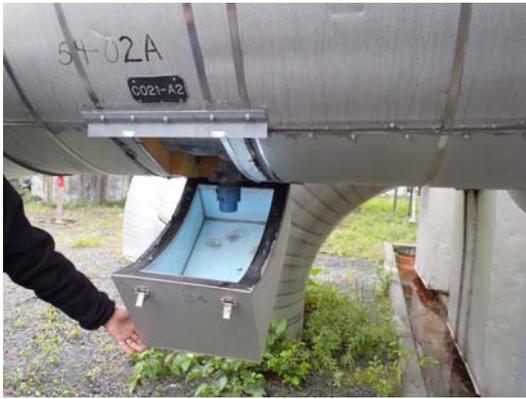
Figure 33: Corrosion inhibitor injection station 54-02A

Figures 33 through 40 show corrosion inhibitor injection points and corrosion coupon points inspected by DRI and APSC personnel (in addition to local contractor escorts) on August 8 and 9, 2012. All of the inhibitor or corrosion coupon stations had excessive moisture dripping from the container boxes. The injector or coupon devices and, more importantly, the carrier pipes were always water wetted. These locations are seen monthly by the corrosion injection crews and semi-annually by the corrosion-coupon crews, employees of two different contractors. There is no evidence that either contractor ever reported the wet piping to the APSC’s decision-making personnel. Perhaps this is due to a lack of guidance to do so by APSC. Guidance to both of these organizations should be provided that require this type of reporting as soon as possible.

APSC procedures and maintenance prioritization processes notwithstanding, Figures 33 through 40 are clear indications to DRI personnel that a reporting system for transferring information between responsible parties, the need for which was discussed earlier in this report, is not in active or in effective operation at the VMT.

APSC guidelines for UT inspection (Figures 34 and 38) and for corrosion inhibitor injection or corrosion coupon insertion/removal crews do not advise the crews to report moisture ingress or corrosion damage.

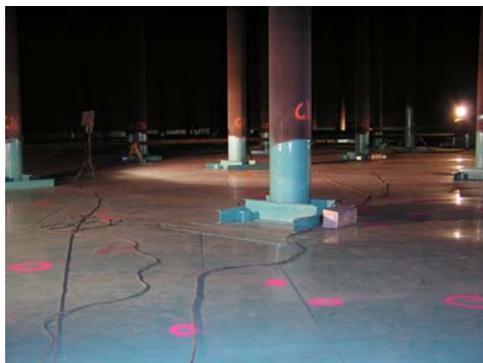
Figure 42: The interior of a large VMT crude oil storage tank during a previous inspection (Photo by T. Kuckertz, PWSRCAC)

Figure 42 shows a crude oil tank interior during a previous inspection and repair. The paint on the lower portion of the vertical support columns as well as the interior tank bottom is obvious in this picture.

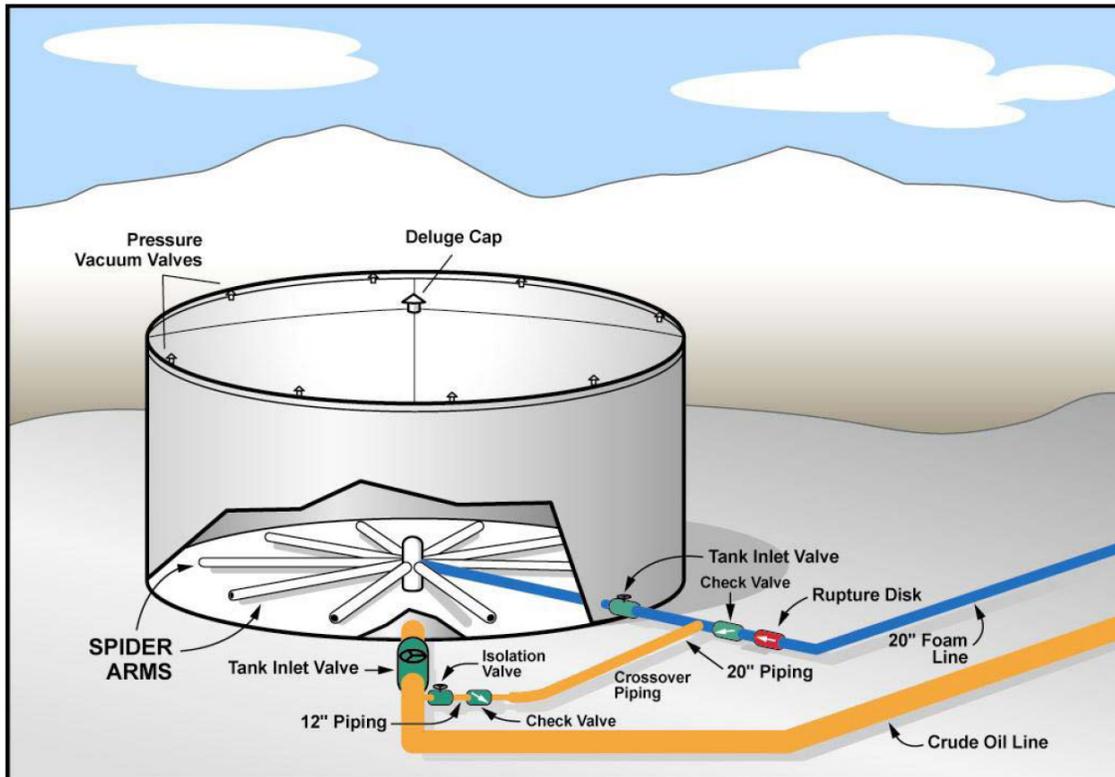
Figure 43: Fire-foam distribution system in a typical VMT storage tank

Figure 43 shows the foam distribution piping systems for a typical above-ground storage tank. In the event of an incident, FFFP foam is mixed and distributed through a piping system to the bottom of the crude oil tanks using carbon steel piping. In recent years, inspections of Tanks 9 and 11 showed that the foam distribution "spiders" in these tanks had corroded, and the corrosion was repaired by using reinforcing sleeves during the 2011 construction season.⁶

APSC T-500, Tank Corrosion Investigation operating procedure was upgraded in early 2012 to require internal and external inspection of these 6 inch foam-distribution spiders flared to 10 inches at the end of the spider. This revised procedure was in use during the 2012 construction season for inspections and possible repairs to Tanks 13 and 14. The same document does not specify any inspection of the piping systems leading to these 6 inch lines. This appears to be an oversight.

The foam distribution systems to the storage tanks are manufactured by specialty suppliers using materials selected for this service. The foam distribution lines are shown in blue in Figure 43. APSC reports the foam distribution pipes are uncoated steel. The storage tanks for the FFFP chemicals prior to distribution are coated steel. APSC reports that these steel FFFP storage tanks are on a 10 year internal inspection cycle, were last inspected in 2012, and will be subjected to an external inspection in 2013. A conference call with a previous consultant retained by PWSRCAC on Thursday,

APSC reports that they conduct annual flow tests of the foam system. These tests ensure the foam skid is in full working order and is able to proportion the foam correctly. In this test, the foam is discharged through test ports rather than through the in-tank distribution system. A method to determine whether the internal foam piping in the crude oil storage tanks is free of corrosion should also be available. While APSC reports that an annual flow test is performed to ensure that the lines are not plugged, this is not the same as inspecting for corrosion. In fact, such testing would not reveal whether a spider is plugged if it had separated due to corrosion. Corrosion of the 20-inch carbon steel crude oil piping shown in Figure 43 was addressed in the revised 2012 version of APSC T-500, but there seems to be no similar inspection of the dedicated foam piping and handling equipment.
