Crude Oil Storage Tank 8 Maintenance Review

PWSRCAC Contract # 5056.20.01

William Mott P.E.

April 2021

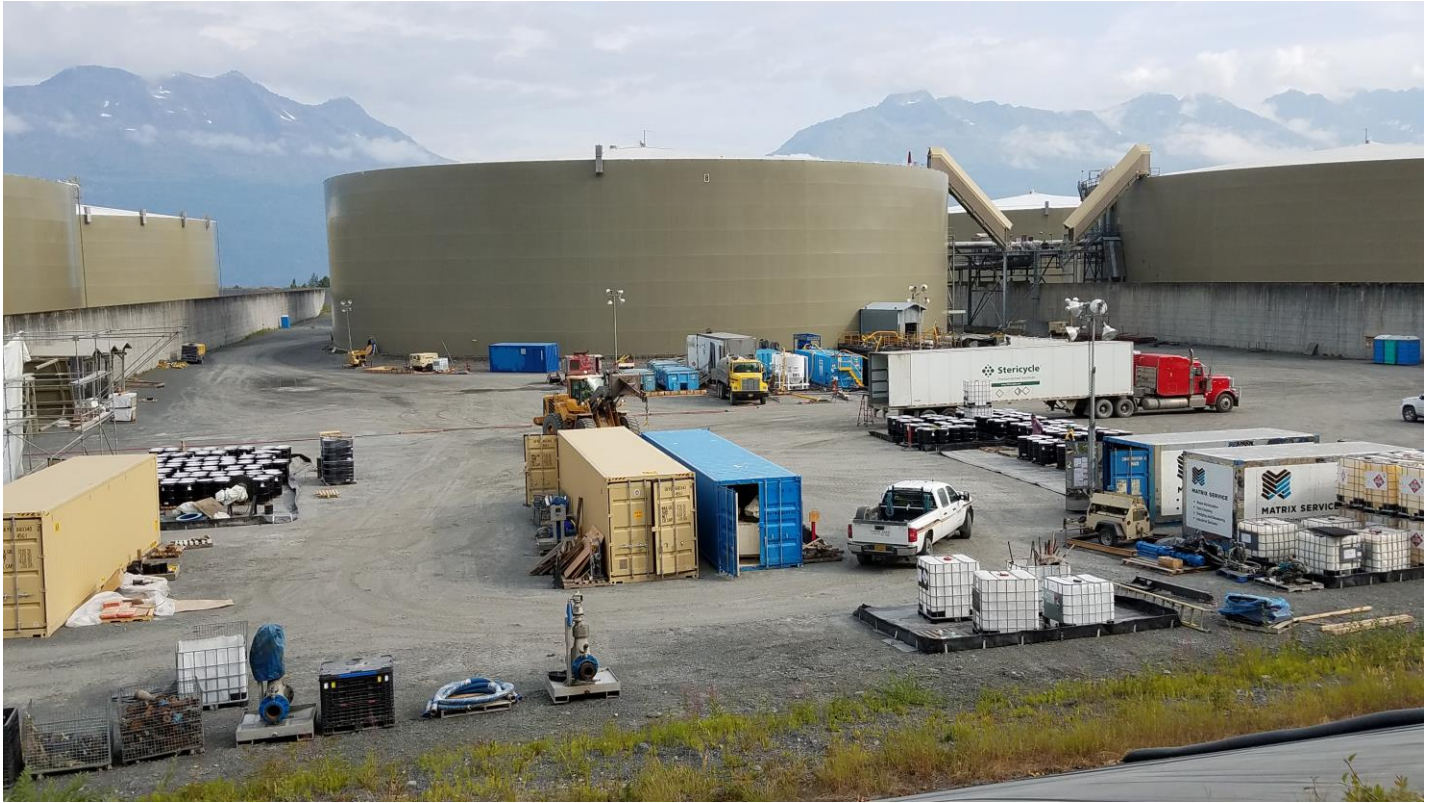
Figure 3 - Tank 8 During 2019 Out-of-Service Inspection (photo courtesy of Austin Love)

Tank 8 was removed from service for internal inspection in 2007 and 2019. After the 2019 out-of-service inspection, minor repairs were completed on the tank floor and the tank was prepared to be coated and returned to service (Figure 3). A follow-up inspection, prompted by one of APSC's engineers, resulted in the discovery of more than 160 additional locations of corrosion that had been missed during the first inspection. At that point, the decision was made to replace the tank floor and CP system. Due to issues arising from the COVID-19 pandemic in 2020, the decision was made to complete minor repairs on Tank 8 and return it to service until 2023. At that time, APSC plans to remove the tank from service and replace the tank floor and CP system.

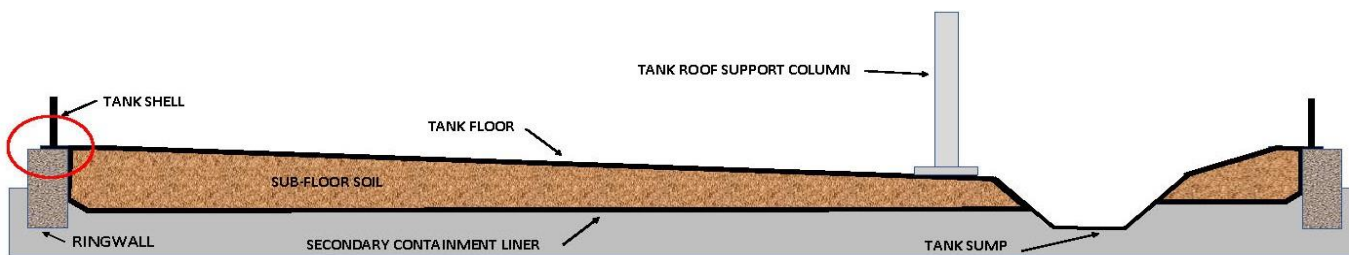
Figure 7 – Crude Tank Foundation and Subfloor Layout

Figure 7 shows a cutaway sketch of the Tank 8 foundation and subfloor layout. The Tank 8 shell (and all of the VMT crude tanks) rests on a concrete ringwall. The floorplate slopes down from the ringwall to the tank sump. The elevation of the perimeter floorplate is 3 feet, 7 inches above the elevation of the bottom of the sump. As shown in the sketch, there are roof support columns in relatively close proximity to the tank sump.

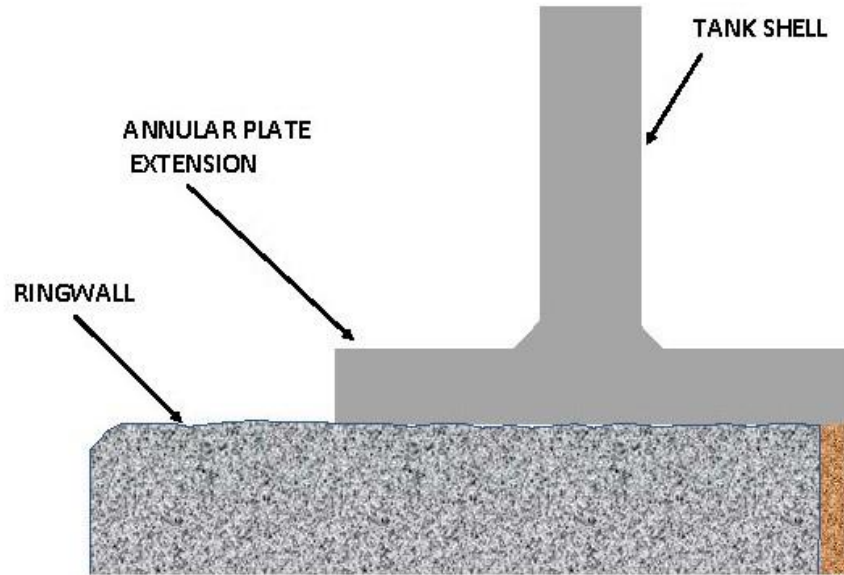
Figure 8 - Annular Plate Extension (No Seal)

Figure 8 represents an enlarged section view of the area in the red circle from Figure 7. The tank annular plate extension (or floorplate extension) rests directly on top of the concrete ringwall. The floorplate extension is not sealed to the concrete ringwall. Any rainwater running down the side of the tank can collect on the top of the ringwall and either run off the outer diameter of the foundation or seep under the annular plate extension and into the soils between the floorplate and secondary containment liner. This can exacerbate corrosion of the tank

floor and potentially lead to buoyancy forces pushing up on the tank floor and damaging it and/or the tank roof column supports – which is discussed in detail later.

APSC should drain as much water as possible from beneath the tanks through the available drainage piping and CP monitoring tubes. They should replace and maintain the ringwall/floorplate seals to prevent further water intrusion beneath the floors of storage tanks at the VMT.

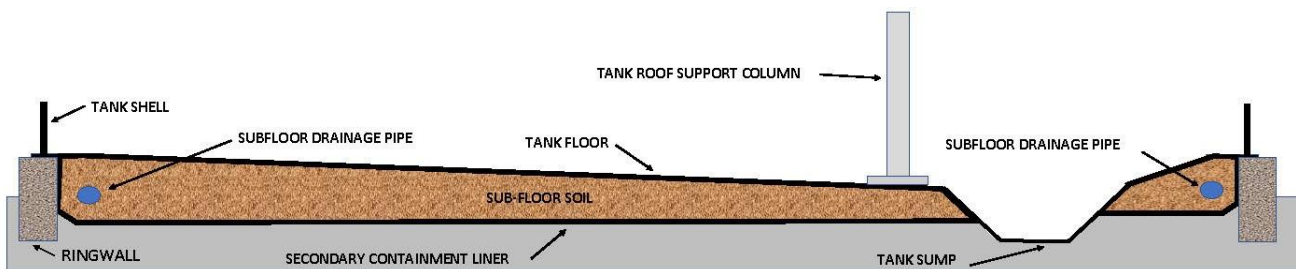
Figure 13 – Subfloor Drainage System Location

On some of the crude storage tanks, APSC installed subfloor drain piping between the tank floor and secondary containment liner (Figure 13). We have not received a record of exactly which tanks have that drainage system. However, the drain piping was installed at a level that is significantly higher than the bottom of the tank sump. While the drain piping will reduce the buoyant forces acting on the sump, it will not totally alleviate those forces.

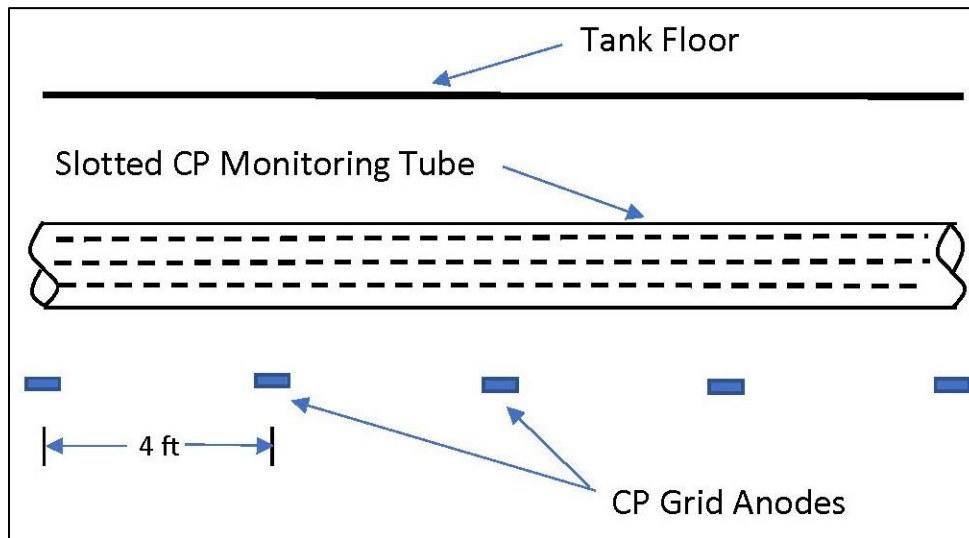
Figure 18 – Subfloor Anode/Monitoring Tube Locations

- Note: readings more negative than -1.4V are due to being taken in close proximity to the MMO grid wires.

Regardless of the cause of the error, this statement is basically saying that the very negative readings include an inherent error and are invalid. If the proximity to the anode grid wires was the cause of the error as suggested by the APSC, then to collect accurate data, the operator would have to know precisely where the reference cell was in relation to each anode grid wire and they also would have to determine the minimum distance between the reference cell and anode grid wire that is necessary to collect accurate data. Figure 18 (below) is intended to depict the relative locations between the MMO anode grid wires, the slotted CP monitoring tube, and the floorplate. The CP reference cell is run beneath the tank through the slotted CP monitoring tube and data is collected at set distances from the tank shell. As can be seen from Figure 18, the reference cell will always be within 2-feet of the anode.
