A Review of Double Hull Tanker Oil Spill Prevention Considerations

Report to Prince William Sound RCAC

December 2009

Elise DeCola
Nuka Research & Planning Group, LLC.
P.O. Box 175 Seldovia, Alaska 99663
contact@nukaresearch.com

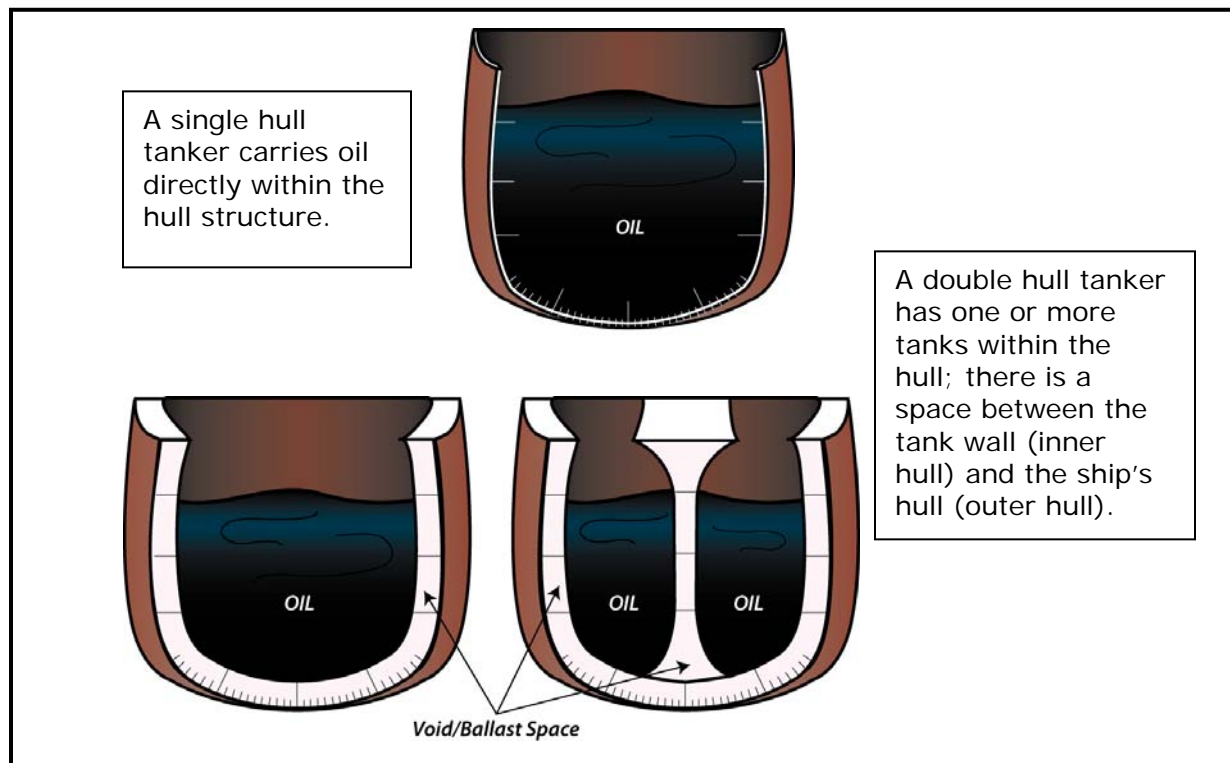
Figure 1.1 Typical Single and Double Hull Configurations

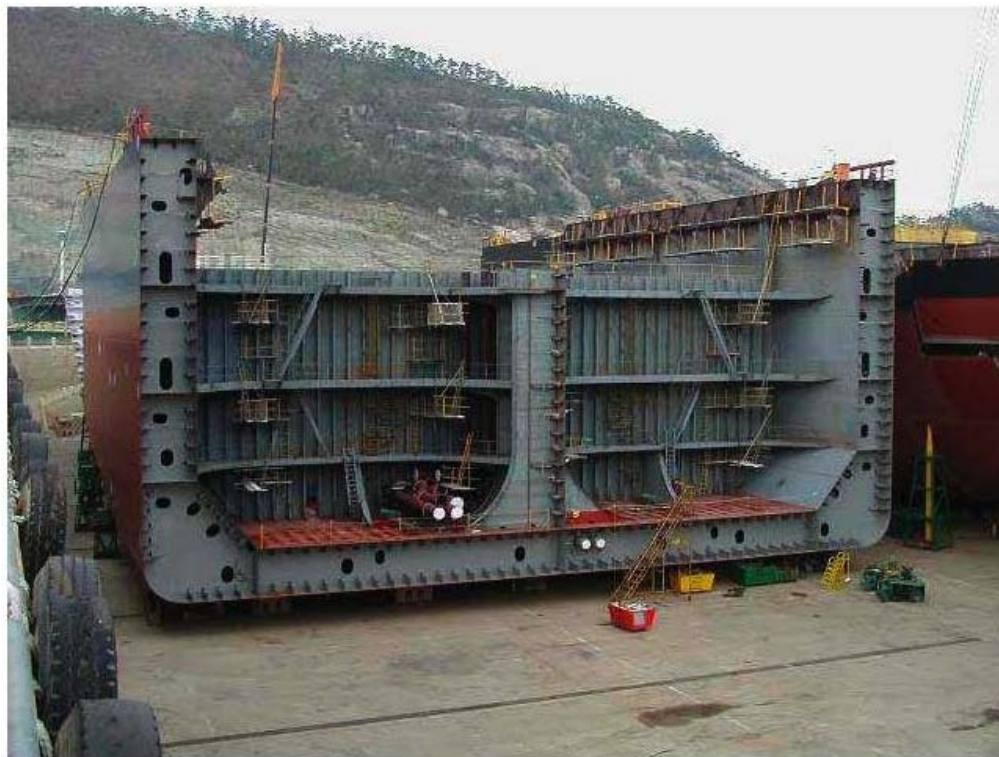
**Figure 2.2 Double Hull Tanker under construction, showing tank spaces and double hull/ballast area (Source: AMSA, 2002)**

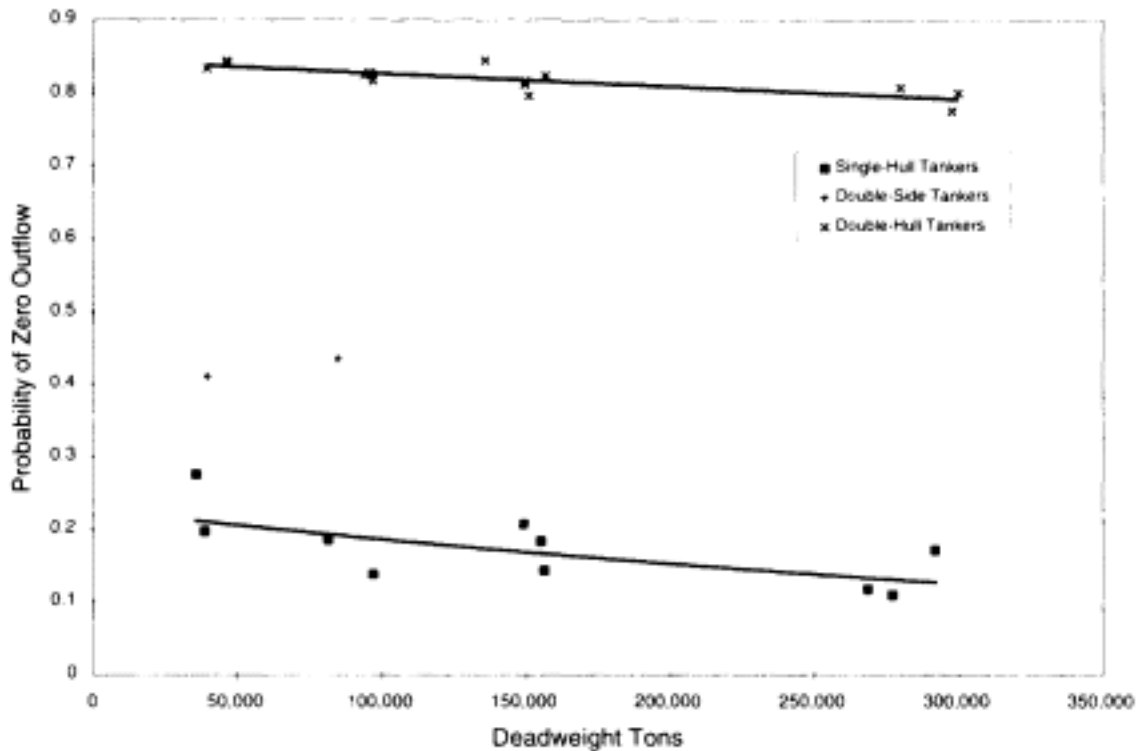
Figure 2.2 Probability of zero outflow for single and double hull tankers (Source: Herbert Engineering Corporation, 1996)

Similar to the Coast Guard study, the 1998 NRC study found that oil outflow from a double hull tanker will occur only if the extent of penetration exceeds the distance between the inner and outer hulls (thereby piercing the cargo tank). The expected spill size is directly related to the number of cargo tanks breached and their size, therefore the likelihood of a double hull tanker spilling oil is heavily influenced by the configuration and dimensions of double bottom and wing tanks. There is therefore a tradeoff between the internal subdivision of cargo tanks and the spacing of bulkheads from tank boundaries – larger cargo tanks have the potential to spill more oil, while smaller tanks that are configured closer to the bulkhead increase the likelihood that more than one tank could be damaged. The study also showed that the subdivision of cargo and ballast tanks by centerline bulkheads can be important to reducing oil outflow in the event of a collision or grounding.

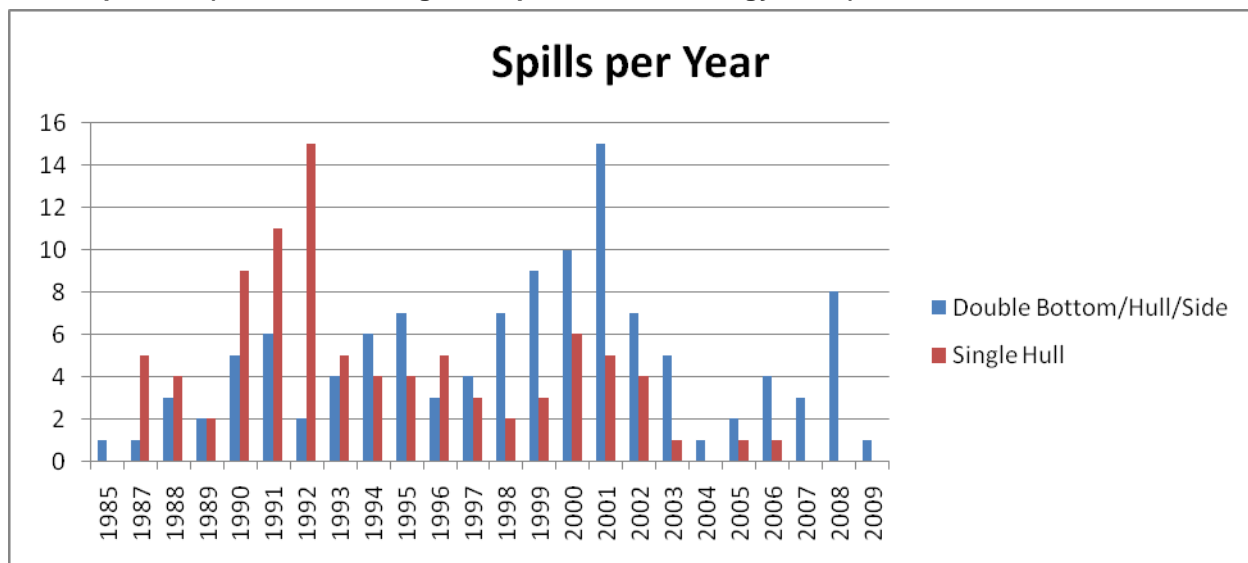
Figure 3.5 Number of Oil Spills from Tanker per Year, in Washington State, from 1985-present (Source: Washington Department of Ecology, 2009).

As shown in Figure 3.5, for each year from 1985 through 1997 (with the exception of 1989), significantly more single hull tankers spilled oil in Washington than double hull tankers. Beginning in 1998-1999, there is a shift in these proportions, with

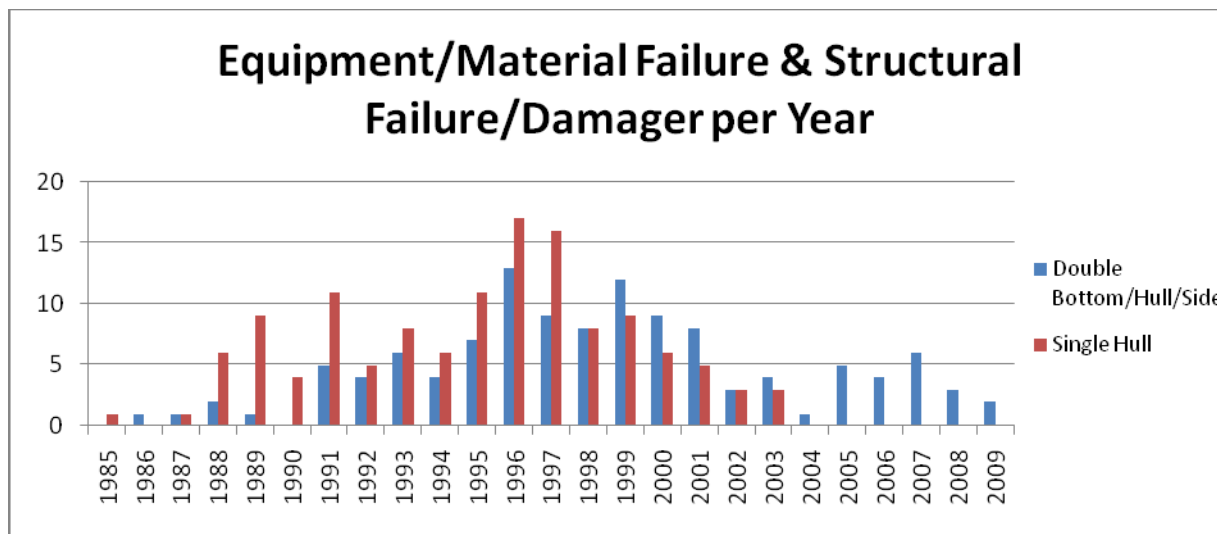
Figure 3.6 Number of Tanker Equipment/Structural Failure Incidents per Year, in Washington State, from 1985-present (Source: Washington Department of Ecology, 2009).

The Washington data set on tanker incidents was also examined to compare trends in the types of incidents that have occurred over the past 24 years based on hull configuration. Figures 3.6 through 3.8 show the number of incidents by hull type and year for three major categories: Equipment, material or structural failure; Fire and explosion; and Loss of Propulsion or Steering (note that these are not oil spills, but reported incidents). Since 2003, incidents involving equipment/structural failure and loss of steering/propulsion have been much more prevalent among double hull vessels, while the fire/explosion data is more variable. For incidents involving equipment/structural failure and fire/explosion, overall numbers have trended downward since the early-mid 1990s. However, the trend is less obvious for incidents involving loss of propulsion/steering, with a relatively high number of incidents involving double hull tankers during several years of the past decade.

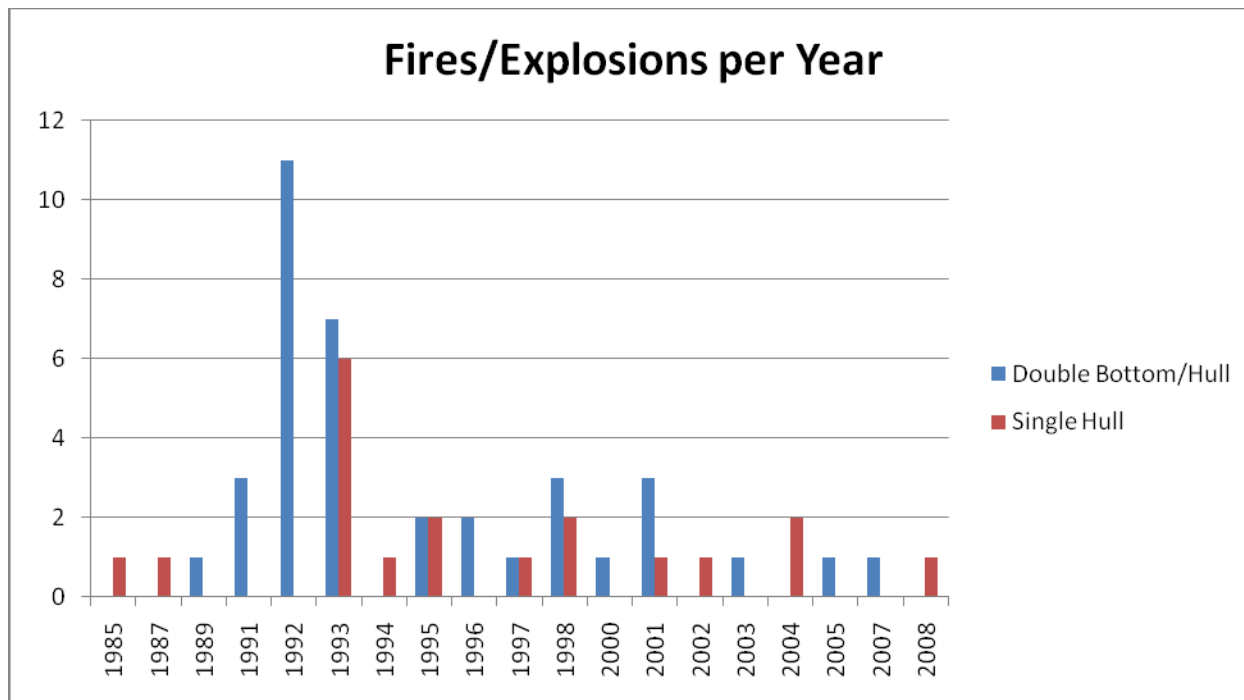
Figure 3.7 Number of Tanker Fire/Explosion Incidents per Year, in Washington State, from 1985-present (Source: Washington Department of Ecology, 2009).

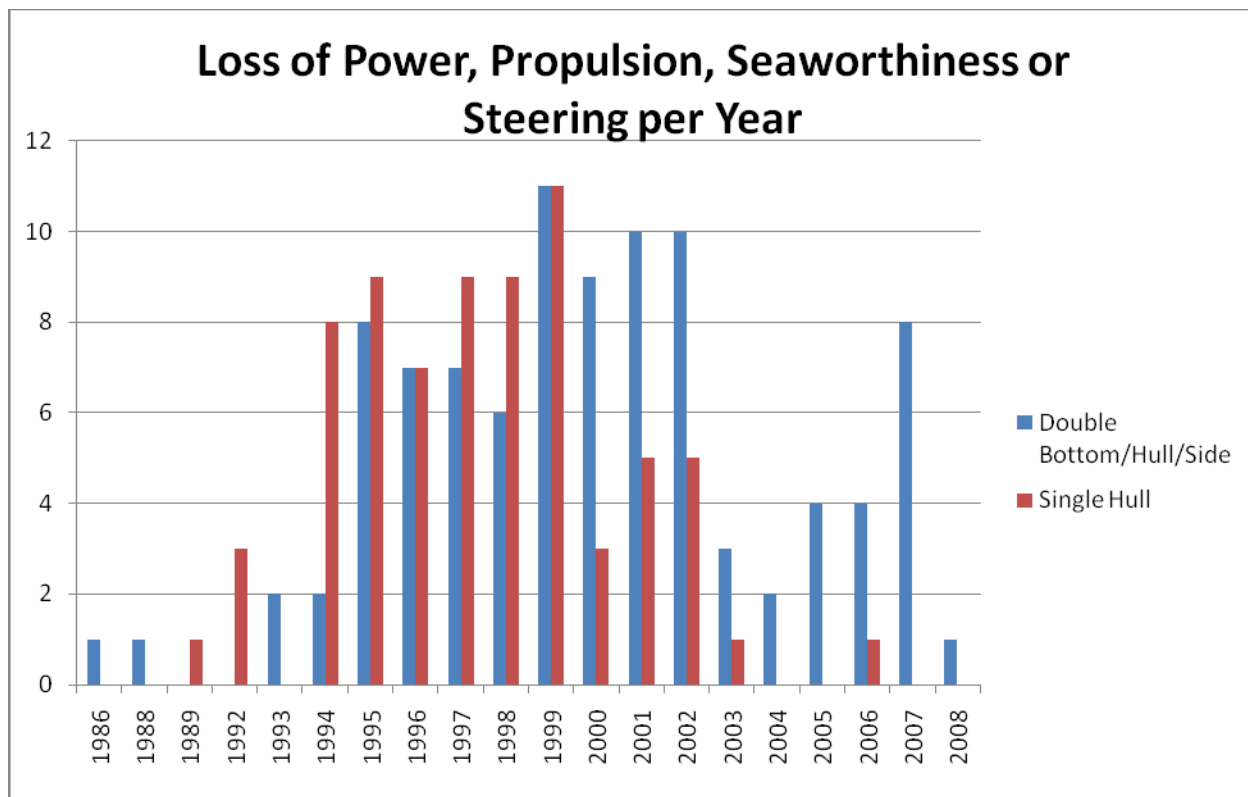
Figure 3.8 Number of Tanker Loss of Propulsion/Steering Incidents per Year, in Washington State, from 1985-present (Source: Washington Department of Ecology, 2009).

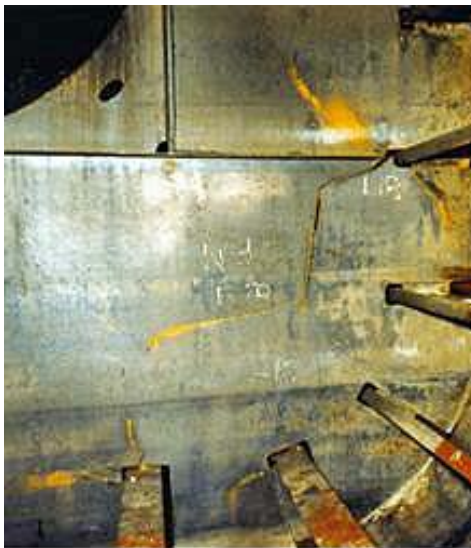
Figure 4.2 Example of fatigue crack (from single hull tanker)

Fatigue cracks, which may occur on all vessel types, can propagate over time and if no action is taken (repairs, etc.) then a major structural failure may occur. Fatigue cracks are associated with cyclical stress and can be linked to poor design, corrosion, stress concentration, incorrect use of high tensile steel and a vessel's trading patterns/area of operation. Fatigue cracks are generally found on older vessels although they have been found on vessels within five years of delivery (EMSA, 2004). Figure 4.2 shows a fatigue crack in the transverse web plating of a wing water ballast tank in a single hull tanker.

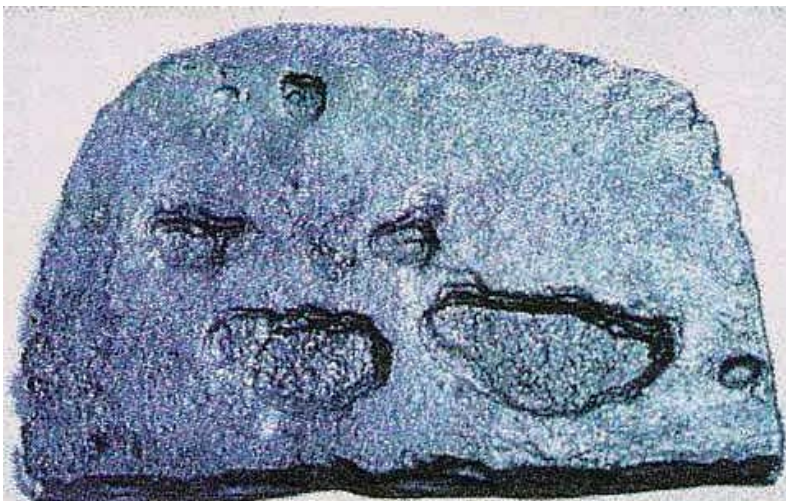
Figure 4.3 Steel plating taken from cargo tank in double hull tanker showing pitting corrosion brought about by microbial attack (Source: EMSA)

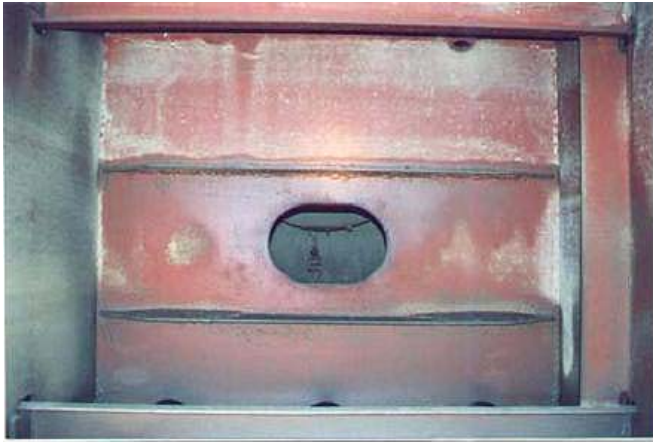
Figures 4.4 Properly applied ballast coating in 13-year old vessel (Source: IACS)

One of the most effective means for preventing corrosion is to protect the hull structure with an efficient coating system. However, the protective coating applied during vessel construction does not always remain effective during the lifetime of the vessel. Improper maintenance of protective coatings and cathodic protection in ballast tanks can lead to leakage and sometimes to fire risks. Once the protective coating has broken down, it can be extremely difficult to repair. Figures 4.4 and 4.5 show ballast tanks from two ships of the same age (13 years). In Figure 4.4, the ballast tank coating was properly applied, while in Figure 4.5 it was not. (EMSA, 2004).

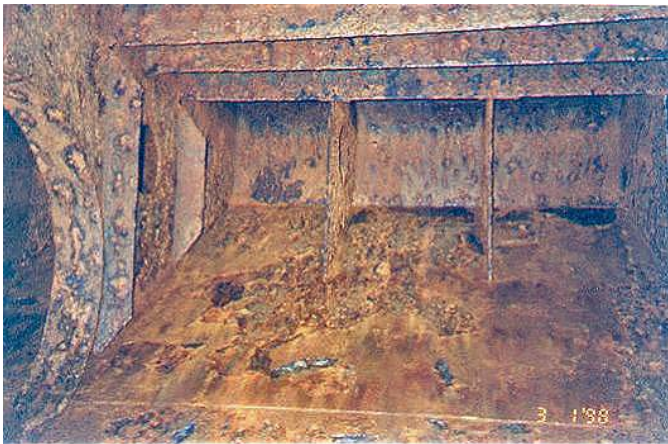
**Figure 4.5 Improperly applied ballast coating leads to significant corrosion in another 13-year old vessel (Source: IACS)**

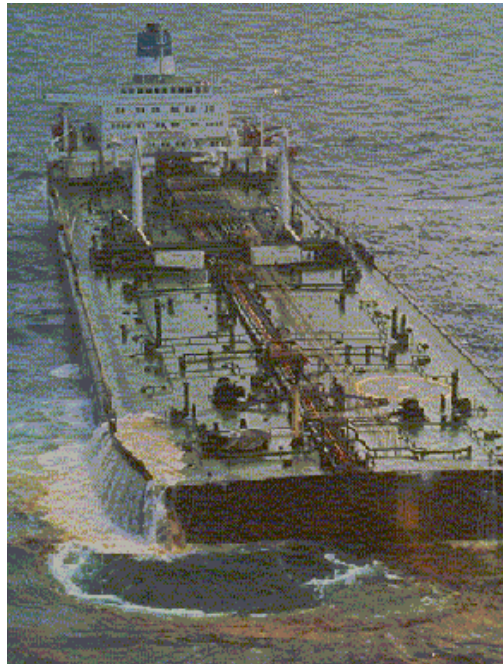
Figure 4.6 Tanker *Kirki* showing missing bow section (Source: AMSA)

Regular maintenance and inspection is the key to identifying and correcting many of the other deficiencies discussed in Sections 4.1 through 4.4 of this report. When issues such as hull fatigue or corrosion goes undetected, major problems may ensue. For example, undetected corrosion was identified as the cause of one of the more spectacular structural failures of tankers over the last few years, the *Kirki*, which lost its bow off the coast of Western Australia in 1991 and spilled approximately 5.4 million gallons of crude oil. Figure 4.6 shows an image of the *Kirki* with the damaged bow section missing. (AMSA)
