A Review of Double Hull Tanker Oil Spill Prevention Considerations

Report to Prince William Sound RCAC

December 2009

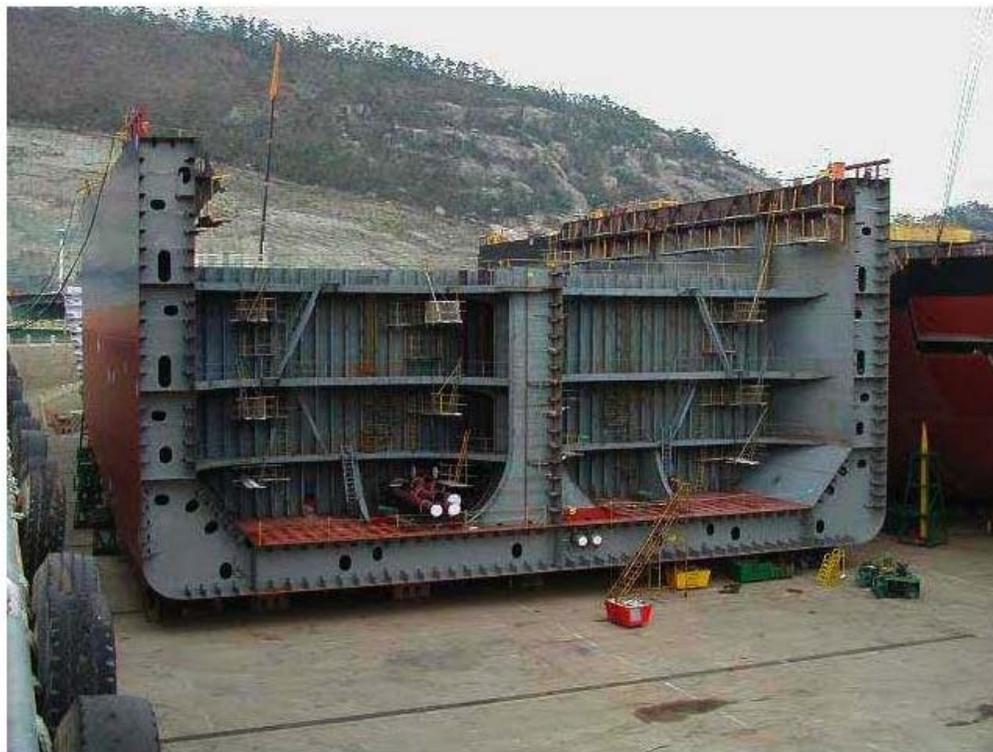
**Figure 2.2 Double Hull Tanker under construction, showing tank spaces and double hull/ballast area (Source: AMSA, 2002)**

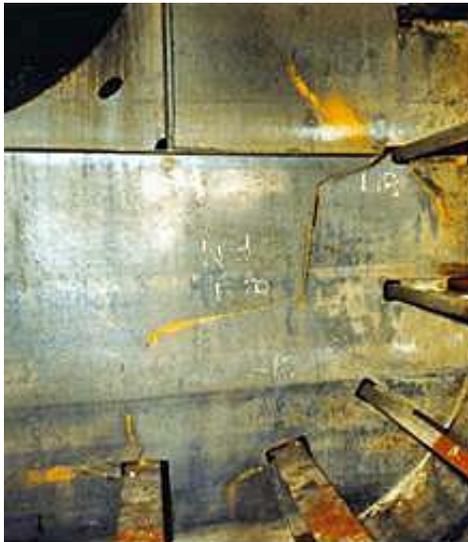
Figure 4.2 Example of fatigue crack (from single hull tanker)

Fatigue cracks, which may occur on all vessel types, can propagate over time and if no action is taken (repairs, etc.) then a major structural failure may occur. Fatigue cracks are associated with cyclical stress and can be linked to poor design, corrosion, stress concentration, incorrect use of high tensile steel and a vessel's trading patterns/area of operation. Fatigue cracks are generally found on older vessels although they have been found on vessels within five years of delivery (EMSA, 2004). Figure 4.2 shows a fatigue crack in the transverse web plating of a wing water ballast tank in a single hull tanker.

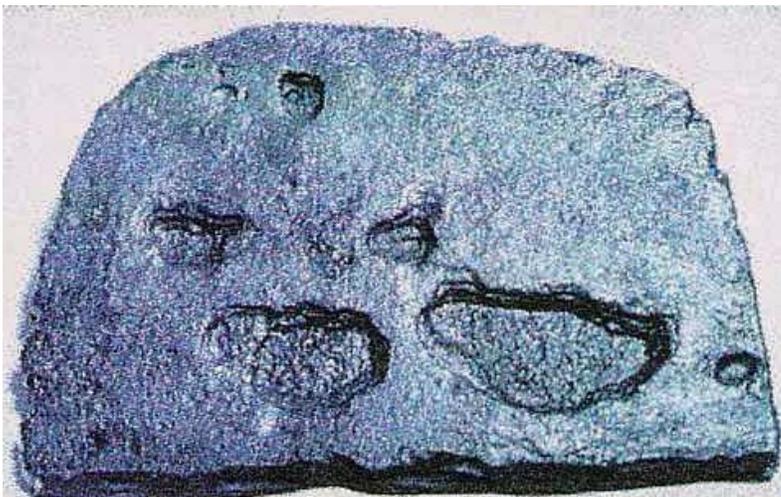
Figure 4.3 Steel plating taken from cargo tank in double hull tanker showing pitting corrosion brought about by microbial attack (Source: EMSA)

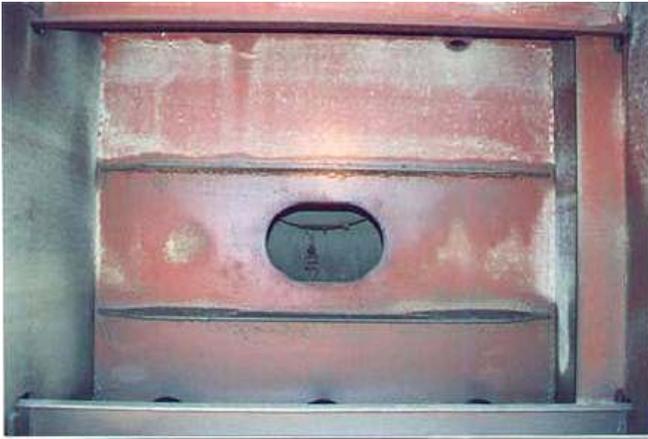
Figures 4.4 Properly applied ballast coating in 13-year old vessel (Source: IACS)

One of the most effective means for preventing corrosion is to protect the hull structure with an efficient coating system. However, the protective coating applied during vessel construction does not always remain effective during the lifetime of the vessel. Improper maintenance of protective coatings and cathodic protection in ballast tanks can lead to leakage and sometimes to fire risks. Once the protective coating has broken down, it can be extremely difficult to repair. Figures 4.4 and 4.5 show ballast tanks from two ships of the same age (13 years). In Figure 4.4, the ballast tank coating was properly applied, while in Figure 4.5 it was not. (EMSA, 2004).

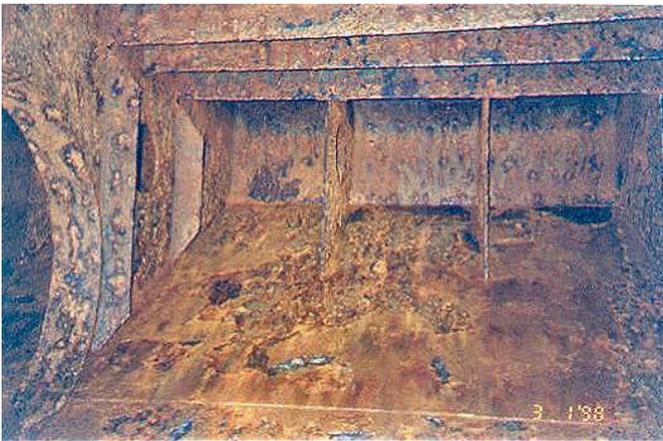
**Figure 4.5 Improperly applied ballast coating leads to significant corrosion in another 13-year old vessel (Source: IACS)**

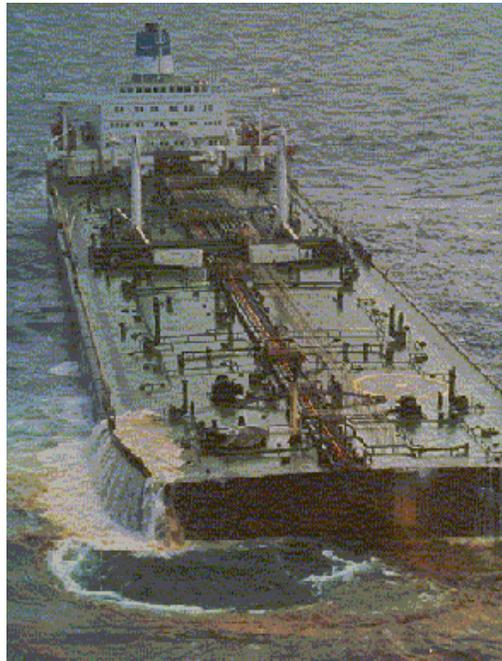
Figure 4.6 Tanker *Kirki* showing missing bow section (Source: AMSA)

Regular maintenance and inspection is the key to identifying and correcting many of the other deficiencies discussed in Sections 4.1 through 4.4 of this report. When issues such as hull fatigue or corrosion goes undetected, major problems may ensue. For example, undetected corrosion was identified as the cause of one of the more spectacular structural failures of tankers over the last few years, the *Kirki*, which lost its bow off the coast of Western Australia in 1991 and spilled approximately 5.4 million gallons of crude oil. Figure 4.6 shows an image of the *Kirki* with the damaged bow section missing. (AMSA)
