Briefing for PWSRCAC Board of Directors – May 2021

Project number and name or topic: 5998 – Valdez Marine Terminal Cathodic Protection Systems Review

REVIEW OF CATHODIC PROTECTION SYSTEMS AT THE VALDEZ MARINE TERMINAL

Project 5998.19.01: Cathodic Protection Systems Review

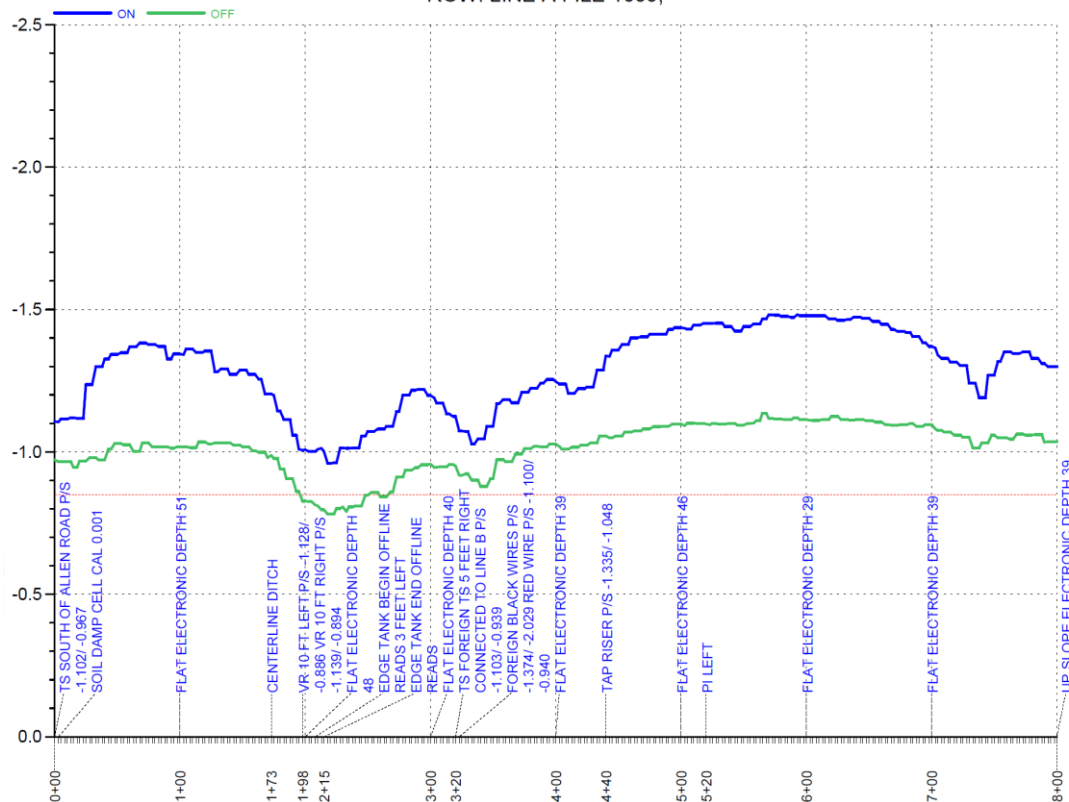
Figure 8: Sample Close Interval Survey Graph

A graph is typically generated to plot the “ON”, “Instant OFF” or polarized potential, and a reference line showing -0.850 volt criterion threshold. The “ON” potential is when the cathodic protection system is energized. This reading is generally irrelevant as it has known measurement errors due to current flowing through resistance of the soil. The “Instant OFF” or polarized potential is more critical in validating adequate cathodic protection. Typically, one would look to have these polarized potentials between -0.850 volts and -1.150 volts. Those polarized potentials less negative than -0.850 volts (e.g., -0.750 volts) would be indicative of inadequate cathodic protection. Likewise, polarized potentials more negative than -1.150 volts (e.g., -1.300 volts) would be indicative of erroneous readings. Figure 8 shows a sample close interval survey graph one might expect to see.

In the case of the CIS that was provided by Alyeska, most of the "Instant OFF" or polarized potentials measured were more negative than -1.150 volts. And in many instances, these polarized readings are more negative than -1.500 volts. All of these readings from this CIS are impacted by the same errors previously discussed above and are thus inconclusive to the true cathodic protection levels along this piping.

Alyeska recognizes these potentials as being erroneous as they're adjacent to the AnodeFlex™ cathodic protection system. This is noted on their graph in a text box underneath the Legend that reads, "Areas with high instant-off readings are adjacent to AnodeFlex systems." The close proximity of the AnodeFlex cathodic protection to the pipeline inherently causes some voltage gradients to remain in the soil. Obtaining potential
